Failure Mechanism Analysis and Support Technology for Roadway Tunnel in Fault Fracture Zone: A Case Study

Abstract: This paper introduces a case study on the failure mechanism and support design of a roadway tunnel in the fault fracture zone of the 106 mining area in the Yuandian no.2 coal mine. Based on the on-site geological conditions (in-situ stress test, borehole television imaging, and lithological analysis), the failure mechanism of the roadway tunnel in the fault fracture zone was studied. The test results showed that the high tectonic stress, fractured rock, and poor lithology are the primary reasons for the roadway instability. According to the support principles of grouting reinforcement, pre-reinforced support, and rational support range, a new type of combined support technology was proposed, including advanced grouting, grouting bolts, and grouting anchor cables. A 100 m roadway section was selected for field testing using the new support scheme, and detailed deformation monitoring was performed. Monitoring results showed that the roadway deformation under the new support was significantly reduced. During the roadway excavation process, no roof collapse phenomenon oc

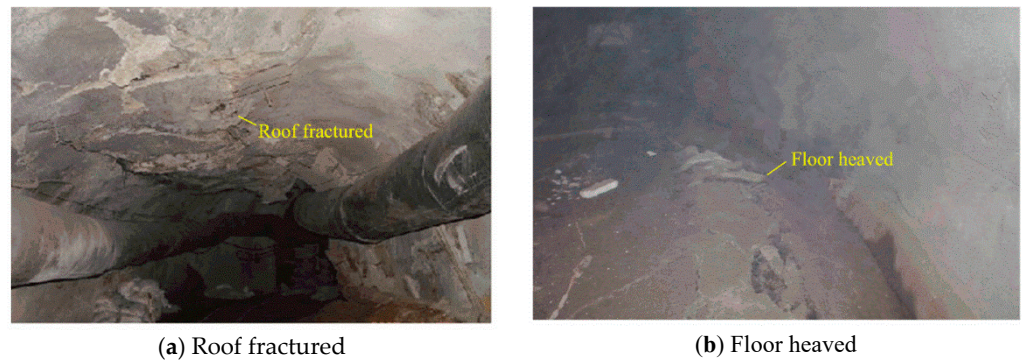
With this roadway support structure adopted, the anchor cable and bolt support were destroyed. As shown in Figure 4, the roof fracture and floor heave were clearly observed during the excavation process. Figure 5 shows the displacement curve of deep surrounding rock in the roof at different tested depths. At some zones, the displacement of deep surrounding rock in the roof was extremely large, and the maximum value reaches 128 mm. The damage of the roadway surrounding rock may be caused by the weak and broken nature of the fault fracture zone, which contains disordered layering, and numerous fractures. As time passed, the anchor cables were loose, which caused the anchor cable support to fail [31]. Moreover, the stress on the fault fracture zone was complicated, which allowed for easy deformation of the roadway after excavation, and thus seriously endangered roadway safety. The field monitoring results showed that the initial support design cannot meet the roadway support requirements in the fault fracture zone.

Figure 4. Roadway failure characteristics under the initial supporting design.

The original support only uses bolts and cables, which is not suitable for the support of roadways in the fractured area. Due to the unreasonable initial support design and lack of specificity, the roadway seriously deformed. During the roadway excavation process,

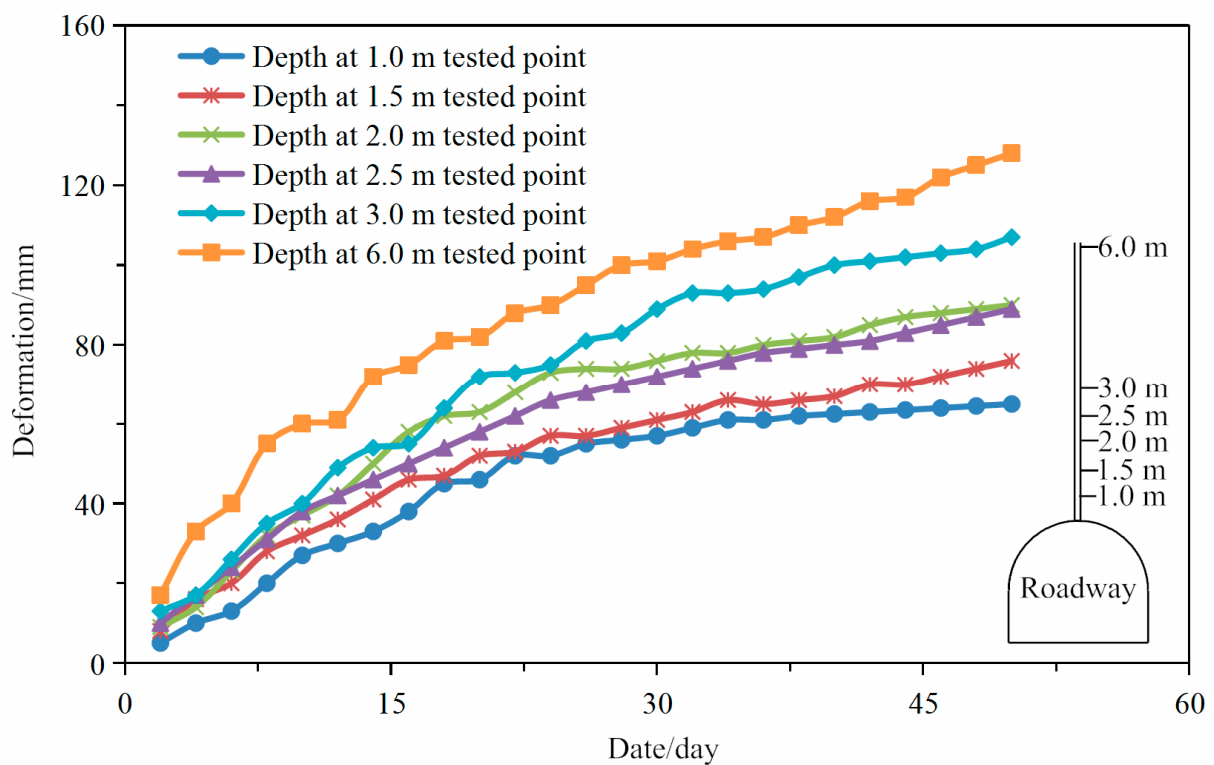
Figure 5. Displacement curve of deep surrounding rock in the roof with the initial support.

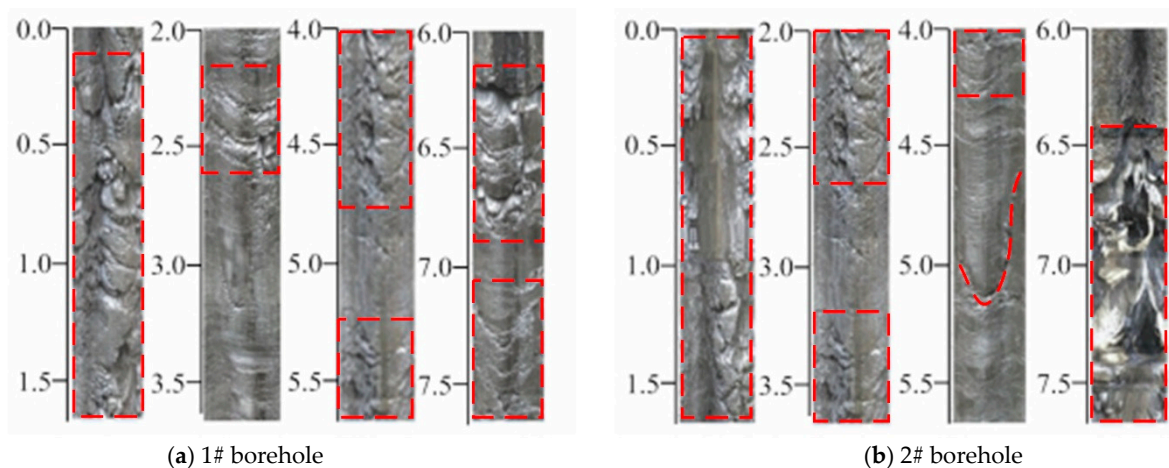
**Figure 7.** Fractures of surrounding rocks from borehole television imager.

The observation showed that the surrounding rock of the roadway is relatively broken, and there is basically no complete surrounding rock. In the range of 2.5 m, the surrounding rock of the roadway was seriously broken, and the anchoring effect of the bolt was seriously affected. In the range of 3~6 m, many groups of horizontal fissures were found in the surrounding rock. A wide range of delamination occurred in the range of 6.5~7.0 m, which was the main cause of roof collapse.

- iii. Rational support range: Field test results showed that the damage depth of the surrounding rock is large, and large-scale delamination and broken rock masses can still be observed at 6.5 m. The length of the anchor cable of the initial support design is only 6.2 m, which is less than the damage depth of the surrounding rock, making the support useless. Therefore, the new support range should be greater than the damage depth of the roadway.

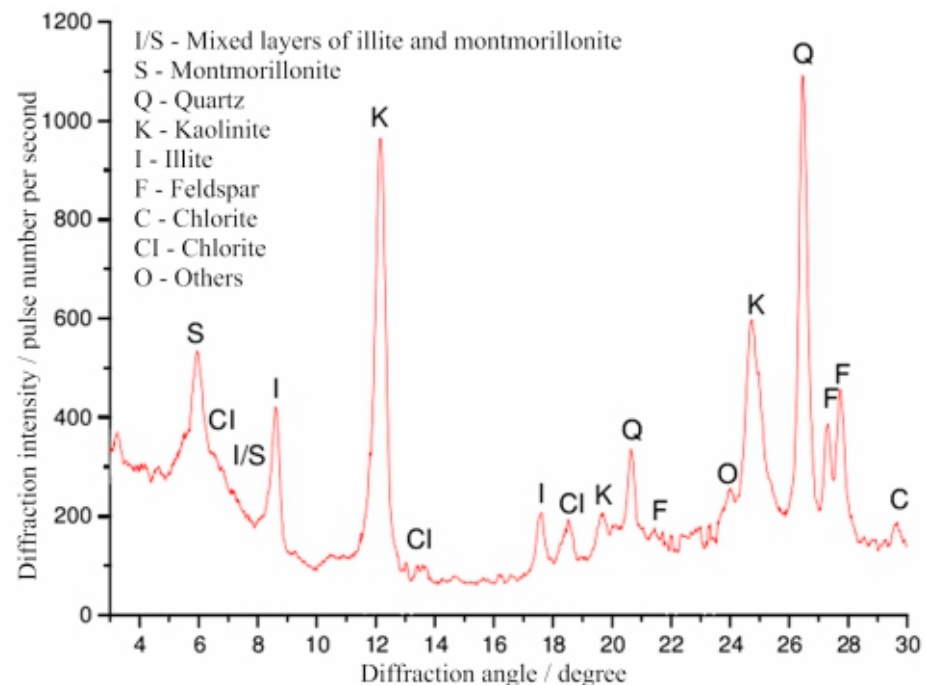
During roadway excavation, the surrounding rock undergoes softening and swelling to water, which further decreases the strength of the surrounding rock. To determine the mineralogical composition of the mudstone, X-ray diffraction analysis was used, and the results are shown in Figure 8. This mineral composition test uses the D8Advance powder crystal X-ray diffractometer produced by the German Bruker Company (Karlsruhe, Germany). In terms of software, the international powder diffraction database (PDF), the powder crystal inorganic crystal structure database (ICSD), and the corresponding analysis software are configured. As shown in Figure 8, the mudstone was composed of a large amount of kaolinite, montmorillonite, and mixed layers of illite and montmorillonite. Among them, kaolinite has water absorption when it is dry, and has plasticity after moisture. The montmorillonite and mixed layer of illite and montmorillonite absorb water and expand rapidly, becoming paste-like. When the rock mass reacts with water physically and chemically, the properties of the rock mass change dramatically, and its volume expands over time, resulting in huge expansion pressure and large deformation. The volume expansion after hydration can exceed 50%.

Figure 8. Mudstone mineral composition X-diffraction pattern.

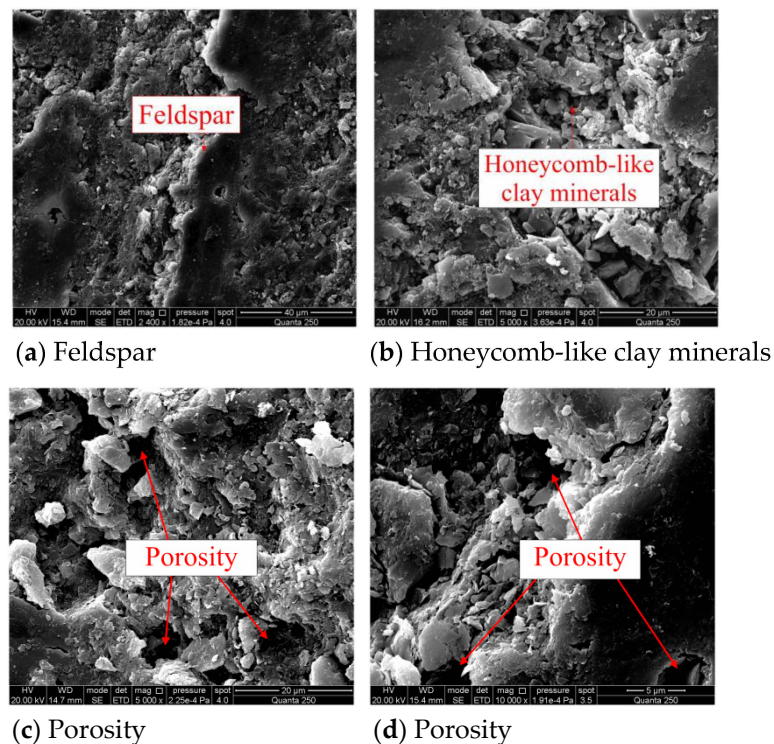
Scanning electron microscopy (SEM) was used to observe the microscopic morphology and composition of the mudstone, as shown in Figure 9. The scanning electron microscopy used the QuantaTM 250 environmental scanning electron microscope produced by FEI Company (Hillsboro, OR, USA) to obtain the micro-morphological features under 2000 times magnification. Results show that intergranular fissures are more developed, and the rock has good water conductance. The expanded pores in the mudstone increase the porosity and the hydrolysis effect of the rock mass. The three-dimensional grid-like holes and the random accumulation between the particles reflect the good permeability of the mudstone and the development of the space channel. Whether it is kaolinite or montmorillonite, uneven expansion occurs after exposure to water, resulting in a large amount of pores. The appearance of these pores destroys the original internal structural system of the rock, which in turn promotes softening and disintegration.

Figure 9. SEM photomicrographs of mudstone.

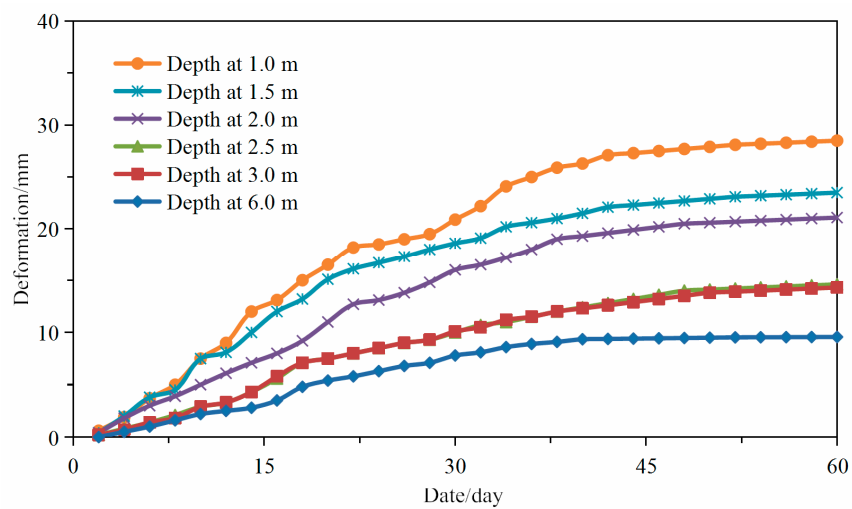
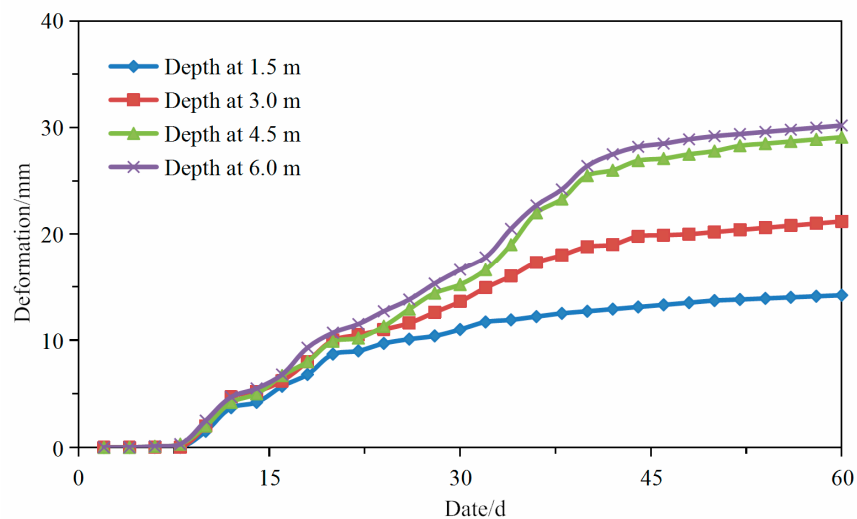
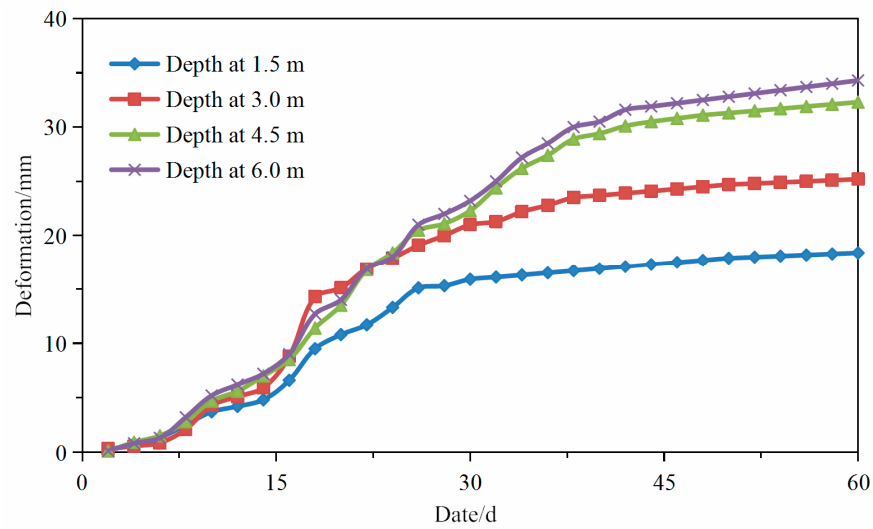
Figure 14 show the displacement curves of the deep surrounding rock in the monitored section. Figure 14a shows that the relative displacement within 6 m of the surrounding rock of the roadway roof is less than 30 mm during the observation period, and Figure 14b,c show that the relative displacement within 6 m of the surrounding rock of the roadway gang is less than 40 mm. After 40 days, displacement of the roadway surrounding rock began to converge, indicating that the overall strength of the roadway surrounding rock after grouting was improved, and the roadway surrounding rock was effectively controlled. The support method can effectively maintain roadway stability.

Figure 14. Displacement curve of the deep surrounding rock in the section roadway.

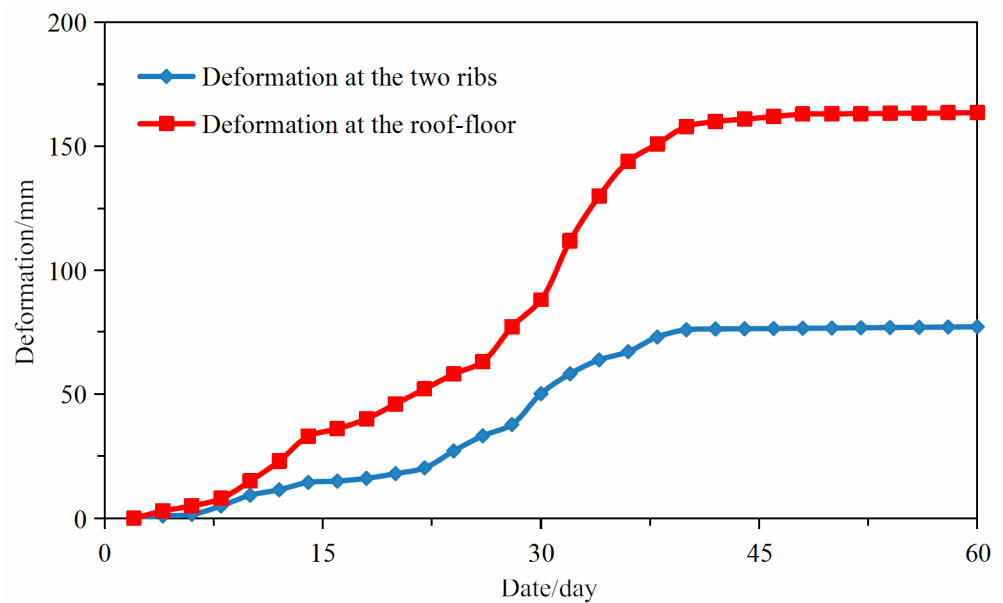
Figure 15. Surface displacement curves.

The deformation from the two ribs at the monitored section is 75 mm, and the deformation from the roof–floor is 161 mm. After 40 days of roadway construction, roadway deformation began to converge. Roadway deformation after support is obviously reduced, and deformation speed is effectively controlled, making the roadway much safer overall. During the monitoring period, there is no obvious deformation of the surrounding rock of the roadway after adopting the new support design, indicating that the new support design can control the deformation and ensure the long-term stability of the roadway. The effectiveness of the new support design can be visually observed in Figure 16.

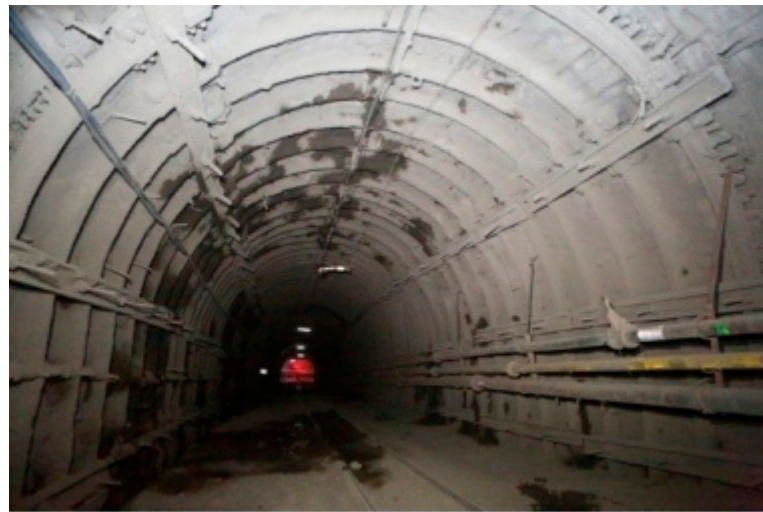
Figure 16. Tested support scheme.
