Dynamic Process and Damage Evaluation Subject to Explosion Consequences Resulting from a LPG Tank Trailer Accident

Citation: Wang, K.; Liu, Y.; Wang, H.; Liu, X.; Jiao, Y.; Wu, Y. Dynamic Process and Damage Evaluation Subject to Explosion Consequences Resulting from a LPG Tank Trailer Accident. *Processes* **2023**, *11*, 1514. <https://doi.org/10.3390/pr11051514>

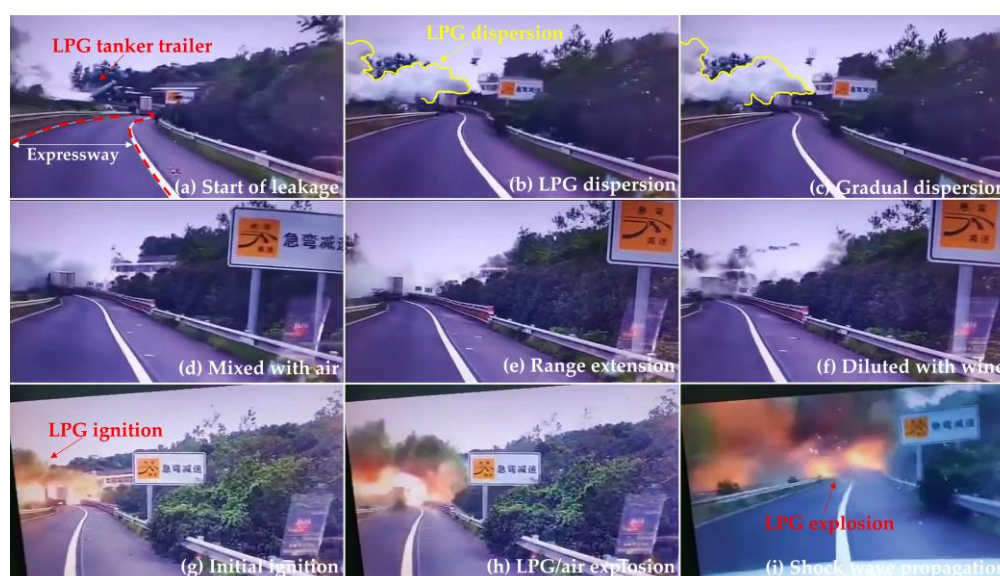
On 13 June 2020, an LPG explosion occurred on the expressway leading to Wenling city of Zhejiang Province, China. A traffic accident occurred in the vicinity of LPG tank trailers, forming a domino effect of accidents. In the initial event involving an LPG tank trailer driving on the expressway, it affected more objects nearby and stimulated unconventional behaviors. The accident induced fuel release, gas/liquid dispersion, mixtures fire, vapor cloud explosion or even toxic gas poisoning. The accidental events generating the damage of the initial LPG pressurized tank are analyzed using the computational method and models, and the core evolution process is developed with the time lapse by TNO's discretization [26]. The domino effect was brought about in the failure of LPG tank trailer and other nearby facilities, resulting in a serial chain of events with greater impact scope and extremely serious damage. Because of the expressway road status, drivers' mistakes, vehicle anomaly or ambient conditions, traffic accidents such as scraping, overturned vehicles and collision occurred between vehicles, pedestrians, and fixed objects during the transport of the LPG tank trailer. Figure 1 shows the whole process of LPG leakage and explosion after LPG tank trailer failed. It can be found that a gas leakage occurred on the accident site, which was similar to white mist. Due to the high internal pressure of the LPG tank, the leaked LPG dispersed in the accident area. At the initial stage, the gas had a high concentration and formed a cloud-like dispersion pattern, as shown in Figure 2b,c. As the leakage time gradually increased, the gas concentration in the accident area was gradually diluted due to the effect of ambient wind speed. LPG was characterized by heavy gas, and began to spread downwind along the nearby ground. As the LPG pressurized tank's internal temperature was much lower than the ambient temperature in accident area, it caused the leaked medium to change from white mist to colorless gas quickly. The gas cloud could not be detected, but the risk of explosion was great. As shown in Figure 2g, the spark at the bottom of the vehicle ignited the gas, and the vapor cloud exploded instantly. The explosion caused by the vapor cloud was so fast that the fire spread westward due to ambient winds. Table 1 shows the material and characteristic parameters related to the LPG tank trailer that exploded.

Figure 1. Accidental chain of the LPG tank trailer failures and explodes in expressway transport.

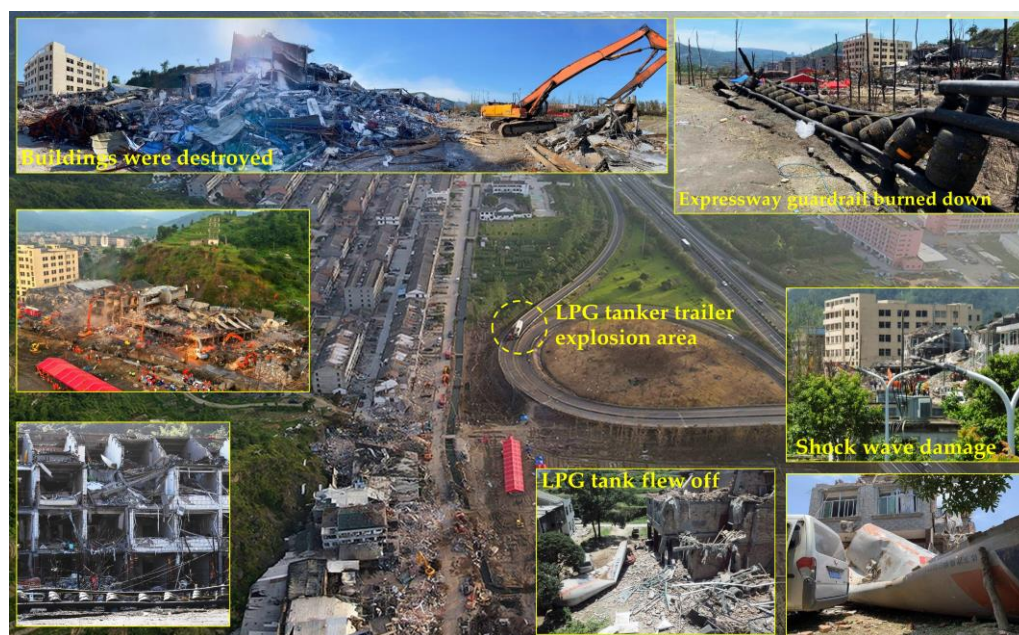
Figure 2. Catastrophic consequences caused by LPG tank trailer explosion in expressway.

In the explosion accident caused by the LPG tank trailer failure, 25 people were killed, 24 seriously injured, and the direct economic damage reached USD 14 million. The remarkable overpressure and shock wave-induced impulse of the explosive products impacted the vessel's internal wall of LPG tank trailer, causing the metal tank to deform. Figure 2 showed that the shock wave directly affected the expressway ground from the LPG tank trailer accident site, resulting in serious damage. The LPG tank trailer's vessel was thrown several kilometers away by the explosion and was found severely crushed and deformed. With the propagation of shock wave, the LPG tank and pavement structure cracked and produced debris. As the explosion expanded the air, the explosive fragments attained a high speed in the process, and these fragments flew around the area of the explosion accident irregularly. When the fragments blew apart, the fragments also accelerated under the pressured action of explosive products. LPG leaked into instantaneous combustion, which was bound to produce a fireball. The fireball transmitted the heat flux to surroundings instantly, which led to the transfer of the thermal effect that posed harm to humans and structures. With the high temperature generated by the explosive fireball, a large number of vehicle windows burst due to the burning heat. Residential buildings near the explosion area were severely damaged, and the front of the building closest to the explosion site was completely destroyed. Residential buildings were affected by the shock wave, and glass areas and other structures were damaged to different degrees. Because the shock wave had a wider impact, the glass doors of residential buildings along the street were directly and completely shattered. The building located on the southwest side of the accident site, collapsed due to the impact of the flying tank. The guardrails on both sides of the expressway were completely destroyed. The fireball's high temperature caused injury to surrounding people who had not been successfully evacuated, resulting in burn injury to people within a certain range.

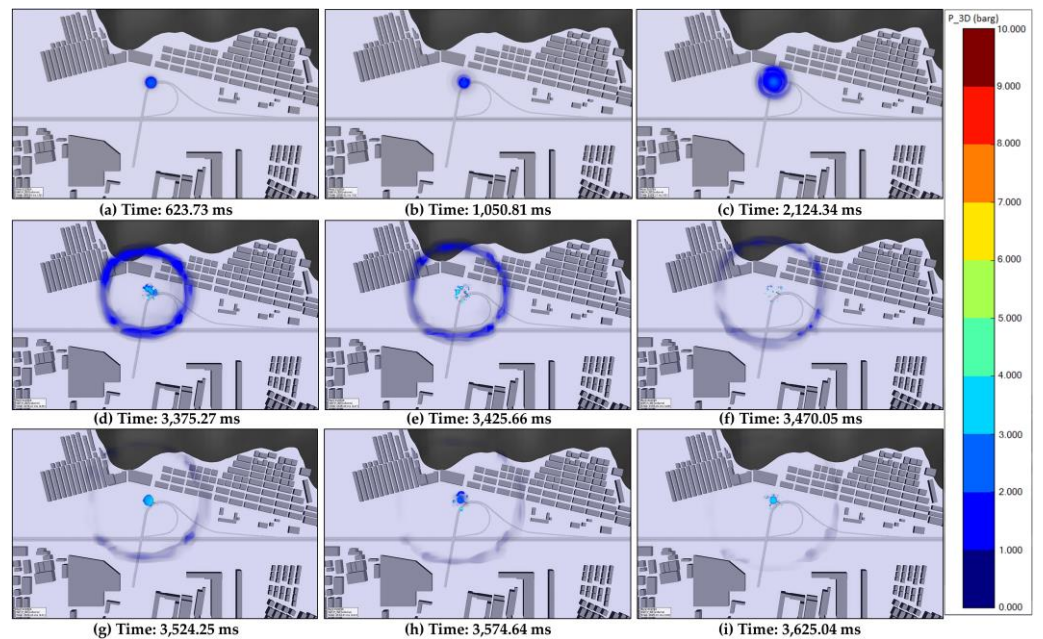
Figure 6. The vertical representation of shock wave propagation during the explosion process.

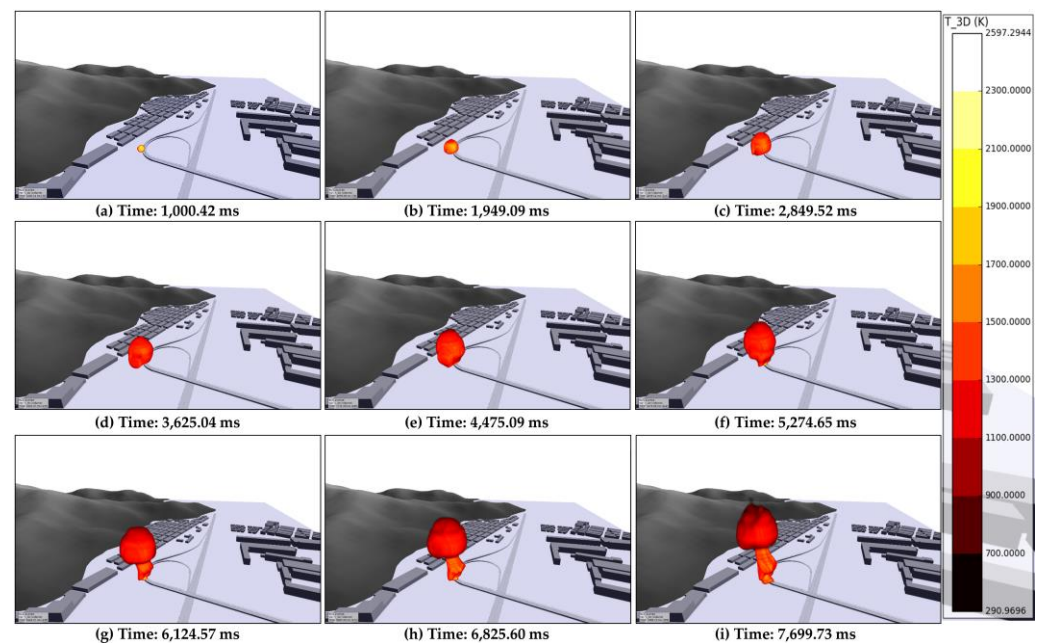
Figure 7 presents the complete explosion process of LPG tank trailer on expressway. Figure 7a shows the initial explosion of the LPG/air mixture induced by ignition. Since the explosion of the LPG/air mixture has occurred, obvious temperature field changes can be observed at the accident site. Figure 7b–d shows the overall process of the LPG tank trailer forming the explosive fireball after the expressway accident. At this point, the temperature image indicates that the fireball has fully engulfed the entire collision area. This is because the explosive fireball gradually changes from momentum-driven to buoyancy-driven activity as the mass of LPG increases. According to on-site MP data, it is found that the temperature rise rate caused by the LPG explosive fireball has the largest variation range in this period. In Figure 7e–f, it can be clearly seen that the explosive fireball has quickly formed a hemispherical shape on the surface of the expressway. The combustion intensity of the LPG/air mixed vapor cloud inside the explosive fireball rises rapidly, and

the explosive fireball radius reaches its maximum on the ground. As the LPG fireball forms on the ground, it begins to lift into the air gradually. The LPG explosive fireball forms spherical size directly above the LPG tank trailer explosion site. The burning flame generated by the explosive fireball appears in yellow and red, and constantly transmits heat radiation to the environment area. Eventually, LPG/air mixture inside fireball is further depleted, and the intensity of thermal radiation gradually diminishes. When the LPG tank trailer explosion takes place in the expressway, the surrounding residents flee in panic after the explosion, and the thermal radiation directly causes burns to people at the scene. The fireball rises into the air to form a complete spherical structure and begins to dissipate. The fireball burns red orange, accompanied by a lot of thick black smoke. The formation and lifting of the LPG fireball are observed from the left and right sides of the expressway. The result shows that the LPG explosive fireball forms a regular half-ball formation near the expressway path and then gradually rises into the air, where the diameter of the fireball is the largest.

Figure 7. Lateral view of LPG explosion fireball evolution process.

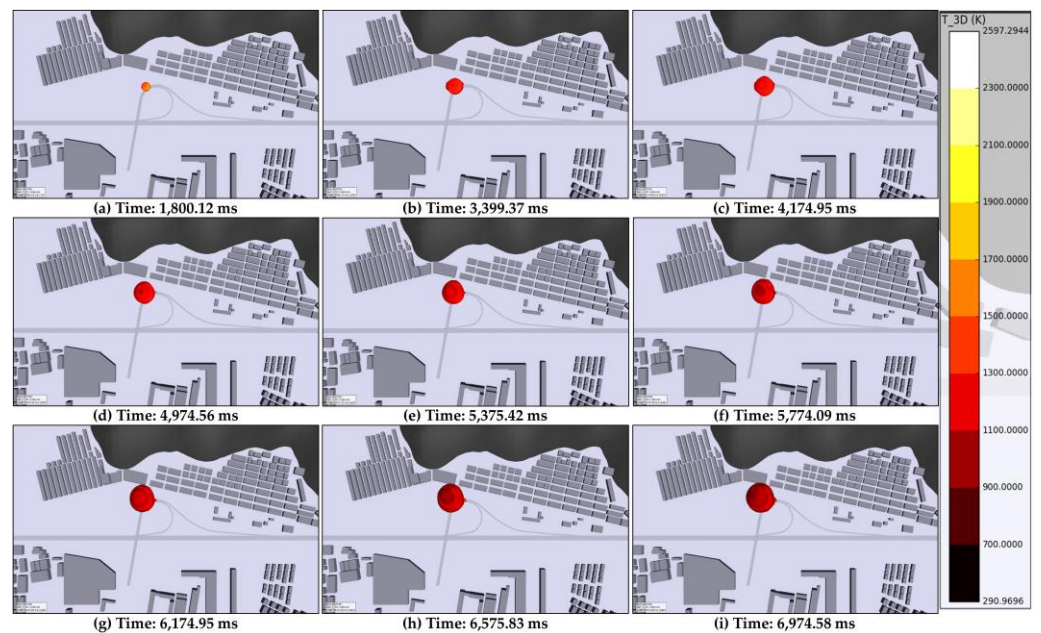
Figure 8 presents the top view of the LPG tank trailer explosive fireball formation process. Figure 8a–i respectively show the changes at the corresponding time when the gaseous mixture from the LPG tank trailer is ignited and explodes until the fireball is lifted into the air. The boundary of the LPG fireball is very regular. The approximately circular area rapidly transmits heat around after the explosion, causing serious damage to building structures and equipment in the horizontal direction. According to the post-accidental investigation and FLACS simulation, the maximum diameter of the LPG explosive fireball onsite eventually extended to nearly 148.20 m. Meanwhile, it is found that the LPG leakage caused a large explosion and created thermal hazards, resulting in extremely serious damage to the built environment around the accident. The road surface at the center of the accident site was deformed and collapsed by the fireball. Since the LPG tank trailer accident occurred on both sides of two large open parking lots, the vehicles were badly damaged. When the explosion fireball forms, the high temperature generated in this area reached more than 2000 K, which has far exceeded the fire resistance temperature of steel structure used for ordinary vehicles. After a certain period of time, the appearance of the vehicles in the parking lot on both sides of the accident has displayed obvious deformation. At a street store far behind the parking lot, it indicates that the canopy above the front door of the store is completely melted and severely damaged.

Figure 8. Top view of LPG explosion fireball evolution process.

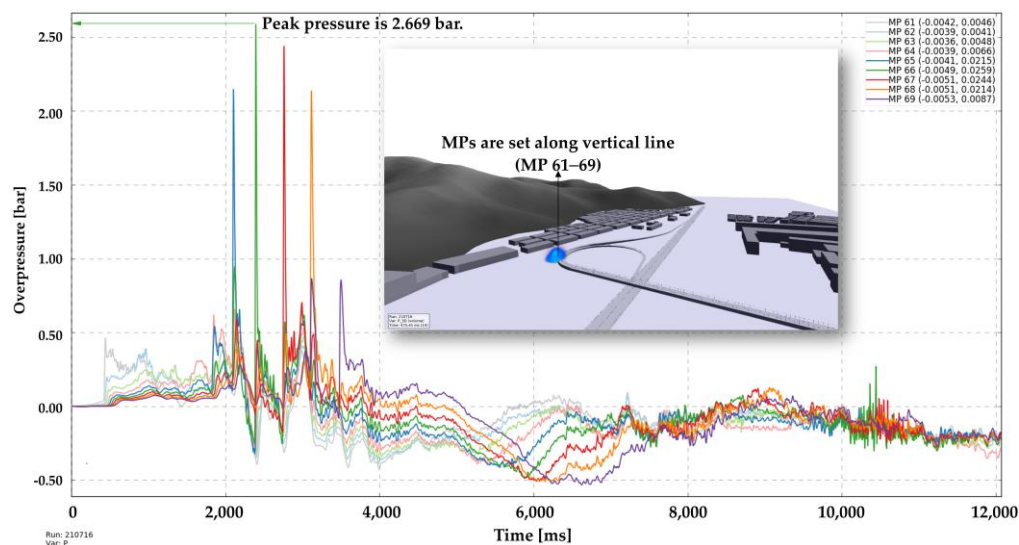
Figure 9 presents the shock wave changing in the time lapse when it propagates in vertical space. MPs 61 to 69 are arranged in the air along the Z axis starting from the center of the explosion source. According to the overpressure data, the MP closest to the explosion source shows the fastest peak overpressure. At nearly 579.02 ms after the LPG explosion, the peak value of shock wave-induced overpressure from the nearest location of the accident source reaches up to 0.489 bar. The pressure rise rate is over 100 Pa/ms, which indicates that the shock wave has the strongest effect on the obstacle in a very

short time. The maximum overpressure generated by the shock wave in vertical space is 2.669 bar. According to the threshold specified from shock wave-driven overpressure, when the overpressure induced by shock wave is greater than 2.0 bar, the steel structure has a positive impact and a large displacement, resulting in complete destruction as a whole. Since there is no shelter in the air where the accident occurs, the worst damage caused by the shock wave is located on the expressway pavement. Combined with the accident investigation, it is shown that due to the effect of the shock wave, serious deformation occurred on the expressway pavement, which is a destructive result of the powerful shock wave formed by the LPG tank trailer explosion.

Figure 9. Overpressure from LPG explosion remains in entries vertical to the direction.

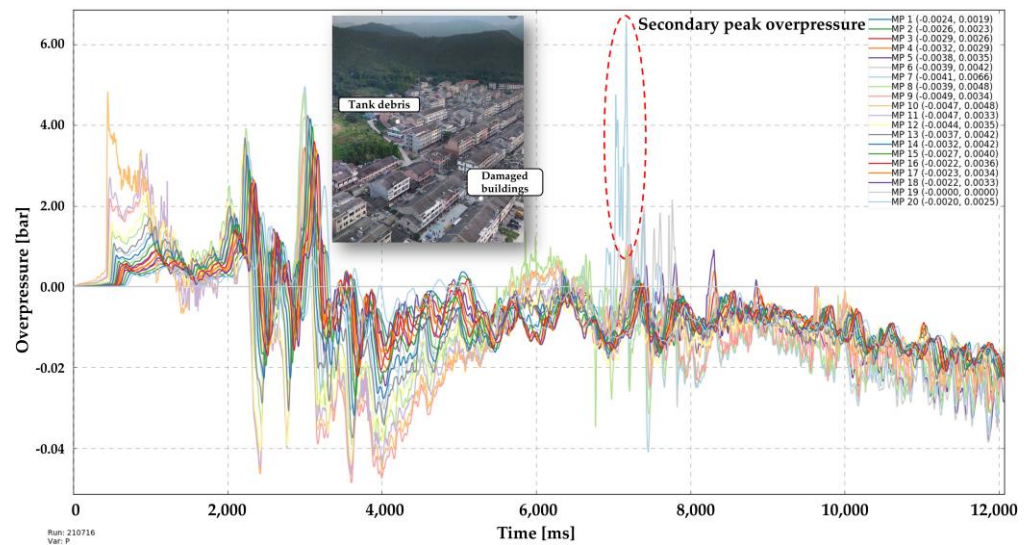
Figure 10 presents the change of shock wave generated by LPG explosion when it propagates from the southeast to the northwest area. The overpressure fluctuates significantly in the shock wave propagation process, which can be roughly divided into three stages over time. The first stage is the initial pressure rise period; that is, overpressure changes will occur immediately after the explosion of the LPG tank trailer. The peak overpressure reaches 4.411 bar in approximately 401.93 ms. At this time, the maximum value of pressure rise rate is more than 120 Pa/ms, which indicates that the shock wave produced after the LPG explosion is remarkably fast. Then, the shock wave propagation enters the second stage, which is the period of unstable fluctuation. During this period of time, the shock wave propagation is affected by the obstacles in the path direction, which will produce varying degrees of change. The product of the explosion initially moves at a high speed, and its speed decreases rapidly until it reaches zero due to the constant dissipation of energy. When the explosive product expands to a specific volume (or limited volume), its pressure drops to the initial pressure when the surrounding medium is undisturbed. The explosive product does not stop moving, driven by the action of inertia and excessive expansion, until it reaches a certain maximum volume. At this time, the uniform pressure of the explosive product is lower than the initial pressure when the medium is not disturbed, and the phenomenon of negative pressure appears. In the second stage, due to the occlusion of residential buildings and other structures, shock wave disturbance is formed. So, the overpressure induced by the shock wave begins to decay and then increases rapidly after 100 ms. During this period, the shock wave produces a phenomenon of secondary peak, with a value of 6.191 bar. The third stage is the attenuation period of shock wave. In this process, the shock wave is gradually transferred to the far field, and the energy of the explosive product is gradually exhausted in the process of propagation. The overpressure fluctuation of the shock wave is stable, and the maximum value is maintained between 0.02 and 0.05 bar. Figure 10 indicates that the shock wave can still cause damage to the

glass and other structures of residential buildings in the third stage, and the damage range is wide. Figure 11 presents the propagation and variation of shock wave in the east-west direction. As the distance between this area and LPG tank trailer is the nearest, the effect of shock wave is most significant. As can be seen from Figure 11, the peak overpressure exceeds 4.0 bar many times. Based on the threshold analysis in shock wave-driven overpressure, it can be concluded that shock wave in this direction will cause fatal injuries to on-site individuals, and meanwhile, irreversible damage to buildings. Figure 11 shows that the front of the house closest to the explosion source is almost completely destroyed by the shock wave, and the steel structures of the buildings are severely deformed.

Figure 10. Shock wave changes with time lapse from southeast to northwest (MP 01~20).

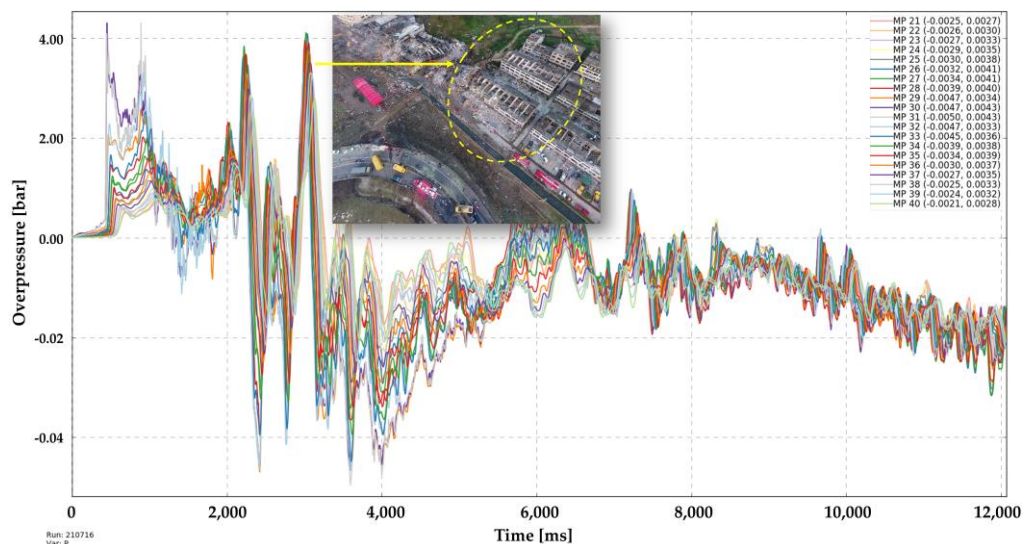
Figure 11. Shock wave changes with time lapse from the east to west (MP 21~40).

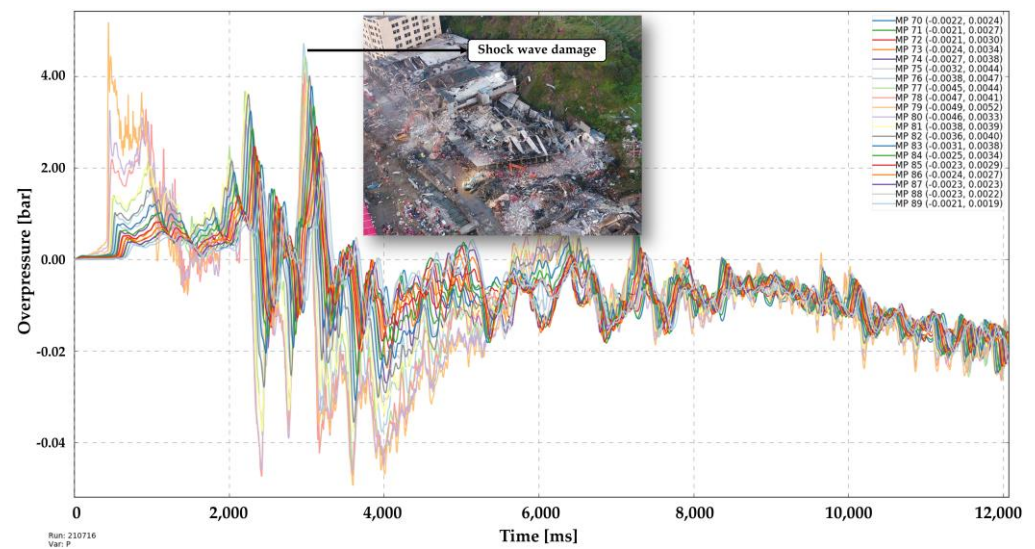
Figure 12 presents the propagation changes of shock wave along the southwest to the northeast direction. It indicates that the initial peak value of the shock wave overpressure is as high as 4.623 bar. Combined with the scene of the rescue situation, the area most affected by the explosion is located in the southwest of the accident. Due to the strong effect of the explosion-driven shock wave, the building structure is likely to experience high intensity damage and failure. On the other hand, the LPG tank flies out and hits the roof of the building in the area, resulting in the complete collapse of the house under the above double

Figure 12. Shock wave changes with time lapse from southwest to northeast (MP 70~89).

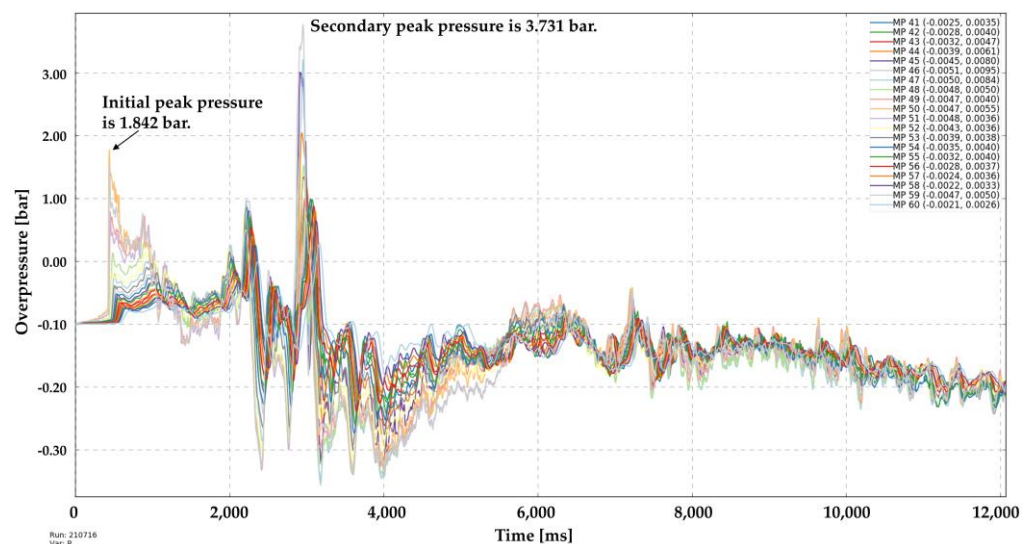
impact. Figure 13 shows the overpressure change of the shock wave from the south side to the north side. The overpressure strength generated by the shock wave is relatively weak in this direction. This is because there are not many obstacles in the north-south direction of the accident site, which is mainly empty ground. Therefore, the propagation process in this direction is consistent with the propagation law of the LPG explosion-driven shock wave in a large open space. The initial peak value of shock wave overpressure is shown as 1.842 bar, followed by the secondary peak value at 2756.19 ms, which is approximately 3.731 bar. Thereafter, the propagation of the explosion-driven shock wave from the direction between the north and the south areas shows a gradually decreasing trend, and there is no large pressure rise again in its propagation path, which is consistent with the situation in the real accident scene.

Figure 13. Shock wave changes with time lapse from the south to north (MP 41~60).

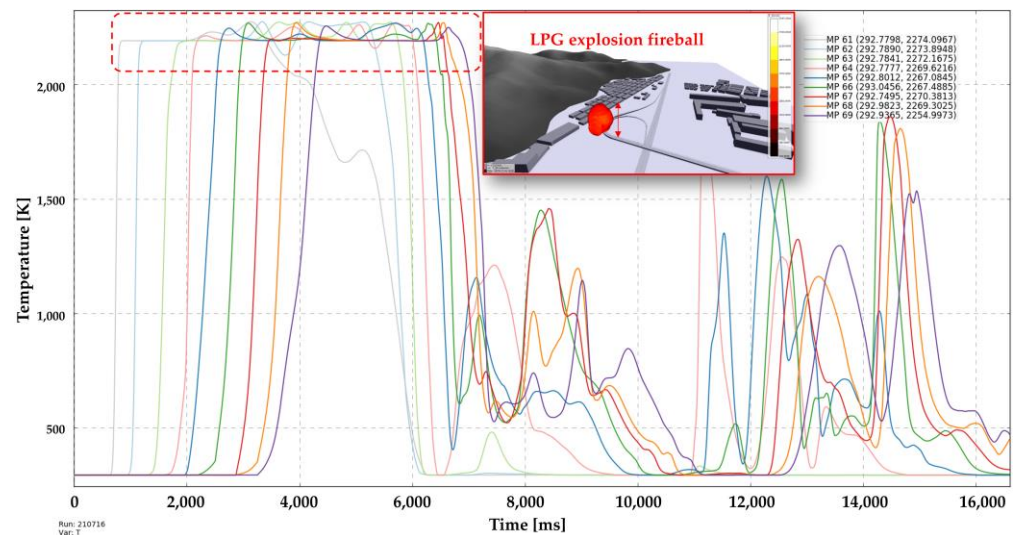
Figure 14 presents the changes in heat radiation transfer of fireball from the perpendicular line of MPs collected data. MPs 61~69 are set at the roof of the LPG tank trailer. The MPs have certain separation distances from LPG pressurized tank. In this research, one point for each MP collects the temperature change data. The maximum temperature of the LPG fireball in the perpendicular direction can reach 2287.5 K. The LPG fireball forms a hemispherical shape near the ground for a short time and gradually rises into the air. A spheroid structure is formed in a certain range and finally dissipates because of the depletion of LPG/air mixture inside the explosive fireball. Figure 14 indicates that a time delay exists within the various values of the explosive fireball temperature at different vertical spaces. The temperature rise rate of the LPG fireball in the air decreases with the increase of the altitude from the expressway ground surface. Then, the corresponding time interval required to reach the peak value of the fireball's temperature increases. In the vertical space where LPG explosion occurs, the propagation intensity of thermal radiation is no longer unified with the lapse of time. Therefore, the distribution of temperature field appears irregular fluctuations. It is worth noting that the temperature in the vertical space rises again because the combustible materials remaining in the site continue to burn after the LPG explosion. It reflects the characteristics of the mixed vapor cloud leaking from the LPG tank trailer as a heavy gas in the early stage of the accident. The above-mentioned result is caused by the dispersion characteristics of the concentration difference of the vapor cloud in the vertical space.

Figure 14. High temperature from LPG explosion fireball releases in vertical space.

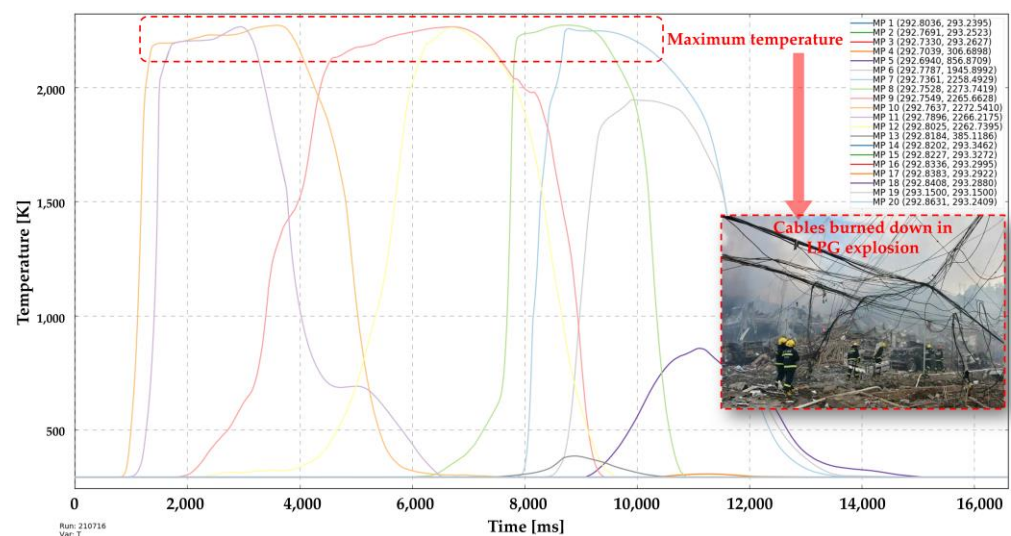
Figure 16 shows the temperature data monitored by MPs from the direction of the southeast to the northwest in accident site. As can be seen from Figure 16, the region close

to the explosion source is significantly affected by the thermal radiation of explosive fireball, which is prominently reflected in the change of temperature over time. When the LPG tank trailer explosion occurs, MP 10 near the explosion source shows the fastest temperature rise to its peak value. The initial peak temperature is about 2291.1 K, and the temperature rise rate is over 7.5 K/ms. On the northwest side is a cluster of businesses that is badly damaged by the LPG explosion. As shown in Figure 16, the electric wires and other cables in front of the shop are all ignited and burned due to the effect of the LPG explosive fireball. Figure 17 presents the temperature data collected by the MPs on the east and west sides of the LPG tank trailer accident. It can be observed that the several times of temperature rise are formed after the LPG explosion. This is due to the unconfined car parking area located in the immediate place on the west side of the accident site. In this accident, the parked vehicles were scorched and almost completely destroyed. It can be observed from Figure 17 that the glass window of the car parked on the west side of accident area completely fractured, and the car frame suffered stressed deformation subject to the fireball's high temperature. Many cars experience secondary ignitions and catch fire, and fragments from the explosion fly directly into nearby buildings. Through the temperature curve, it indicates that the temperature in this region presents several fluctuations, and a secondary peak temperature occurs. Figure 18 presents the temperature data collected by MPs positioned in the southwest to the northeast directions of accident site. The maximum temperature of heat transfer by LPG fireball in this region is approximately 2304.7 K. The space in the northeast side is a relatively empty large open space. The thermal radiation from the LPG fireball decreases rapidly in this region, so the increase of temperature data is not obvious. Some buildings are located on the southwest side; there are some buildings here which are affected by the thermal radiation of the explosive fireball. When the LPG explosion occurred, the southwest side of the buildings is quickly ignited, causing a large area of fire. Based on the temperature data, the high temperature lasted for a long time on the southwest side. The region remains over 3000 ms after reaching its peak temperature. It indicates that the thermal radiation transmission in the region encounters obstacles, or causes a larger scale combustion accident. According to the post-accident investigation, the damage effect from LPG explosive fireball has a strong destructive effect on people and the environment around the accident source where the LPG tank trailer explosion occurs, while the effect is significantly weakened in a certain distance from accident site.

Figure 16. Heat flux fluctuates with time lapse from southeast to northwest area (MP 01~20).
