Cause Analysis of Condensed Water Induced Bulging in High-Pressure Steam Tee Joints of a Pyrolyzer

In October 2019, a pyrolyzer, belonging to a Chinese petrochemical enterprise, was shut down to overhaul. During the basic investigation, a high-pressure steam tee joint located between a ultra-high pressure main pipe and medium pressure pipe was found to

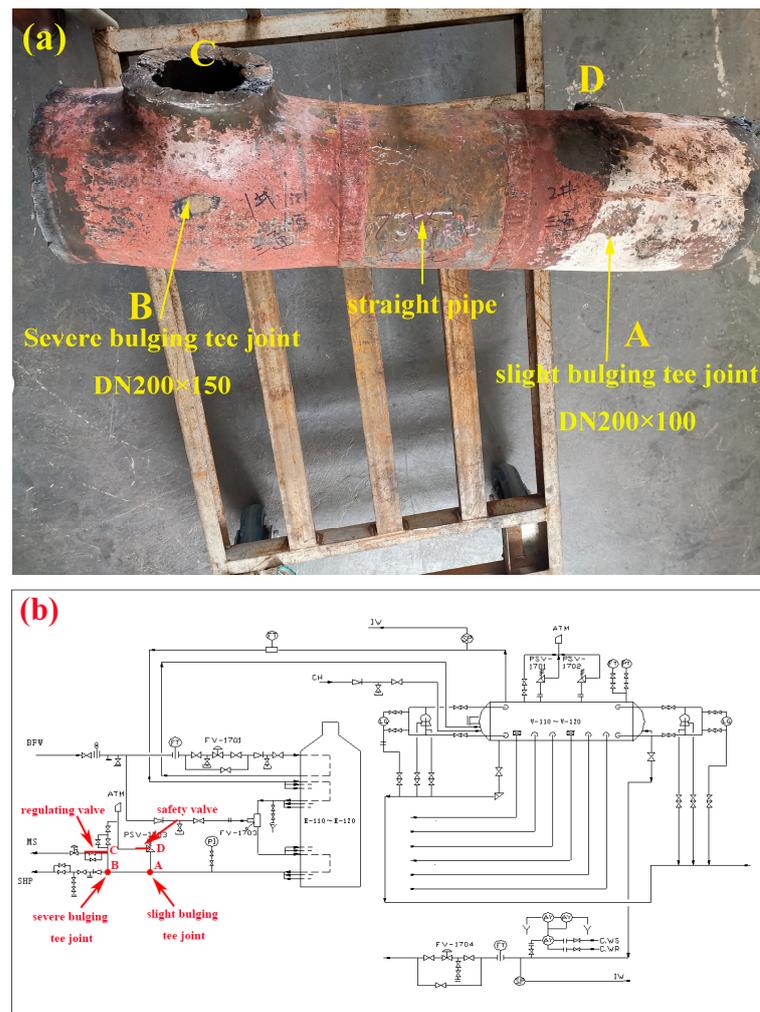
have abnormal bulging, while the external diameter increased from $\Phi 219$ mm to $\Phi 243$ mm. Meanwhile, the same phenomenon was discovered in another tee joint connecting the main pipe and safety valve branch pipe, whose external diameter increased from $\Phi 219$ mm to $\Phi 226$ mm. P11(1.25 Cr–0.5 Mo) alloy steel was selected as the design material for the high-pressure steam pipe. The operating pressure and temperature are 12 MPa and 500–540 °C, respectively.

The sampling location of the macro image for the abnormal bulging tee joint is shown in Figure 1a, including the slight bulging part (marked with A), straight pipe part (between A and B) and severe bulging part (marked with B). The branch pipes connected with the regulating valve and safety valve are marked with C and D, respectively. Furthermore, the detailed location of A, B, C and D are depicted in the schematic image of the abnormal bulging tee joint (Figure 1b). The specification of the tee joint is DN200, while the external diameter, internal diameter and thickness are 219 mm, 166.2 mm and 26.4 mm, respectively. According to the SCH160 standard, the relevant external diameter, internal diameter and thickness are 219 mm, 171 mm and 24 mm, respectively.

Figure 1. (a) Macro image of the bulging tee joint; (b) schematic location of the bulging and cracking pipe.

- (1) Replace the unqualified pipes and conduct inspections on pipes under similar service conditions.
- (2) Place emphasis on the inspection and life cycle assessment of high-pressure steam pipes.

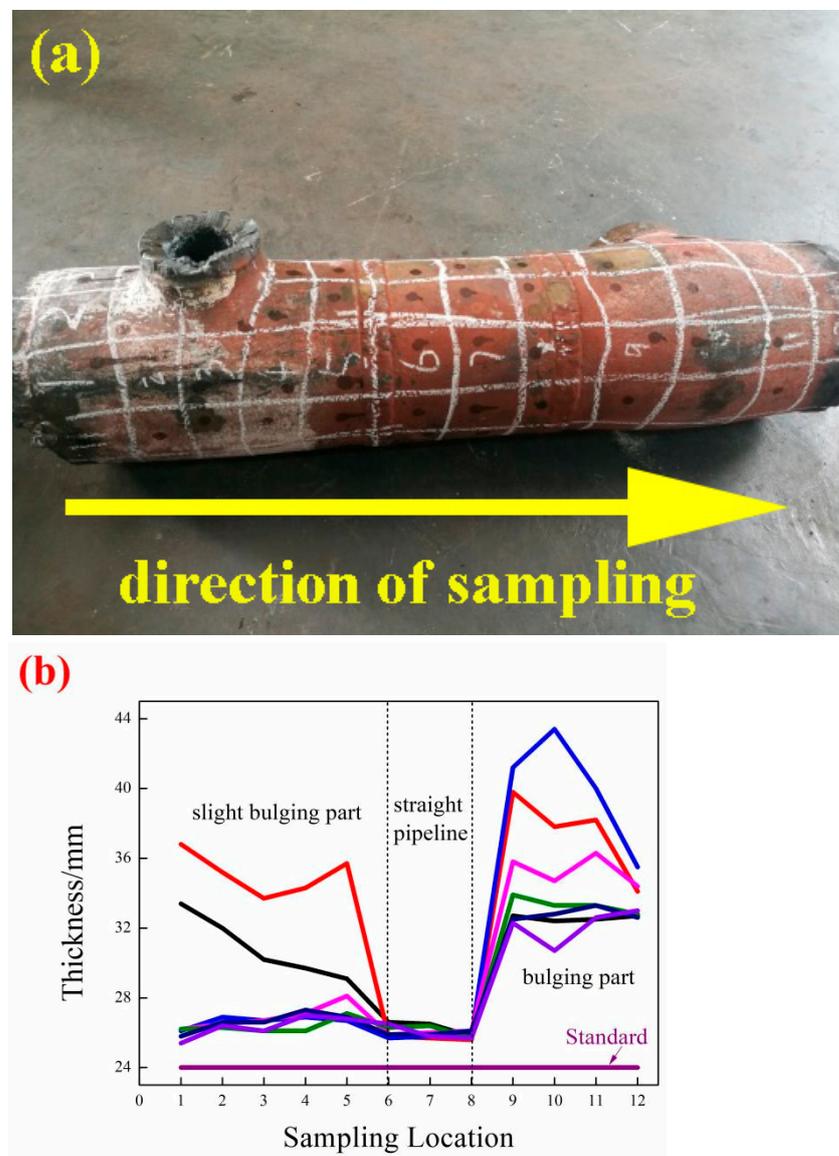
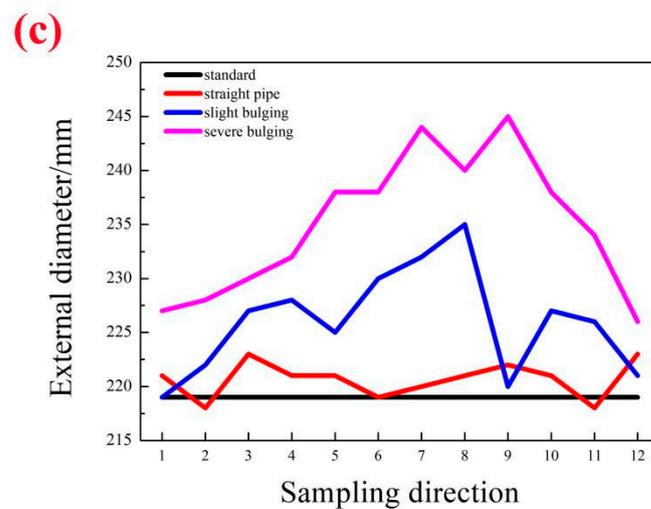
Thickness measurements were conducted on all the sampled parts. The sampling location of the macro image for the abnormal bulging tee joint is shown in Figure 2a, including the slight bulging part (location 1–location 5), straight pipe part (location 6–location 8) and severe bulging part (location 9–location 12). The thickness data of each location were collected more than 10 times from different axial directions and then the results were averaged. As shown in Figure 2b,c, the thickness of all the sampled parts exceeds 24 mm. The slight bulging part exhibited a maximum thickness of 36.8 mm and a minimum thickness of 25.4 mm, while the straight parts had thicknesses ranging from 26.6 mm to 25.4 mm. Additionally, the thickness of the severely bulging tee joint ranged from 30.7 mm to 43.4 mm. Generally, both the slight bulging part and the bulging tee joint displayed unevenly distributed thicknesses, which might have originated from the extruding process and uneven abnormal bulging. Furthermore, concerning the external diameter results, a similar phenomenon was observed in all the sampled parts. Even the external diameter of the straight pipe reached 223 mm, which could be attributed to slight bulging.

Figure 2. (a) Sampling location of the bulging tee joint; (b) thickness of the sampling location for the bulging tee joint; (c) external diameter of the sampling location for the bulging tee joint.

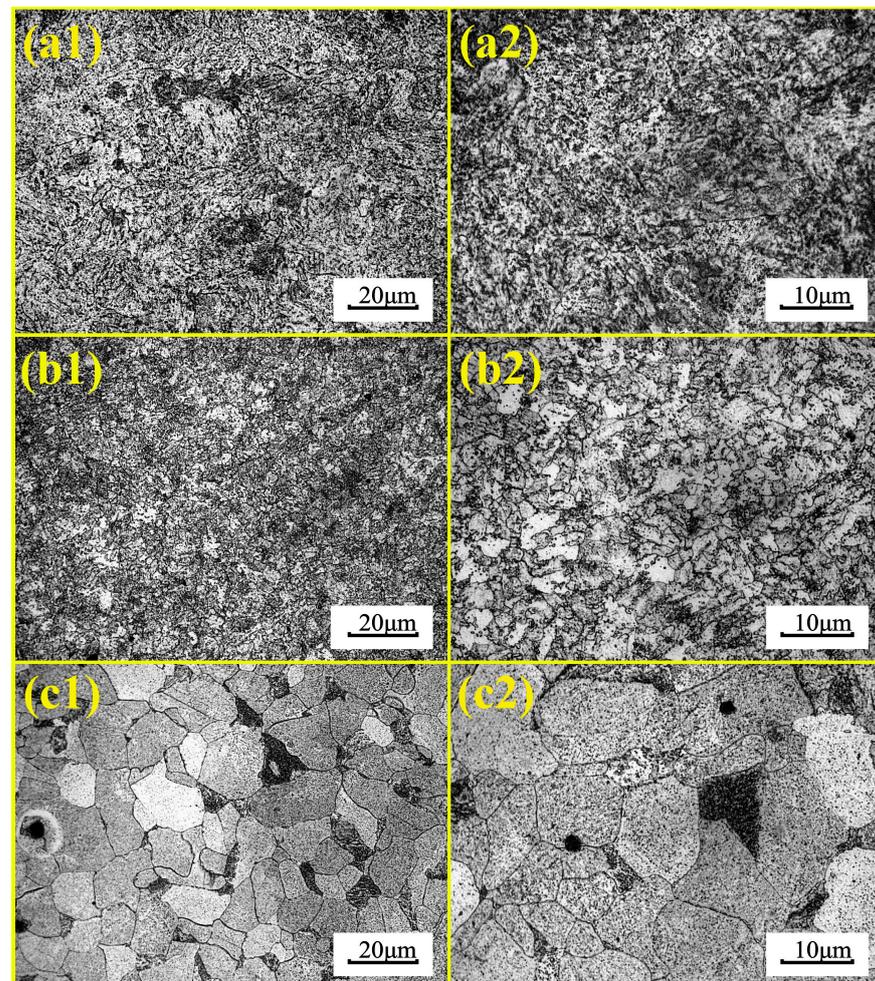
Figure 3. (a1,a2) Metallographic image of the severe bulging tee joint; (b1,b2) metallographic image of the slight bulging tee joint; (c1,c2), metallographic image of the straight pipe.

According to Figure 3(a1,a2), the severe bulging tee joints present the microstructure of pearlite and ferrite without creep cavity and creep crack. However, the relevant structure of pearlite appeared to have severe spheroidization, while the quantity of carbide was

precipitated in the ferritic structure. Additionally, the slight bulging sample (Figure 3(b1,b2)) depicted a similar microstructure of pearlite and ferrite with no creep cavity and creep crack to the severe bulging sample. The relevant structure of pearlite exhibited less severe spheroidization and a medium degree of precipitation for the carbide in the ferrite structure. For the straight pipe in Figure 3(c1,c2), only slight spheroidization in the pearlite structure as well as a mild degree of precipitation for the carbide in the ferrite structure were observed, while no creep cavity and creep crack were found.

Generally, the above observed results reveal that severe abnormal bulging was accompanied by the severe precipitation of carbide in ferrite as well as severe spheroidization in pearlite. No creep cavity and creep crack were found, illustrating that creep has no effect on abnormal bulging.

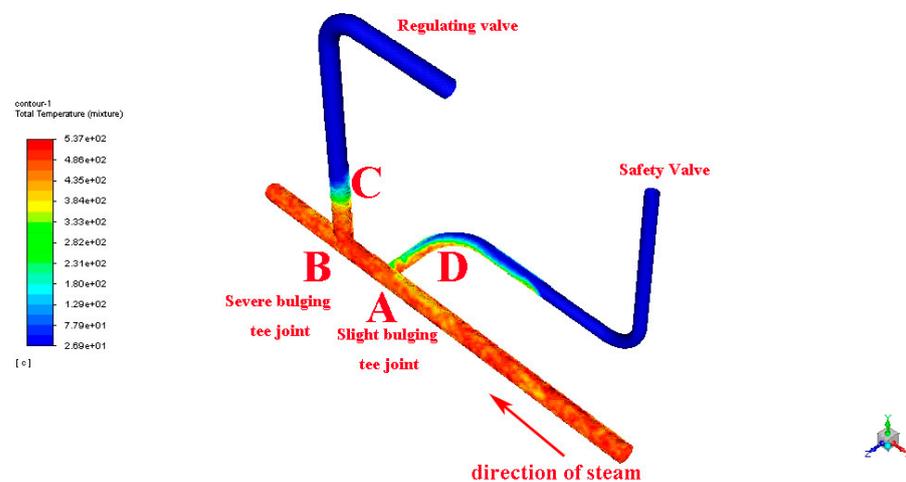
In order to clarify the relationship between service conditions and the variation in microstructure and mechanical properties mentioned above, modeling was conducted for the severe bulging tee joint, slight bulging tee joint and straight pipe to simulate the actual service condition, including the fluid inside the pipe, pipe wall and external thermal insulating layer. Steam, $515\text{ }^\circ\text{C}$ and 11.6 MPa were selected as the pipe medium, temperature and operating pressure, respectively, while the regulating valve and safety valve maintained the normal shut-down condition. As shown in Figure 4 regarding the distribution of temperature inside the pipe wall, it is observed that temperature inside the main pipe part was $515\text{ }^\circ\text{C}$. As the pressure increases, the regulating valve and safety valve are turned on to vent some high-pressure steam to the mid-pressure steam pipes, thereby increasing the temperature of the remote branch pipes connected to the regulating valve and safety valve. However, during the shut-down condition of the regulating valve and safety valve, the steam becomes stagnant, causing the temperature of the remote branch pipes to decrease significantly below $322.13\text{ }^\circ\text{C}$, which is the saturated steam temperature under the corresponding pressure condition. As a result, the temperature of the remote branch pipes ranges from $515\text{ }^\circ\text{C}$ to $29\text{ }^\circ\text{C}$ during the cyclic variation of shut-down and turn-on conditions. Therefore, the precipitation of condensed water is likely to occur in the remote branch pipes connected to the regulating valve.

Figure 4. Distribution of temperature inside the bulging tee joint.

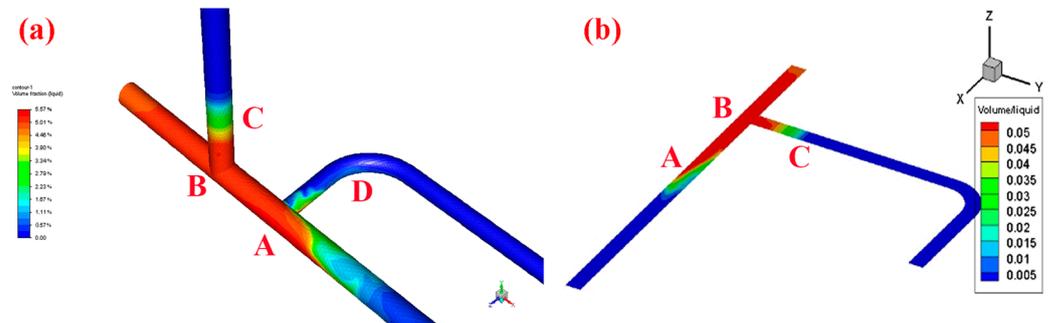
According to the distribution of the liquid phase in the inner side of the pipe in Figure 5a,b, the condensed water basically distribute in the inner side of the pipe wall, illustrating that the condensed water would not evenly distribute in the high-pressure steam, but would drop on the tee joint along the vertical pipe. As the surface temperature of the tee joint reaches 515 °C, the process of condensed water dropping would generate a quenching effect to increase the hardness of the tee joint.

Figure 5. Volume (a) and cross-sectional distribution (b) of the liquid phase inside the bulging tee joint.

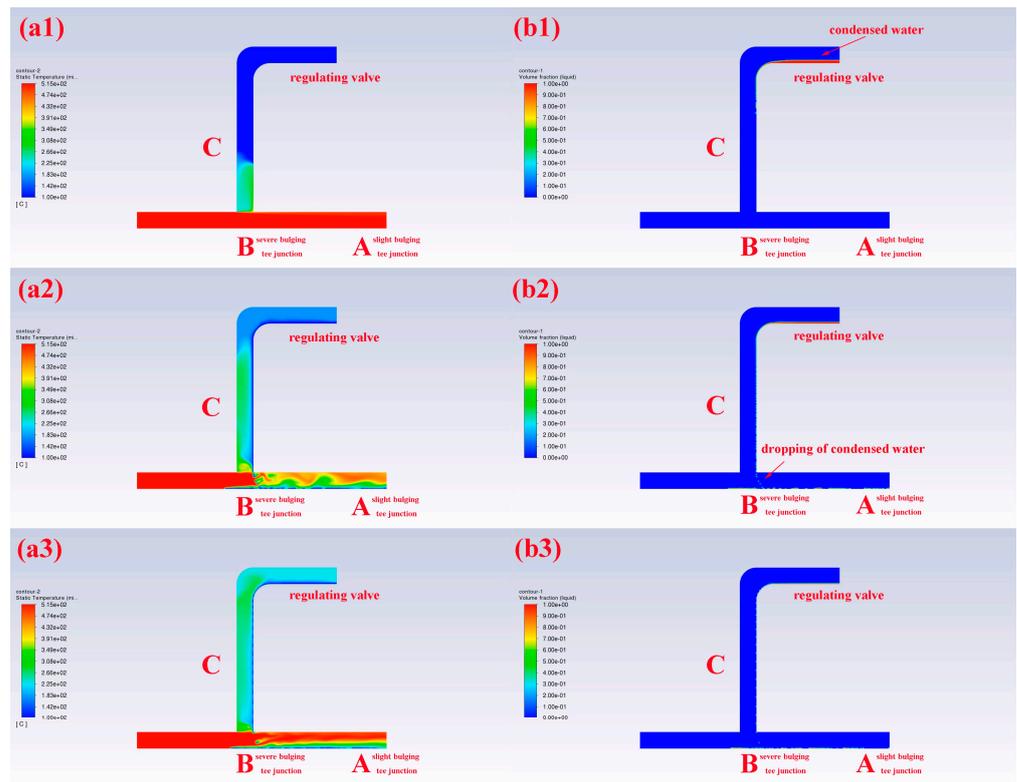
As depicted in Figures 6 and 7, the temperature of a condensed water droplet ranges from 500 °C to 200 °C, which is responsible for the generation of alternating thermal stress. It can be seen that a condensed water droplet would be vaporized after dropping on the inner side of pipe wall, subsequently absorbing the heat to generate a rapid decrease in the inner surface temperature of the pipe wall. Therefore, the continuous dropping of a condensed water droplet would produce a rapid cooling effect similar to the quenching process, which would obviously increase the hardness of the tee joint. However, the droplet would finally be vaporized by a high inner surface temperature, increasing the inner surface temperature of the tee joint to a saturated steam temperature. As the constant variation in temperature field and stress generate, regions of high stress would be generated at the inner side of the pipe wall. According to Figure 7a–d, it can be seen that stress produced by a condensed water droplet ranges from 532.8 MPa to 59 MPa by continuously applying it to the tube wall of the tee joint. Combined with the variation in the temperature field in Figure 6, the temperature of the severe bulging tee joint and slight bulging tee joint alternates. Due to the cyclic transformation and dropping of condensed water, the alternating thermal stress and ratcheting effect would be generated, causing abnormal bulging in the tee joints [22–26]. The dynamic variation in the temperature field and phase field induced by the transformation of condensed water is attached in the Supplementary Files.

Figure 6. Variation in (a1–a3) the temperature field and (b1–b3) phase field induced by the transformation of condensed water.

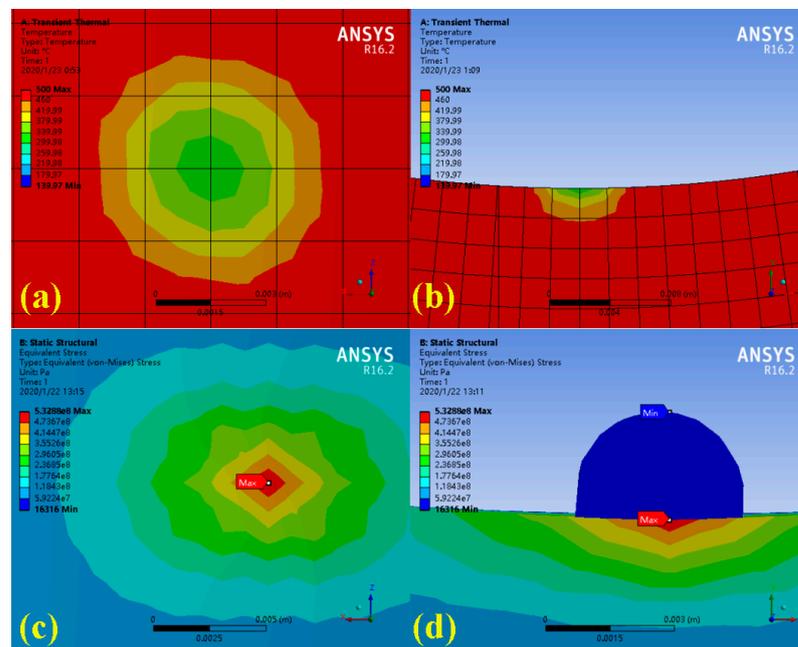
Figure 7. (a,b) Temperature field and (c,d) stress field of condensed water droplets on the bulging tee joint.

The abnormal bulging of the tee junction is attributed to the thermal ratcheting effect induced by the cyclic precipitation of condensed water, with pearlite spheroidization serving as a secondary mechanism.
