Categorization of Failures in Polymer Rapid Tools Used for Injection Molding

Anurag Bagalkot, Dirk Pons, Digby Symons, Don Clucas

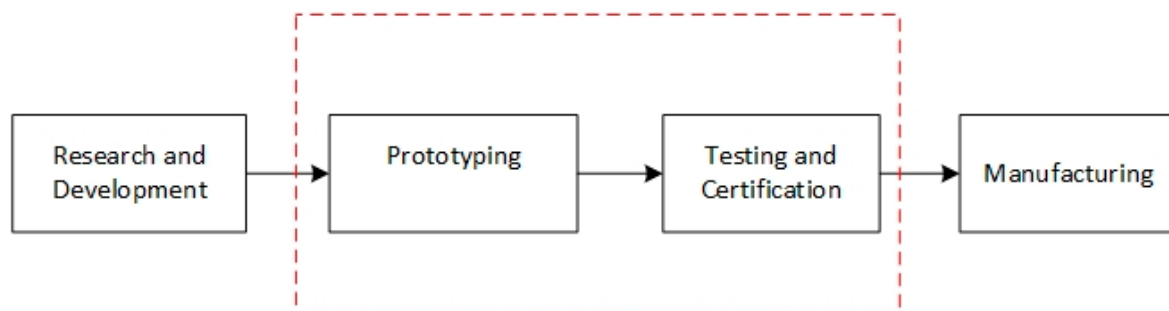
Figure 1. Stages of a new product development (NPD) process from an engineering perspective.

The middle phase of the NPD process highlighted in Figure 1 is often the most difficult phase, due to cost and time constraints; especially for innovative start-up firms and small organizations [4]. In the case of polymer products, injection molding (IM) is one of the most widely used polymer processing techniques. Conventionally, IM tools are machined out of blocks of steel, aluminium, or copper–beryllium alloys, and the choice of mold material is dependent on factors such as the molding material, the complexity of the part, the required life, and the available budget [5–7]. In cases of low-volume production, the capital cost of the injection molds is the largest cost component of an injection molded part, followed by the molding material and the processing costs [8]. Complex product geometry requires complex tooling, which increases the cost and lead times if manufactured by conventional methods, which does not work well for keeping the costs of prototype tooling low [6,9]. Hence, the NPD process for injection molded parts typically faces issues (delays) during the prototyping and testing phases. Since more than 35% by weight of all polymers is by IM, the highest demand for low cost tooling is from the IM industry [8]. To stay competitive, industries are looking to reduce the wastage of raw materials, shorten product lead times, and eliminate the need for expensive tooling [10]. In the above situations, industries increasingly turn to additive manufacturing (AM) to solve these challenges via direct part production [11]. However, there are disadvantages: lack of material availability; varied material properties; inaccurate representations of the final part; poor surface finish. For accurate evaluations of a prototype, industries prefer to manufacture prototypes by using the same materials and the same process as the final part. In such situations, industries may use rapid tooling (RT).

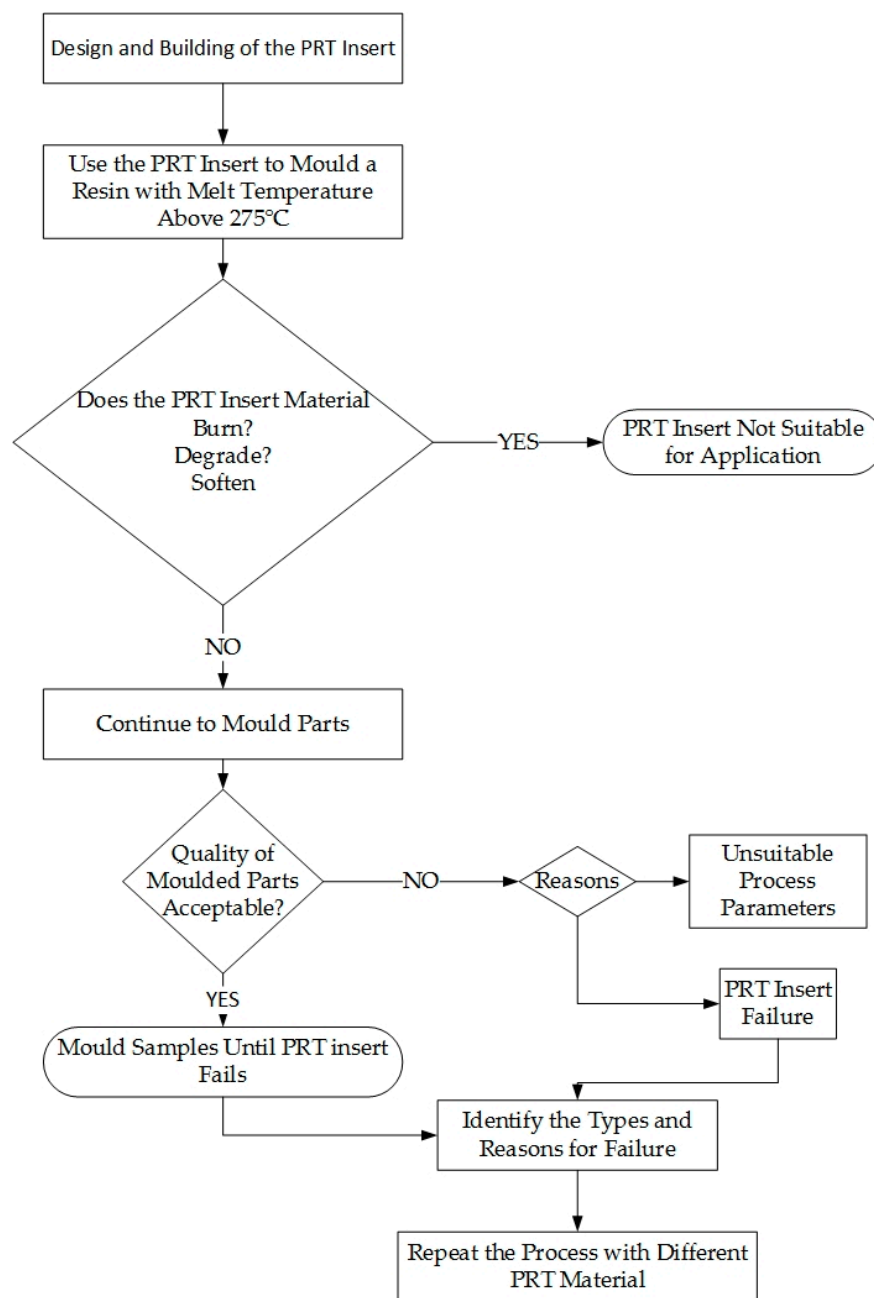
The process for setting up each case study, and for extracting failure insights is shown in Figure 2.

Figure 2. Process workflow.

The different failures observed in the PRT inserts occurred at different times during the molding cycle. We identified the shot number, during which we first observed the signs of each failure type. Each part was inspected to detect failures, and likewise the tool. We continued the molding process, while the tool damage was minor (surface deterioration, surface scalding, bending), and terminated the test when catastrophic tool failure occurred.

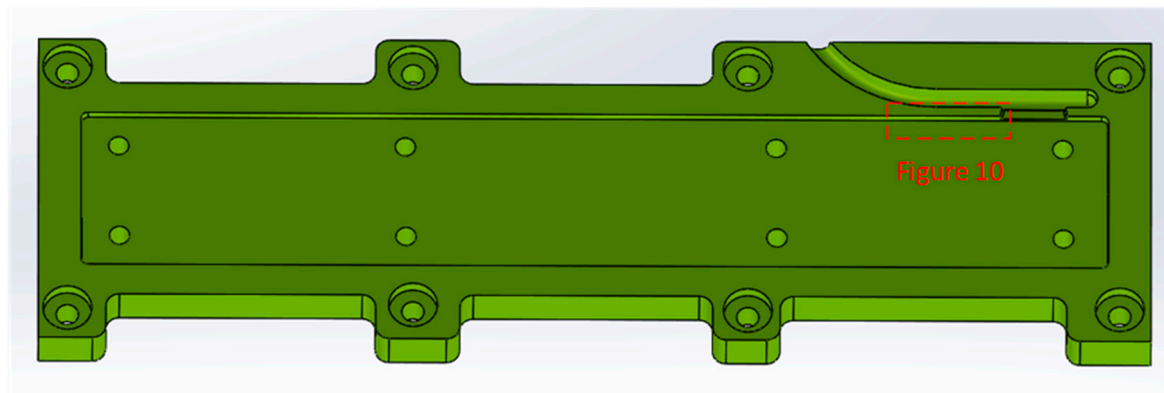
this case study was a standard test specimen used for the vertical Bunsen burner test for cabin and cargo compartment materials. It is a flat rectangular plate ($304.80 \times 50.80 \times 2.56$ mm), and the solid model that was used for printing the core insert is shown in Figure 3.

Figure 3. Solid model of the cavity insert used for printing.

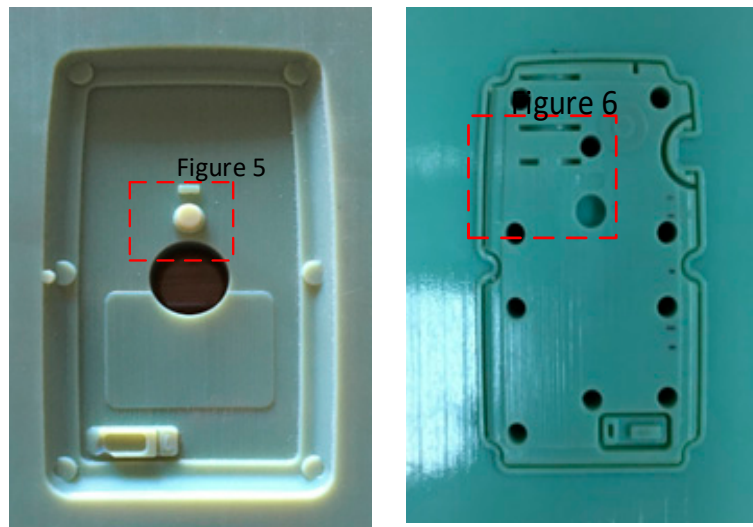
Case study 2 represents a part with more complex geometric features, including a boss, thin walls, and thin core pins; see Figure 4. An aerospace resin Lexan 943-A from Sabic Australia PTY LTD Melbourne was injected. The part chosen was already in production using a steel insert, and was used as a reference. The inserts were printed on a Stratasys OBJET 350 Connex 3 Polyjet Machine from Stratasys, Minnesota, United States. Digital ABS[®] from Stratasys, Minnesota, United States was the material used for printing the inserts, with a 30 micron layer height setting and glossy print mode being used. The inserts were not hand-polished, as there was a risk of damaging the parting surface. A 450 ton injection molding machine with a maximum injection pressure of 170 MPa was used. The mold temperature was set at 45 °C to keep the tool below its T_g , which is about 53 °C. The recommended mold temperature from the resin supplier was 105 °C. Table 3 compares the process

Figure 4. Core and cavity insert.

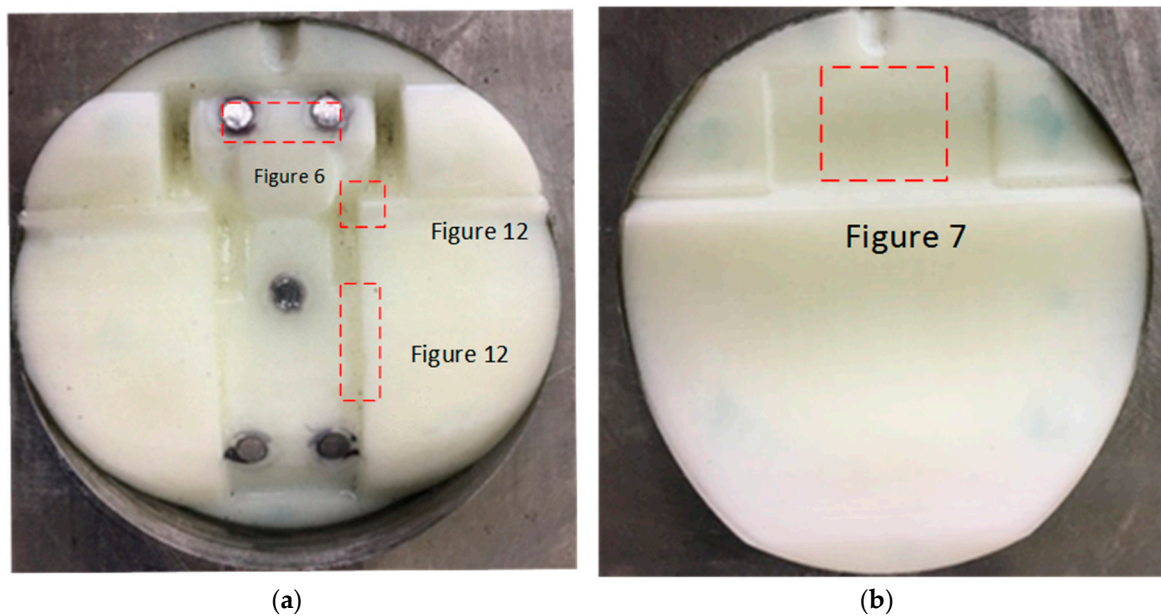
For case study 3, we used a production part for the aerospace industry; see Figure 5, which shows the core and cavity insert. The inserts were printed onto a 3D systems ProJet MJP 3600 series printer from 3D systems, South Carolina, United States. The material used was Visijet M3-X[®] from 3D systems, South Carolina, United States. An ultra-high definition (750 × 750 dpi) print mode with a 29 μm layer thickness setting was used to print the inserts. For post processing, the inserts were placed in an oven at 100 °C for 1 h; they were then cooled and scrubbed with a hot detergent to remove all the wax (support material).

Figure 5. (a) Core insert for case study 3, fitted inside a master unit die. (b) Cavity insert for case study 3, fitted inside a master unit die. The tool outer diameter is 55 mm.

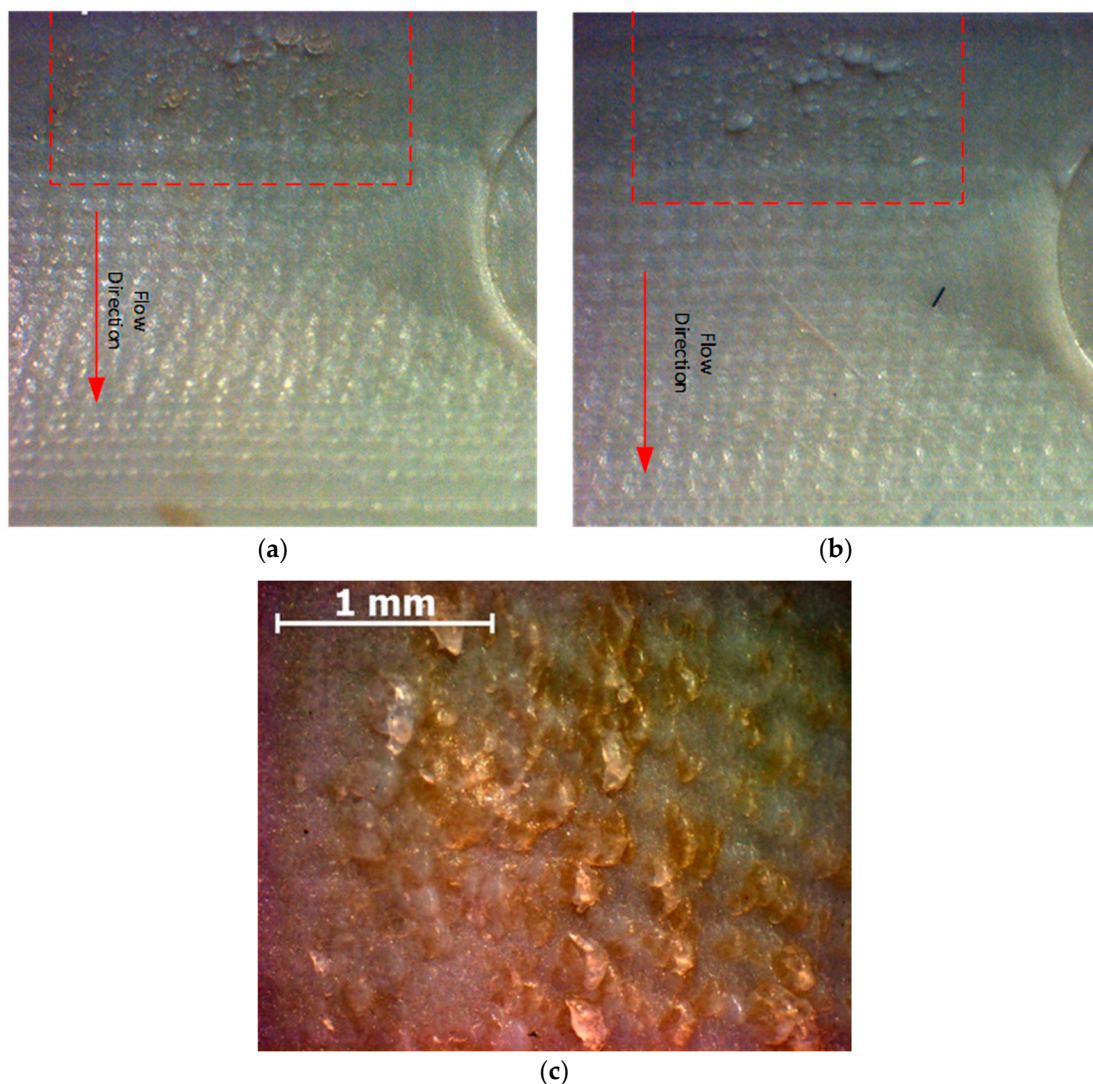
As the molten polymer enters the cavity, it begins to cool, while the PRT inserts begin to rise in temperature; at a certain stage of the molding cycle, the tool temperature is above the T_g of the tooling material, which causes the tool to soften. During the injection stage, as the polymer flows,

there is a constant shear between the molten polymer and the top surface of the tool, resulting in erosion/spallation of the tool. The erosion tends to increase, with polymers having a low melt flow index, as they usually require a higher injection pressure. The erosion was microscopic, and could not be seen by the naked eye on the inserts in between shots, and the tool surface had failed completely by the end of the production cycle. The surface erosion was detected only when the parts were viewed by using a microscope. In Figure 6a, the brown protrusions are pieces of the tool material that have been eroded and stuck to the part, thus creating small voids over the tool surface. Since the tool surface is no longer flat, the next molded part will have protrusions that are similar to the eroded area. In Figure 6b, similar protrusions are evident as in Figure 6a, but now they are the same color as the part. The surface degradation worsened after each shot. A magnified image of the deteriorated surface can be seen in Figure 6c; the magnified image shows both the protrusions molded from the previous shot in white, and the brown protrusions are new fragments of the eroded surface from the current shot.

Figure 6. (a) Tool material eroded and deposited on the seventh shot from the tool. (b) Protrusions on the eighth part, due to surface deterioration of the tool in the same vicinity. (c) Magnified image of the area of the eroded tool surface.

After each molding cycle, the parts were inspected for quality, and once the part showed any signs of quality defect, we inspected the tool to assess tool damage. No quality defect was identified for the first six shots. A small area of deteriorated surface was seen on the seventh shot, on the tool and the part. The surface deterioration worsened after each subsequent shot.

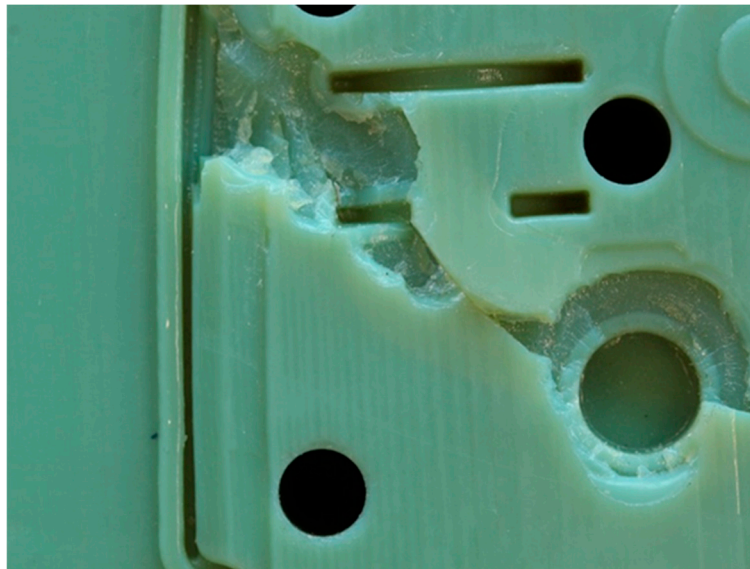
Once the mold was 95% filled, a second stage (hold) pressure was applied, to force excess melt into the cavity, to compensate for the shrinkage of the injected polymer. This second-stage pressure resulted in adhesion between the deteriorated surface of the PRT insert and the part. Avulsion failure was observed in case study 2 on the core insert; see Figures 8 and 9. The central hole on the core insert was initially observed to be deteriorating, and as the cracks extended, the part was seen to be avulsing chunks of material from the insert during each shot.

The insert at this stage was at a higher temperature than the T_g of the tool. We infer that this causes the tool to lose its strength, and also when the part is ejected; hence, avulsion of the mold surface may occur. The term avulsion refers to the ripping and peeling of the surface material of a body. Our proposed explanation is that during the first few shots, surface damage occurs, which leads to surface cracks (micro-spallation). During subsequent shots, molten polymer enters these micro-cracks and enlarges them; as the cracks grow, more molten polymer is forced into the cracks before solidifying. During ejection, this solidified polymer causes layers of the mold to be torn off. Avulsion failure is a progressive rather than an abrupt failure mode.

Figure 8. Avulsion failure region on the PRT insert from case study 2. This failure mode is characterized by progressive peeling of the substrate material. The image shows the catastrophic end-state of the process.

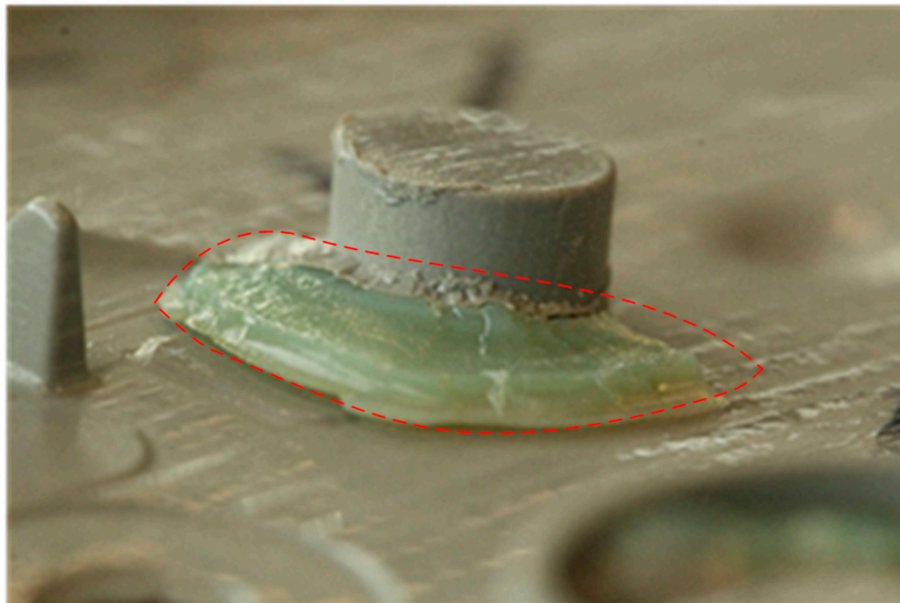
Figure 9. Molded part showing peeled off tool material from the top surface. This occurred during the ejection of the part. (Area highlighted is the tool material pulled out).

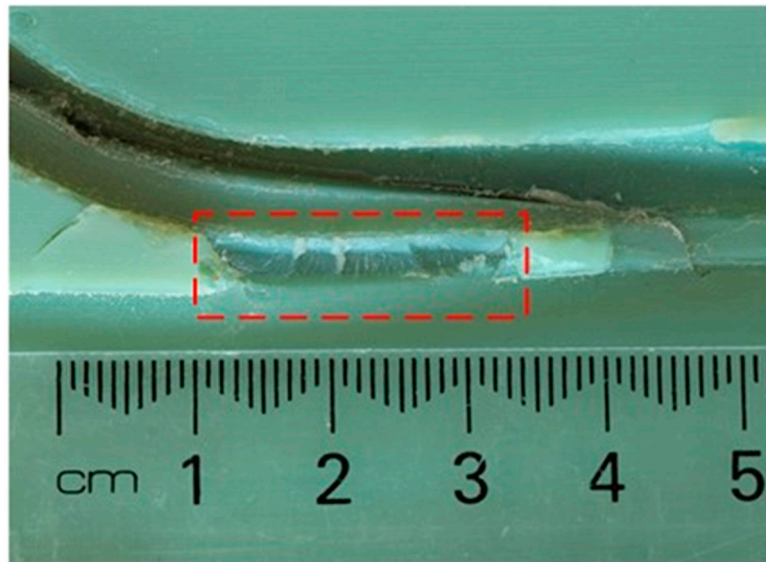
During the injection stage, the polymer melt is forced into the insert under pressure. The polymer melt while filling the cavity exerts a force on the mold features, such as walls, bosses, and ribs. This force is responsible for a stress which, if exceeds the ultimate tensile strength of the material at that temperature, may result in the failure of the feature. The injection pressure is highest during the start of the injection cycle, and gradually reduces; this means that the features of the insert that are the closest to the injection point (gate) are more susceptible to failure. Shear failure was observed during case study 1 on the runner wall of the PRT insert; see Figure 10. The high melt pressure during the initial process parameter setup phase caused the wall to shear and cause a catastrophic failure of the

mold. The wall of the runner sheared off on the first shot, but it did not completely break off from the mold surface; during the subsequent shots, the wall broke off the mold surface. Figure 3 shows the wall of the runner that sheared off. This was classified as shear failure, due to the low aspect ratio (height/thickness) of the wall. This was a critical failure, as it was a runner wall, and we could not produce any more parts from the insert—it would be unsafe to try. We infer that shear failure may be a particular risk in areas with low aspect ratio thin walls that are close to the gate (melt entrance).

Figure 10. Shear failure of the runner wall (boxed area), due to high injection pressure. See Figure 3 for the location on the tool.

- I. Add thickness to walls nearer to the gate, to give them extra strength. The current industry practice is to reduce the amount of printed material, as it is expensive, but this practice leaves the tool vulnerable, and may not serve the end purpose of cost reduction.

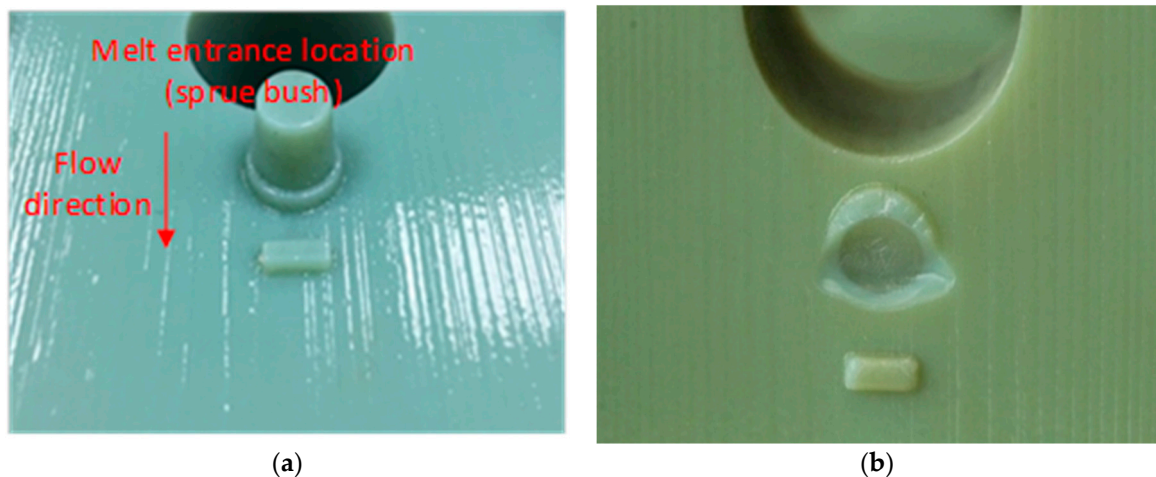
A bending failure was observed in case 2; see Figure 11. This feature on the tool was supposed to create a hole on the part, but the boss feature was broken off the tool after five shots, and all the parts molded after it had a thick section instead of a hole. Although this made the part functionally defective, it was not considered a critical failure, as it was still safe to operate the tool. The melt pressure was causing the boss to bend during the initial filling stage. This eventually led to a crack at the bottom surface, and failure of the boss in subsequent shots. The boss was situated directly 5 mm in front of the injection point; this meant that the boss was experiencing the highest pressure of all of the features on the tool.

The incoming polymer melt during the injection stage exerts a pressure on the front face of a feature, leading to a deflection; as the melt front reaches the back face of the feature, there is a reduced pressure difference between the back and front faces, and the deflection of the feature reduces. This cycle is repeated during each molding cycle, and may be responsible for the development of a crack, which may eventually lead to a complete failure of the PRT insert. Features with high aspect ratios (height/thickness) should in principle, be the most vulnerable to bending failure.

Figure 11. (a) Boss feature before molding. (b) Bending failure of the boss feature due to high injection pressure. See Figure 4 for the location on the tool.

- II. Avoid choosing gate locations that are close to features with high aspect ratios, as otherwise these could be vulnerable to early failure. The effect of injection pressure on features is high at the start of the filling phase, and is much reduced at the end of flow.

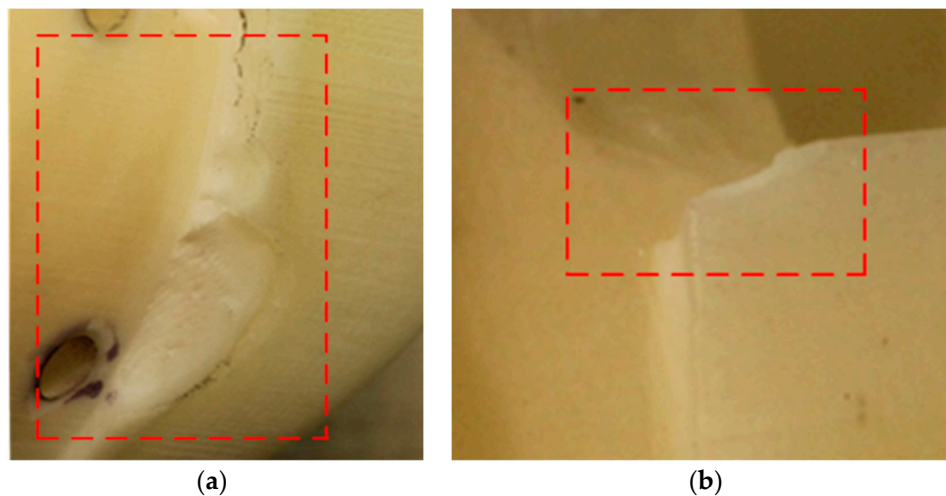
The edges of the PRT insert deteriorated with each shot, and small chips of the material were seen to be eroding from the edges; see Figure 12. This was particularly worse near the areas of the runner (melt entrance) where the melt pressure was high; the edge deterioration was less on the edges at the end of the melt flow.

Figure 12. (a) Chipped edge of the tool caused during the ejection of the part. (b) Chipped corner of the tool due to injection pressure. See Figure 5 for the location on the tool.

The other reason for the edge failure is the draft on the walls. During ejection, there is constant friction between the part and the mold walls. The mold during the ejection stage is above its T_g and has low yield strength. The part while ejecting starts to degrade the surface (erosion) during the early shots, and results in chipping when there is significant deterioration. An advanced version of the edge failure was observed in case study 3. During case study 1, edge failure was not considered as a significant failure, because it did not pose any safety issues, and it was not flashing. However, the PRT insert in case study 2 was only used for five shots, after which it failed via the shear failure mode. In case study 3 the tool survived the initial process parameter setup phase, and the edges deteriorated progressively from the ninth to the 13th shot. During the ejection of the 14th shot, a large shard of material was pulled out. After this shot, the tool was flashing, due to the failure of the edge that was on the parting line of the tool. Surface erosion was seen on all of the edges along the flow path,

and chipping was only seen on edges that had no draft. At the end of the 19th shot, the fracture was about 5 mm wide, and this was the final failure on the tool.

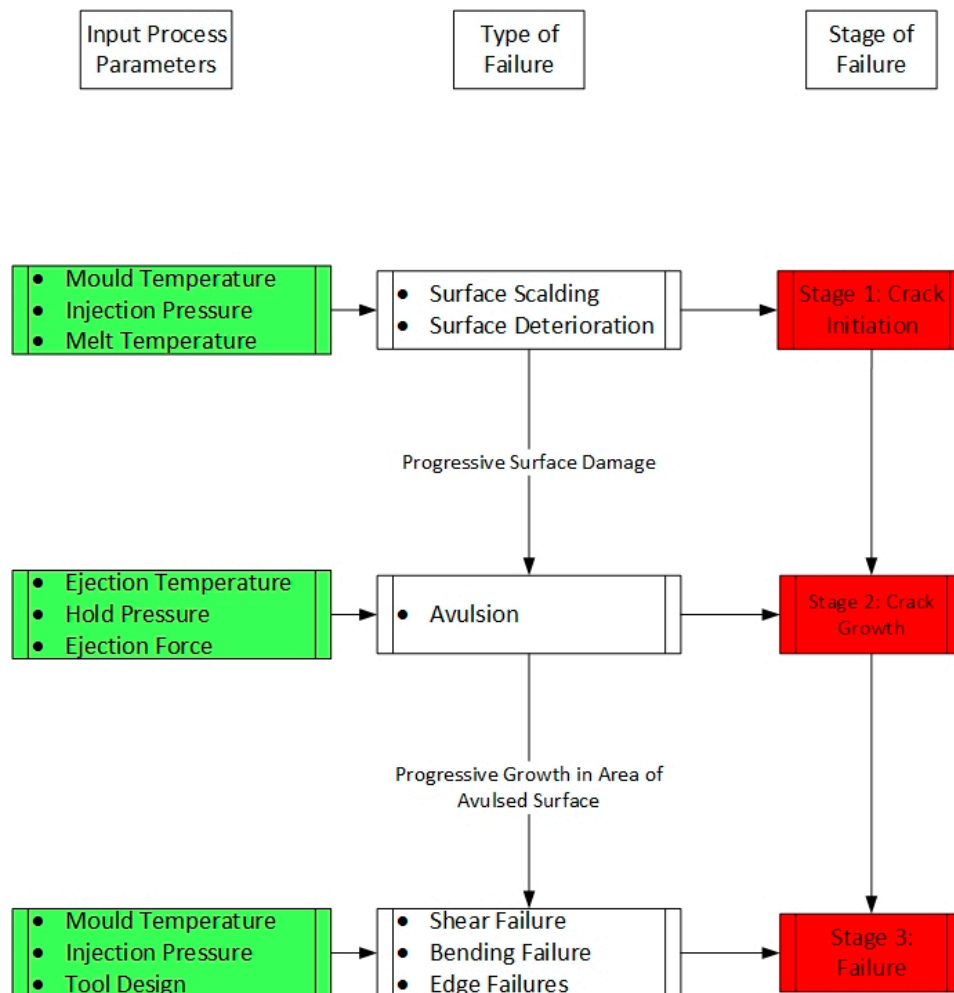
Third Stage: Rapid destruction of the features within the tool, and a catastrophic deterioration of the integrity of the features, and sometimes of the tool (shear and bending failure). This process is similar to the generally accepted creep-fatigue failure process, but is accelerated by the intrusion effect. We propose the following conceptual map of the failure process; see Figure 13. The green color in the image represents the reason for failure and the red color represents the underlying failure mechanisms.

Figure 13. A conceptual map of the interaction between the root causes and the failure modes.
