Experimental and Numerical Study of Polymer-Retrofitted Masonry Walls under Gas Explosions

Keywords: field test, polyurea, gas explosion, masonry wall

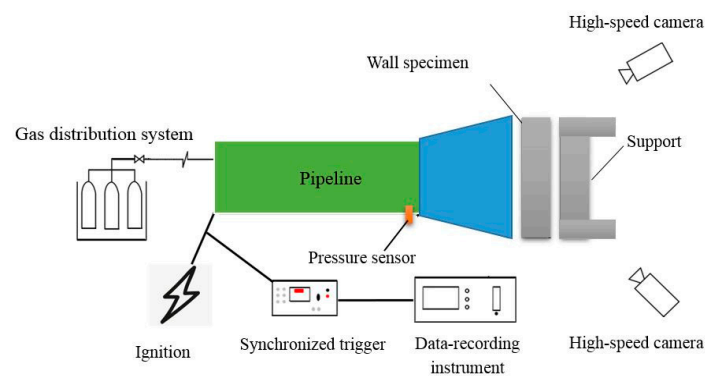
Figure 1. Schematic diagram of the testing setup.

A specially designed testing system was prepared for the gas explosion tests. The test system consisted of a pipeline, wall specimens, data-recording instruments, and gas distribution instruments, as shown in Figure 1.

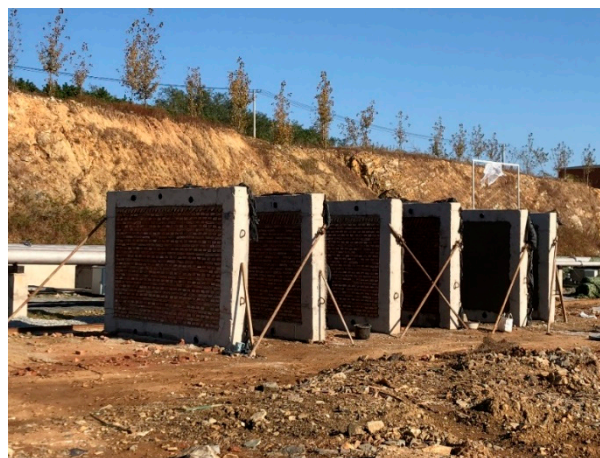
Figure 2. Wall specimens.

One unstrengthened specimen and one rear-face-strengthened specimen were prepared. According to the Chinese standard (GB50003-2011), MU 15 clay bricks and M 5.0 mortar were used for the clay brick walls. The wall specimens with dimensions of $3 \times 2 \times 0.12$ m were lumped with clay blocks with dimensions of $240 \times 115 \times 53$ mm and 10-mm-thick mortar in a “running” pattern, as shown in Figure 2. Large wall dimensions were selected to avoid scale effects and to reflect the actual performance of a reinforced masonry unit wall under blast loading [15].

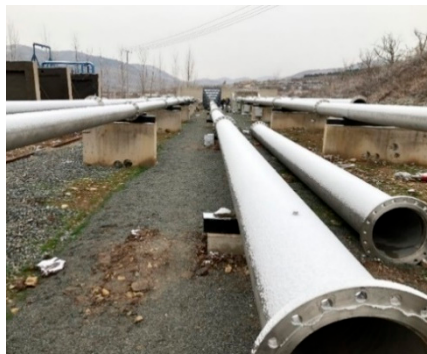
Figure 3. Pipe.

The device main body included a pipeline and flaring, as shown in Figures 3 and 4, respectively. The pipeline was used to store gas. Its diameter and length were 500 mm and 50 m, respectively. To create a more uniform explosion load on the wall surface, the flaring, with dimensions of 2×2 m, was installed at the end of the pipeline.

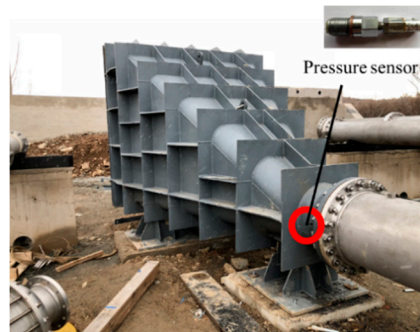
Figure 4. Flaring.

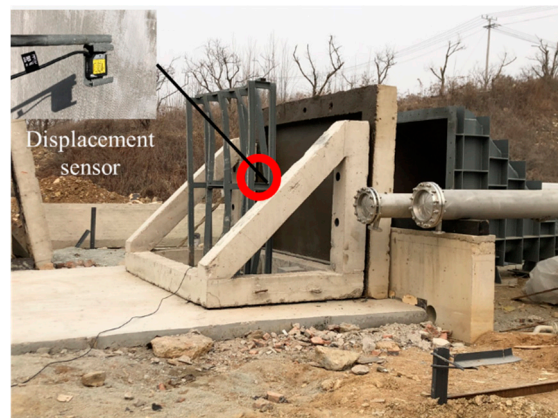
Figure 5. Arrangement of the displacement sensor.

The data-measuring system was used to record the explosion overpressure, displacements, and wall failure modes. It was composed of a synchronous trigger instrument, data acquisition instrument, piezoelectric pressure sensors, displacement sensor, and high-speed cameras. The pressure sensors were used to measure the peak overpressure and positive pressure acting time of the explosion shockwaves, as shown in Figure 4. The measurement range was 0–10 MPa. The displacement sensor was used to measure the displacement of the central points of the test walls, as shown in Figure 5, with a measurement range of -5 to $+5$ cm. High-speed cameras were arranged on the left and right sides of the test walls to record the failure process of the wall during the test, and the speed of high-speed cameras were 6400 frames. The signals from the pressure sensor and displacement transducers were logged by the data acquisition instrument.

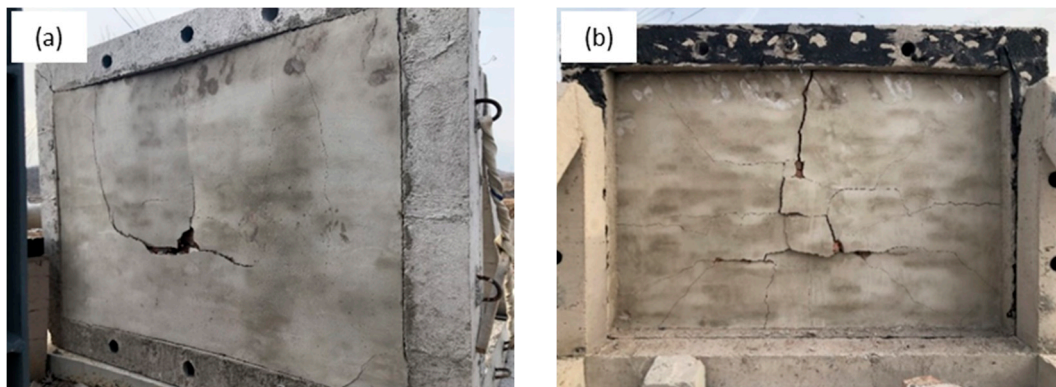
Figure 6. Damage of unstrengthened specimen in test 1. (a) front face and (b) rear face.

Explosion tests of the unreinforced masonry wall were conducted to analyze the failure mode and anti-explosion capacity of the wall. The test results of the masonry wall without an explosion-resistant coating under the first explosion (test 1) are shown in Figure 6. As shown in Figure 6a, large-area concave deformations appeared on the explosion face of the unreinforced wall, and the deformation was almost symmetric. The compression failure of the unstrengthened masonry wall was caused by the high reflected peak pressure. A \perp -shaped penetrating crack appeared in the upper half of the wall, as shown in Figure 6b. The fracture lengths in the horizontal and vertical directions were approximately 1.8 and 1.4 m, respectively, and the widths of cracks were about 25 mm. Bricks almost fell from the central area of the back blasting surface, and cracks developed radially from the center of the wall to the surrounding area. The wall was severely damaged, which indicated that the explosive load was close to the ultimate load-bearing capacity of the unreinforced wall. The blast load time histories were also recorded during the test, and Figure 7 shows that the peak overpressure of the explosive shockwave was about 5.5 MPa. However, no displacement data were obtained due to the mechanical failure.

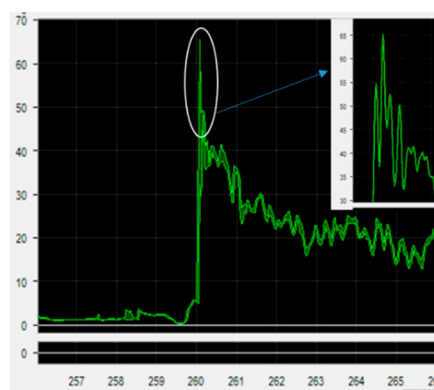
Figure 7. Pressure-time histories in test 1.

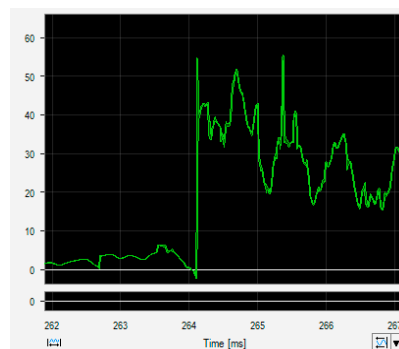
Figure 8. Pressure-time histories in test 2.

To study the distribution of wall debris under explosive loading, subsequent tests were carried out on the wall. The peak overpressure of the explosive shockwave was about 5.2 MPa, as shown in Figure 8. The failure process of the unstrengthened wall specimen during the second explosion (test 2) is shown in Figure 9. Compared with the tests of high explosives in Table 1, the peak pressures from gas explosions were lower but the duration of pressure waves were longer, which lead to different structural responses. Local damages such as spalling or punching damage were more likely to occur when the masonry walls were under close-in TNT explosions as compared to the overall flexural deformations in gas explosions. The test results were similar to those carried out by Li et al. [17], wall specimens experienced damage modes of flexural deformation and a through crack occurred at the middle of the walls. The crack developed with the rise of pressure and the wall specimens collapsed at the latter stage of gas explosion.

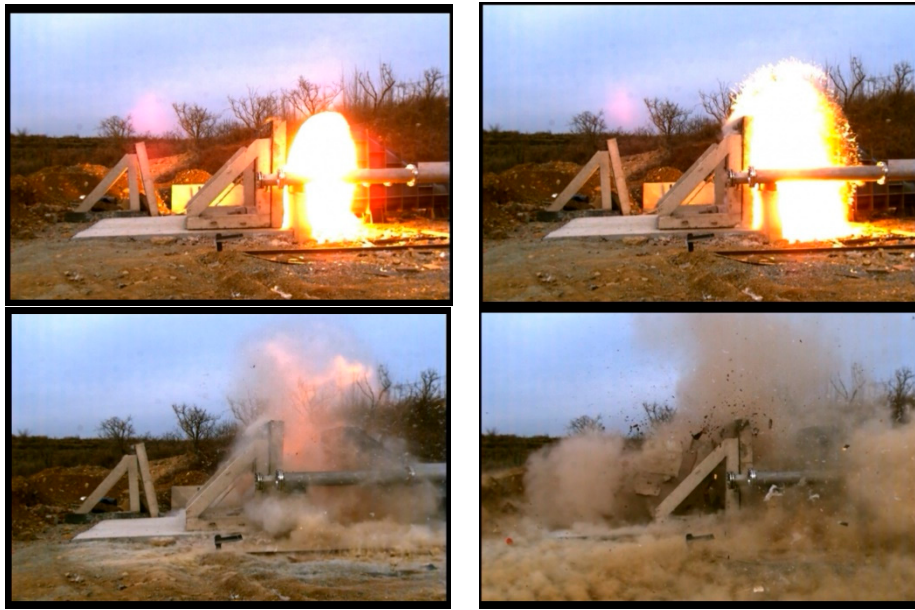
Figure 9. Failure process of unstrengthened wall specimen in test 2.

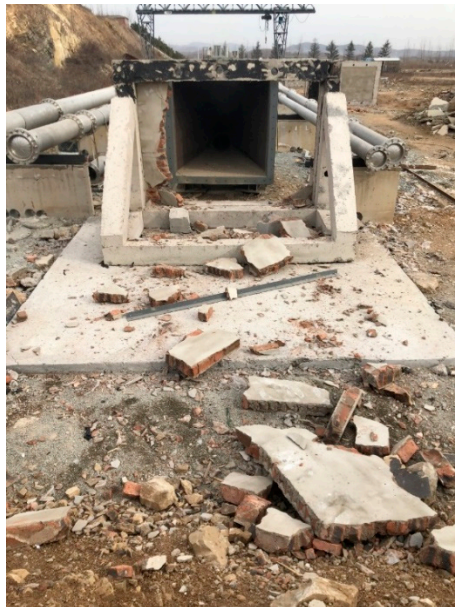
Figure 10. Distribution of debris after the failure of the unstrengthened wall.

The fragment distributions of the wall specimen after the gas explosions are shown in Figure 10. The wall collapsed and broke along the bottom, top, and left joints of the frame, with only a 0.4-m-wide wall remaining on the right side. The debris was dispersed in an area of approximately 7.6 m in length and 5 m in width. Masonry walls are often used as filling walls of frame structures. The debris produced by a masonry wall under a blast wave can cause severe injuries to indoor personnel.

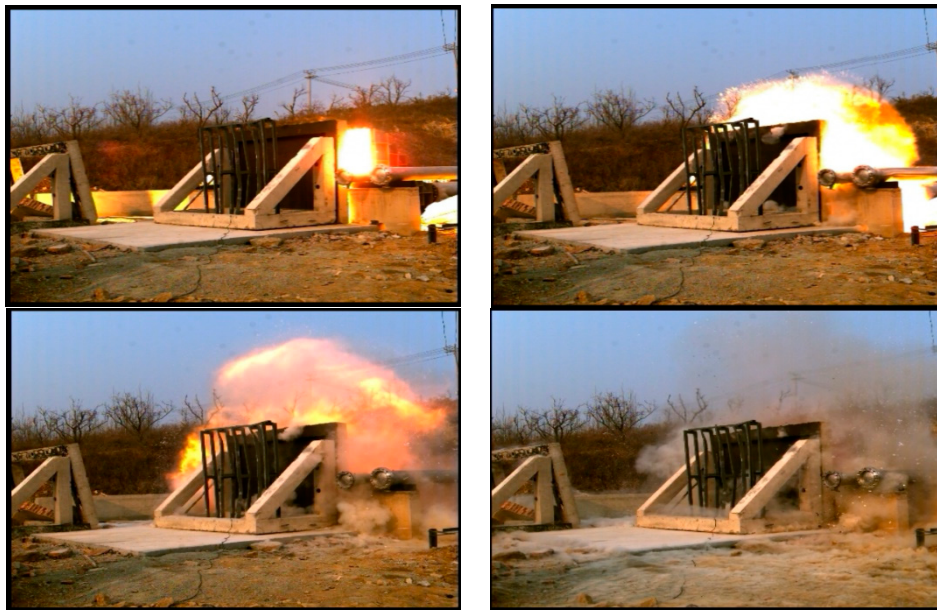
Figure 11. Structural response of rear-face-strengthened wall specimen in test 3.

Test 3 was carried out to investigate the effectiveness of the polyurea layer and the performance of a polymer-retrofitted wall subjected to gas explosions. The thickness of the polyurea layer on the rear face was 6 mm. The dynamic response of the rear-face-strengthened wall specimen is shown in Figure 11.

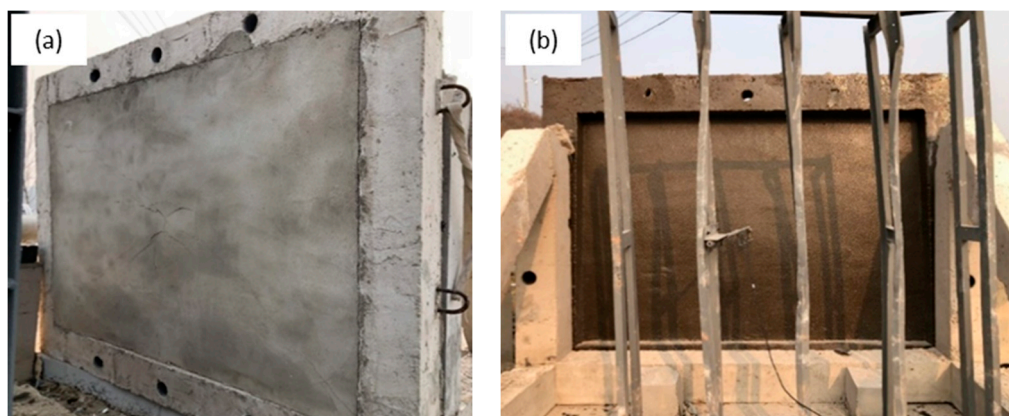
Figure 12. Local damage of rear-face-strengthened specimen in test 3. (a) front face and (b) rear face.

Figure 12 shows photos of the damage of the rear-face-strengthened wall after the explosion. The wall was concave and deformed slightly, with X-shaped cracks appearing in the central area of the front face. The maximum plastic deformation at the bottom was about 0.06 m. The polyurea coating on the back blasting surface was intact, and no cracks formed. This suggested that the presence of the polyurea layer could effectively improve the blast resistance of the unreinforced wall and reduce the wall failure to local bending deformation.

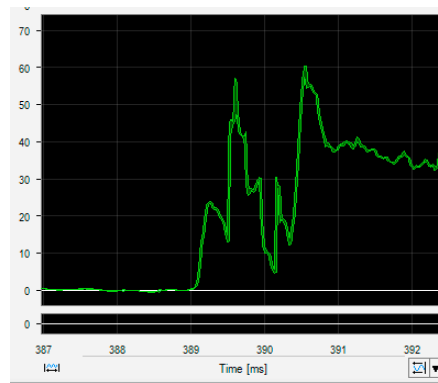
Figure 13. Pressure-time histories in test 3.

As shown in Figures 13 and 14, the peak overpressure in tests 3 and 4 was 6.0 and 5.5 MPa, respectively. The peak pressures in all the tests were basically the same, which indicated that the gas mixture was relatively uniform during each test. Figure 15 shows photographs of the damage to the masonry wall after test 4. The reinforced brick wall collapsed. However, compared to the unreinforced wall, the traveling distance of the debris was significantly reduced, and the debris was almost completely distributed in the framework of the supporting body. The polyurea coating peeled off along the left, right, and lower edges of the frame. The coatings sprayed on the upper part of the frame were partially torn, whereas the remaining coatings were basically intact. The polyurea layer could absorb the explosive energy, thereby reducing the kinetic energy of the debris and preventing high-speed wall fragments from harming indoor personnel. However, in this test,

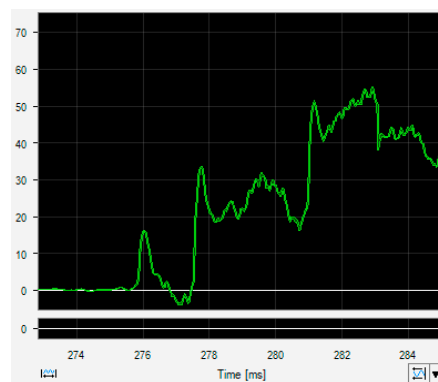
Figure 14. Pressure-time histories in test 4.

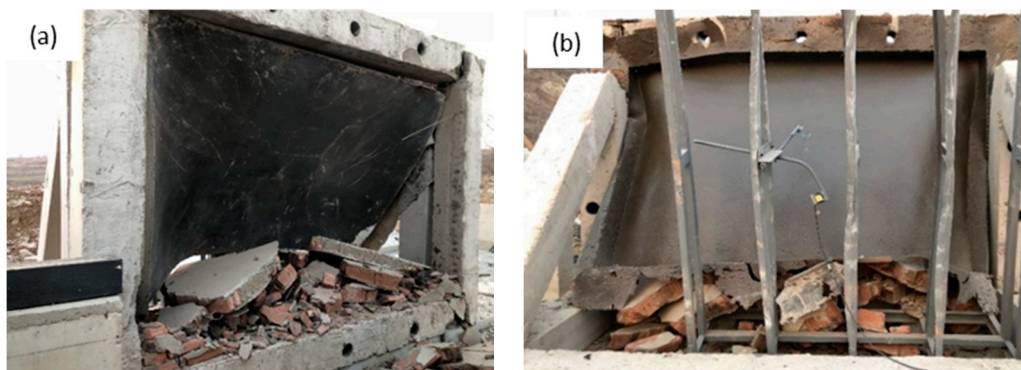
Figure 15. Failure of rear-face-strengthened specimen in test 4. (a) front face and (b) rear face.

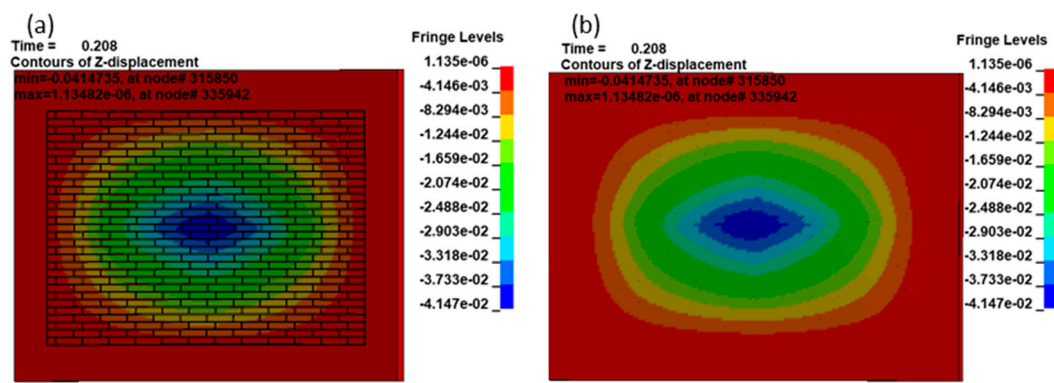
Figure 17. Failure pattern predictions of polymer-retrofitted wall under the first explosion. (a) front face and (b) rear face.

Figure 17 shows the numerical simulation results of the polymer-retrofitted masonry wall in test 3. In Figure 17a, the deformation area of the central area of the wall was approximately 0.12 m², and the numerical simulation predicted a value of approximately 0.14 m². In Figure 17b, the coating on the back burst surface remained intact, and the calculated results showed that the coating was also intact, with slight arching in the center of the coating. Therefore, the numerical model developed in this study yielded acceptable predictions and could be used to predict the performances of polymer-retrofitted masonry walls against gas explosions.

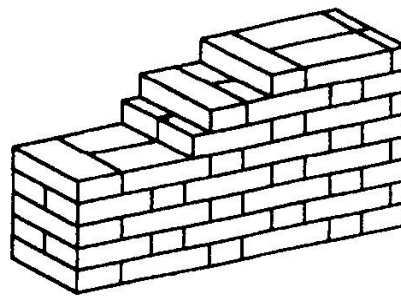
Figure 18. Wall with 240-mm thickness.

The masonry walls of petrochemical buildings are larger than the specimens used in this study, and most are 240 mm thick. Therefore, based on the calibrated models, numerical models with dimensions of 4 m × 3 m × 240 mm were established according to the pattern shown in Figure 18. In the simulation calculations, the peak overpressure was 69 kPa, and the positive-pressure time was 20 ms [22,23].

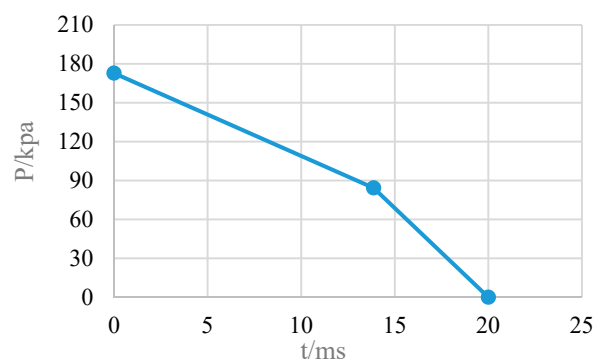
Figure 19. Wall loading.

where I_w is the positive pressure impulse, S is the clearing distance, which is the smaller of H or $B/2$ (m), t_e is the duration of the equivalent triangle (s), and t_c is the duration of the reflected overpressure effect (s). The calculated front wall loading is shown in Figure 19.

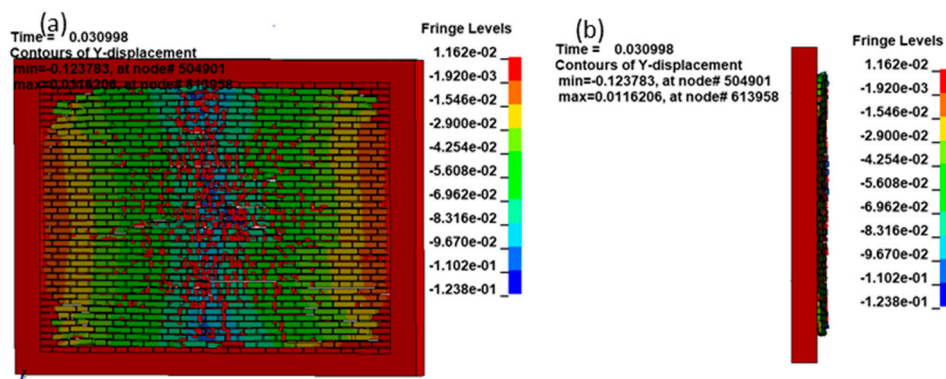
Figure 20. Structural response of the clay brick wall without sprayed blast-resistance coating. (a) front view and (b) side view.

Figure 20 shows the structural response of an unsprayed wall. According to the figure, the brick wall collapsed. Selecting the center point of the wall as the observation point, the displacement curve is shown in Figure 21. In the range of 0–0.2 s, the displacement tended to increase significantly, and the maximum displacement was 0.7 m, which was larger than the thickness of the clay brick wall. The velocity curve is shown in Figure 22. As shown in the figure, the wall velocity increased first, after which it remained basically constant, reaching a maximum velocity of 3.84 m/s at 0.028 s.

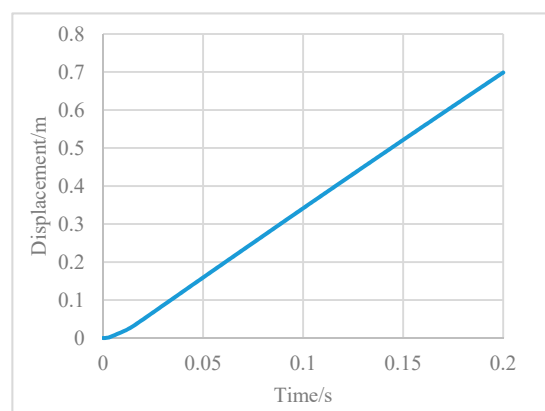
Figure 21. Displacement-time history curve of the unreinforced wall.

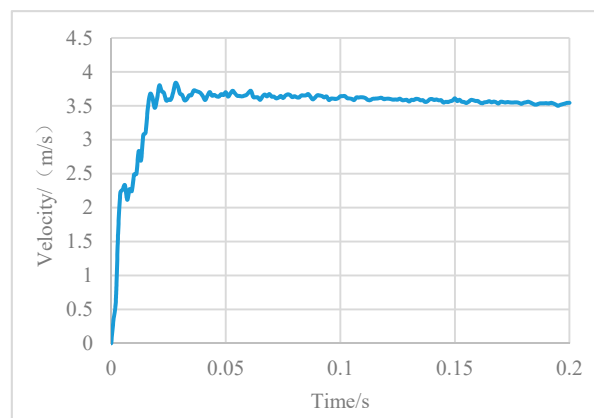
Figure 22. Velocity-time history curve of the unreinforced wall.

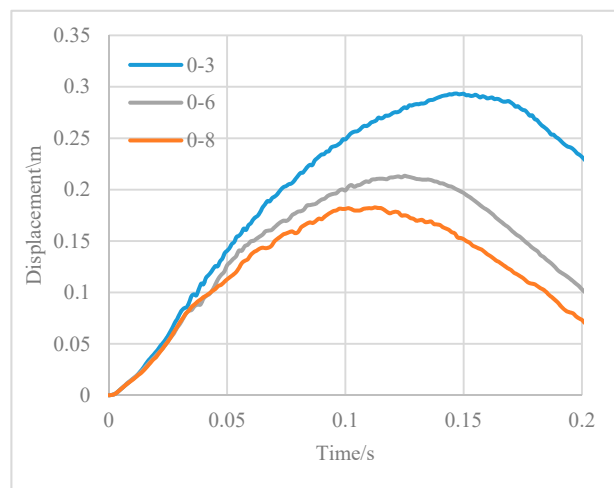
Figure 24. Displacements of walls strengthened with different coating thicknesses.

The displacement histories at the centers of masonry walls are shown in Figure 24. The notation 0–3, 0–6, and 0–8 represent the polyurea coatings with corresponding thickness (mm) sprayed on the rear surface of clay brick wall and no coating on the front surface. The displacement of all the reinforced walls increased first and subsequently decreased gradually. The maximum displacements

of the 0–3, 0–6, and 0–8 walls were 0.29, 0.21, and 0.19 m, respectively. With the increase in the coating thickness, the maximum displacement of wall decreased, which indicated that the anti-explosion ability was significantly improved. The kinetic and internal energies of the coatings are shown in Figures 25 and 26, respectively. The internal energy absorbed by the coating was much greater than the kinetic energy. With the increase in the coating thickness, the amount of wall deformation decreased, the internal energy of the coating decreased, and the wall absorbed more explosive energy through the destruction of the mortar or brick.

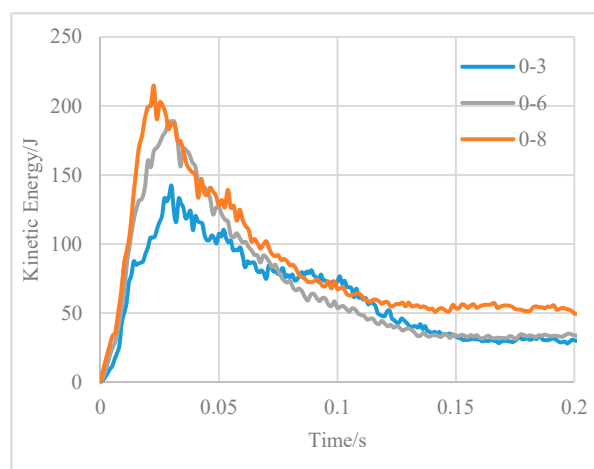
Figure 25. Kinetic energies of coatings with different thicknesses.

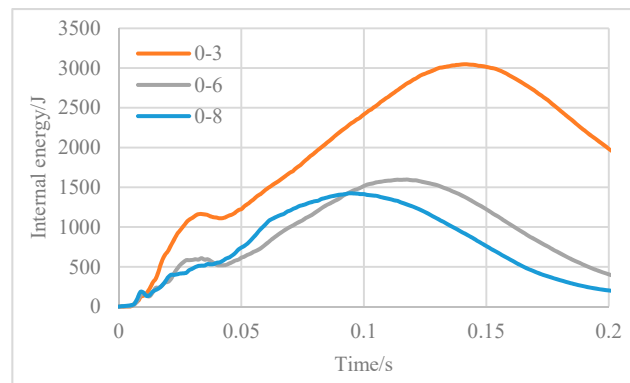
Figure 26. Internal energies of coatings with different thicknesses.

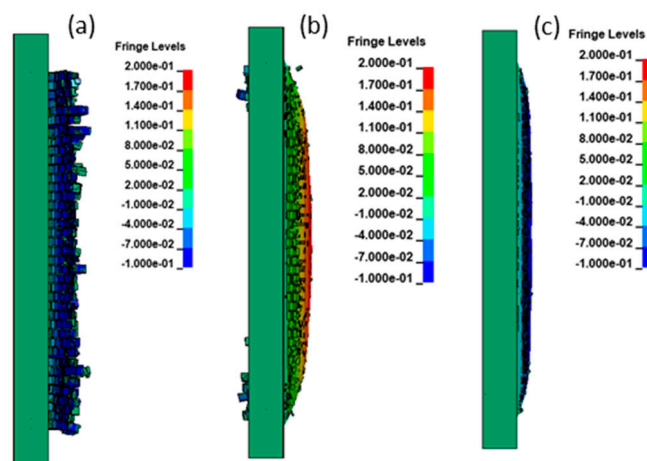
Figure 27. Structural responses of clay brick walls (0.07 s). (a) 3–0, (b) 0–3 and (c) 3–3.

The coatings of the walls strengthened using three different spray patterns were not damaged under explosive loading. The side views of the reinforced walls are shown in Figure 27. When the polyurea was sprayed only on the front face of the masonry wall, debris was launched from the back of the wall.

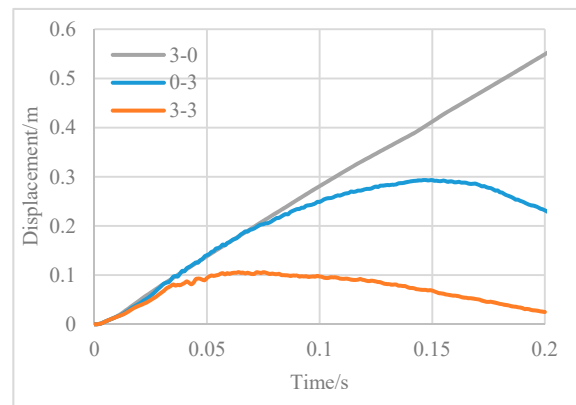
Figure 28. Displacements of walls strengthened with different spraying patterns.

The displacement curves of the different spraying methods are shown in Figure 28. The maximum displacements of the 3–0, 0–3, and 3–3 walls were 0.55, 0.29, and 0.11 m, respectively. This suggested that the masonry wall with the double-side reinforcement exhibited the best explosion resistance. For the 3–3 wall, the thickness of the coating on the front side was the same as that on the back side. The kinetic and internal energies of the coating on the front side were larger than the corresponding values of the back side, as illustrated in Figures 29 and 30, which showed that the energy absorption effect of the front face coating was better than that of the back face coating.

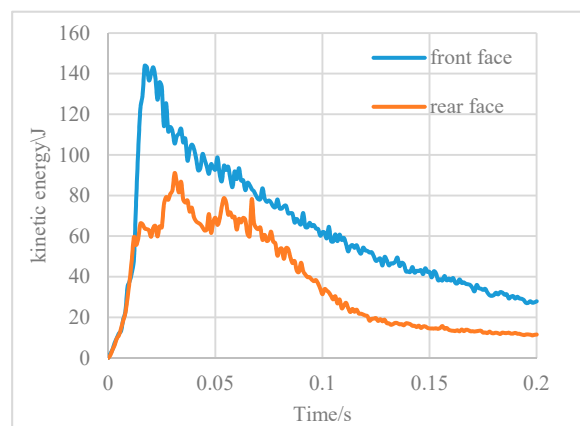
Figure 29. Kinetic energy of the 3-3 wall coating.

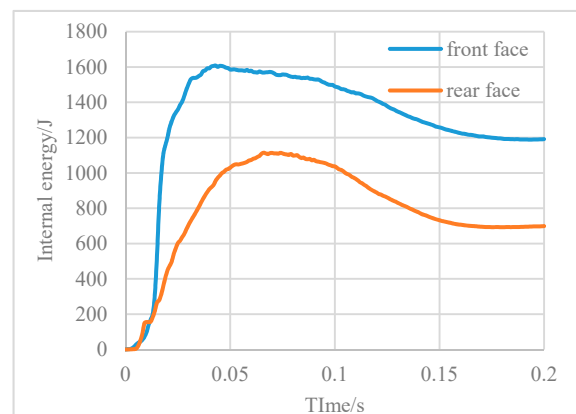
Figure 30. Internal energy of the 3-3 wall coating.

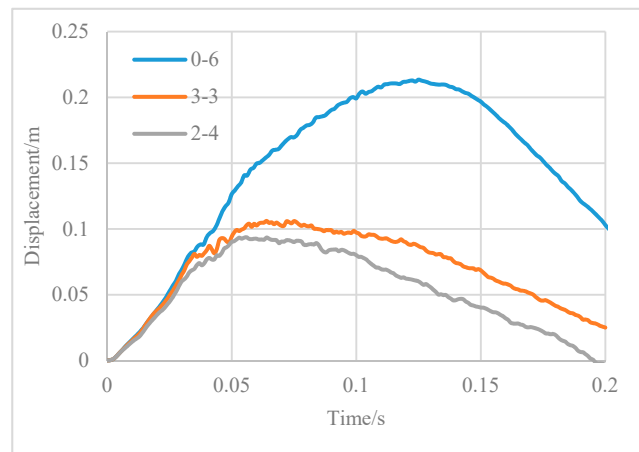
Figure 31. Displacements of walls strengthened with the same thickness.

The displacements of the walls strengthened with the same thicknesses are shown in Figure 31. The maximum displacements of the 0-6, 3-3, and 2-4 walls were 0.21, 0.11, and 0.09 m, respectively. The explosion resistances of the masonry walls could be further improved by optimizing the combination of the coating spraying method and thickness.
