Investigation and Analysis of a Hazardous Chemical Accident in the Process Industry: Triggers, Roots, and Lessons Learned

Keywords: organization, individual, 24Model, cause analysis, hazardous chemical accident

Case Report

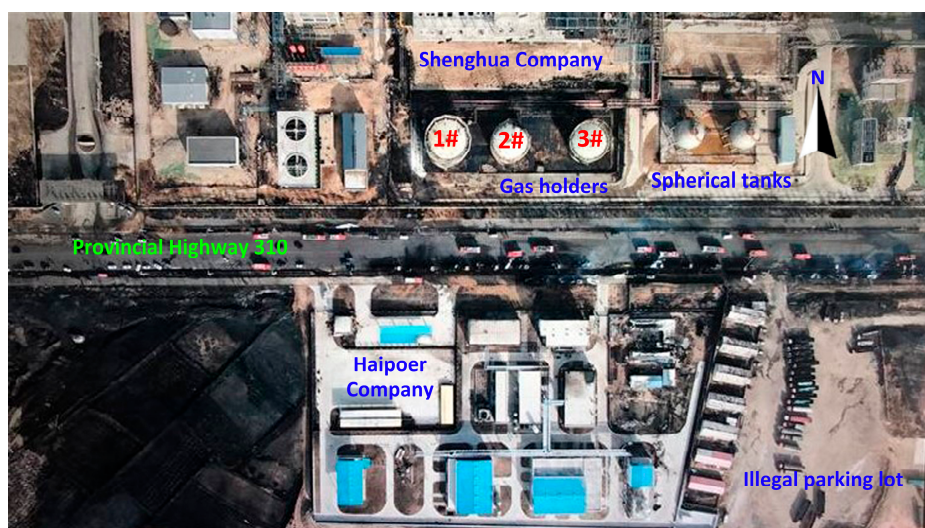
Through on-site investigations, the storage installations of vinyl chloride are located on the south side of Shenghua Company. There are three gas holders distributed from west to east, with volumes of 5300 m³ (1#), 2500 m³ (2#), and 2500 m³ (3#), as well as two similar spherical tanks installed side-by-side, with a volume of 2000 m³. The specific distribution in the plant is shown in Figure 4 below. According to the accident report, the leaks just occurred in the 1# gas holder with the largest amount of vinyl chloride. This installation is designed as a double-layer bell-shaped structure sealed by the water. When the bell housing pulls the middle section up, a U-shaped annular water seal will be formed. The designed height of the water seal is about 0.350 m, which can seal vinyl chloride of 3.43 kPa. The schematic structure of 1# vinyl chloride gas holder is shown in Figure 5.

Figure 4. The map of the accident scene.

As shown in Figure 3, the vinyl chloride gas holder group is located at the southernmost side of Shenghua Company, about 20 m away from the north side of the Provincial Highway 310. Affected by the local terrain condition and the wind direction at the time of the accident, the leaked vinyl chloride spread along the road extensively and diffused to the opposite Haipoer New Energy Technology Company (hereinafter, Haipoer Company, Zhangjiakou, China) who was mainly engaged in the preparation of hydrogen and oxygen by electrolysis of water. Through the on-site surveillance videos, eyewitness interviews and fire spread path analyses, the investigators finally determined that the fire source resulting in the explosion was from a high-temperature muffle furnace near the oxygen preparation and filling area in Haipoer Company. A further investigation and test showed the device had been continuously energized for 4 h and 24 min by the time of the incident, and the temperature at

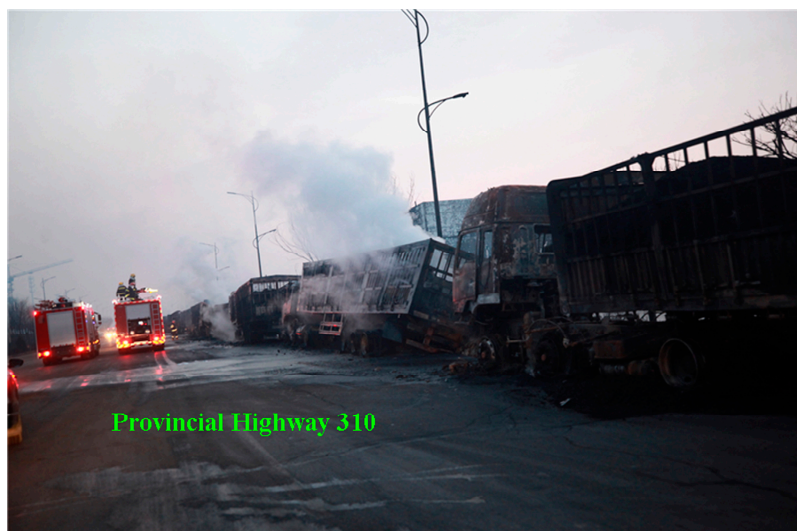
When the explosion occurred, lots of vehicles loaded with raw materials and fuels (coal) hired by Shenghua Company, as well as several small passenger cars were being illegally parked on the Provincial Highway 310 and the opposite illegal parking lot. Many drivers and supercargoes stayed in the trucks overnight because of Shenghua Company's delay of unloading. After the leaked vinyl chloride was ignited, the fire rapidly spread to the vehicles; moreover, the fire further expanded and quickly formed domino effects (see Figure 8) due to the flammable and explosive substances in the vehicles. Therefore, it was not surprising that the accident caused such heavy casualties and property losses.

Figure 8. Damaged vehicles on the Provincial Highway 310.

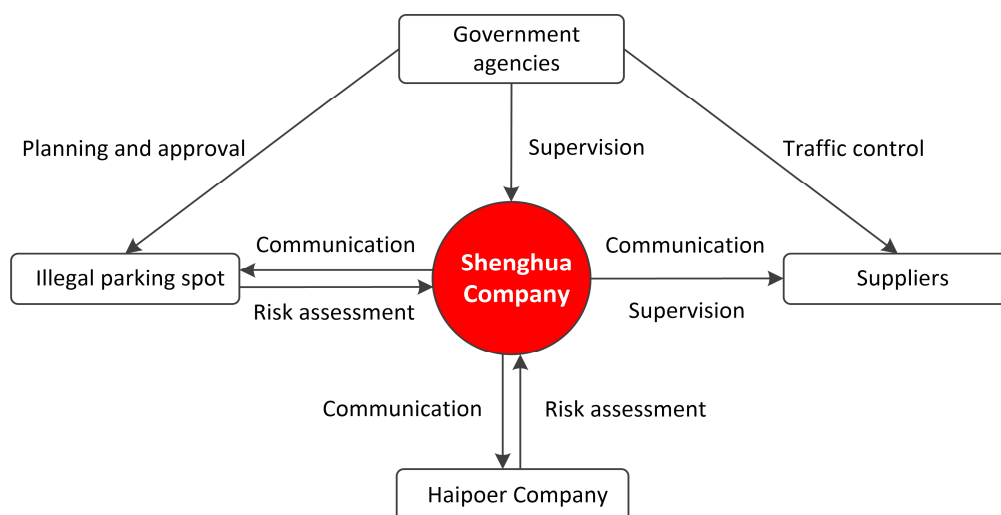
In the complex sociotechnical system, accidents usually occur in an organization and are affected by other factors outside the organization [18]. The interactions between different organizations should be considered in a comprehensive manner when carrying out the analysis and prevention of accidents. Similarly, several organizations were involved in this hazardous chemical accident, among of which, Shenghua Company was just the organization where the accident occurred, and the causes associated with it are the emphasis for investigation and analysis. Besides, other related organizations, such as the supplier transportation company, the illegal parking lot, the Haipoer Company, and some relevant government agencies (i.e., the local traffic control department, the local land and resources department, as well as the local supervision department of work safety), exerted indirect effects on the occurrence of the accident and the expansion of various losses. Therefore, the adverse factors from those interested parties should also be taken seriously. The interrelationship among these organizations in the accident are shown in Figure 11.

Figure 11. Organizations involved in the accident and the interrelationship among them.
