# Evaluation Residual Compressive Strength of Tunnel Lining Concrete Structure after Fire Damage Based on Ultrasonic Pulse Velocity and Shear-Wave Tomography

**Abstract:** In this study, ultrasonic pulse velocity (UPV) and ultrasonic shear-wave tomography are combined to measure the residual compressive strength (RCS) of small-scale lining concrete blocks and to detect inner defects in the lining structure. The characteristics of and variations in the RCS of test blocks after being exposed to elevated temperatures (200–800 °C) and constant heating times (2 h, 3 h, and 4 h) were studied. At 800 °C, the RCS values reduced by 64.4%, 69.2%, and 74.6% at heating times of 2 h, 3 h, and 4 h. Scanning electron microscopy (SEM) was used for the micro-phase analysis of the samples that had been exposed to high temperatures. The heating time and RCS as well as the SEM micro-structure relationship were compared. Finally, a tunnel lining slab sample was designed to simulate the post-fire damage inside the blocks. Additionally, shear-wave tomography with 32 probes was able to detect the  $\phi 10$  mm void defects at a depth of 200 mm.

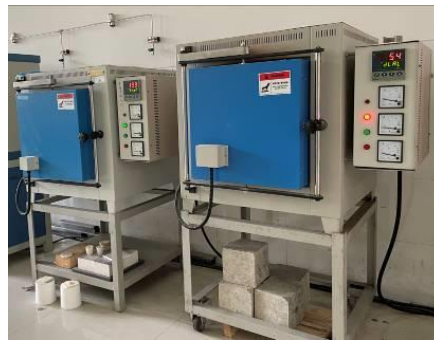
(a) Furnace.

The YFFG10/12Q-YC model furnace used in the present study has a chamber size of 200 mm × 200 mm × 250 mm, as shown in Figure 1a, and the elevated temperatures varied from 200 °C to 800 °C. Heating rate was 10 °C/min up to the target temperature. The peak temperature was maintained for a period of 2, 3, and 4 h (constant heating time). A cooling rate of 8 °C/min was applied, and the samples were then allowed to cool gradually at air at room temperature [36].

**Figure 1.** The experimental set-up.

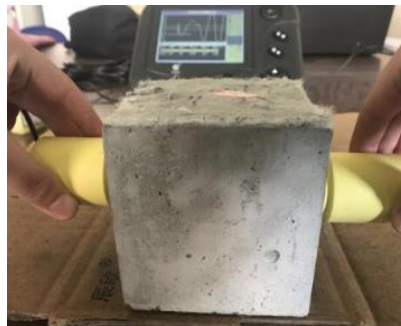
(b) Ultrasonic pulse transmission time measurement.

A transmitted ultrasonic pulse frequency 50 kHz was applied, and pulse transmission time was measured as shown in Figure 1b. An NM-4A non-metal ultrasonic wave detector from Beijing concrete engineering Corp was chosen for the UPV test. The transmission times of the ultrasonic pulse through the unexposed blocks and fire-exposed blocks were compared. Each point was tested three times. The measured ultrasonic wave transmission time  $\Delta t$  through the block was used to calculate the pulse velocity  $v$ . Finally, the compressive tests were conducted using an MTS servo-hydraulic universal testing machine with a capacity of 2000 kN, as seen in Figure 1c. The cubic block was axially loaded at 0.5 MPa/s post-fire exposure. Typical concrete specimens were tested under different elevated temperatures, as seen in Figure 2. MIRA is a low frequency (20–100 kHz) multifunctional phased array ultrasonic system that can be used to detect objects, interfaces, and anomalies in concrete structures [30]. Since the ultrasonic probes in MIRA do not require a coupling gel to ensure the transmission of waves into the concrete, the probe can be moved from one position to the next position with almost no surface preparation. Shear wave velocity is 2160 m/s. MIRA-A1020 consists of 32 dry-point-contact (DPC) transmitting and receiving transducers in a matrix antenna array with 8 channels spaced 30 mm apart; each channel has four transducers that are laterally spaced 25 mm apart. If each channel acts as either a transmitter or a receiver, then there are a total of 56 transmitting and receiving pairs for 8 channels. One of the most powerful features of MIRA is its ability to reconstruct the condition of concrete in a three-dimensional format. The MIRA-A1020 set-up is shown in Figure 3.

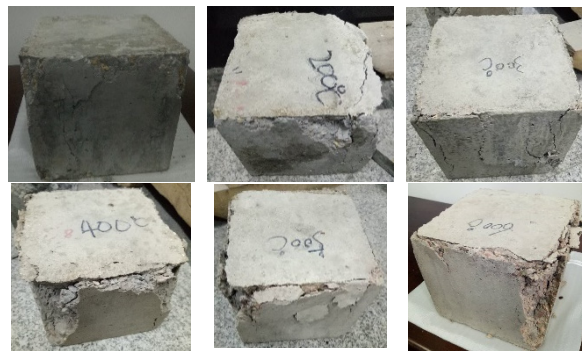
**Figure 2.** Typical test blocks under exposed temperatures (200 to 800 °C).

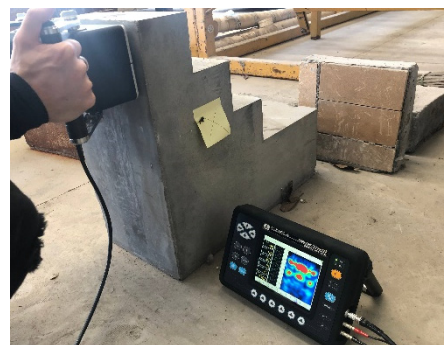
**Figure 3.** MIRA A1020 set-up.

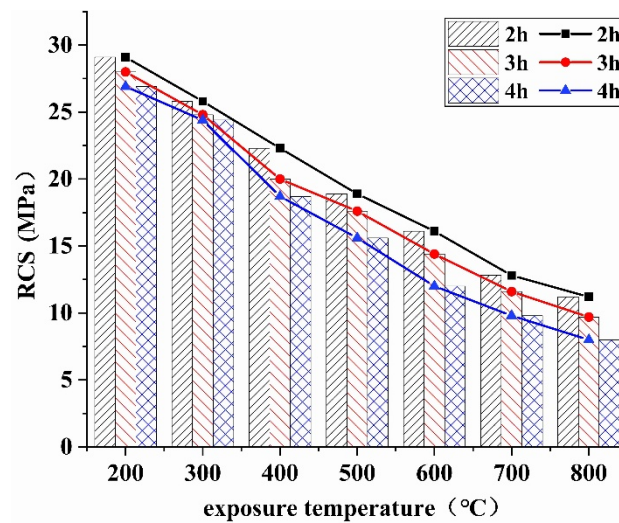
Then, the  $f_{cu}$  values are compared at the constant heating times of 2 h, 3 h, and 4 h constant in Figure 6. For the fixed exposure heating times (2 h, 3 h or 4 h), it is clear that variations in the  $f_{cu}$  values have the same trend. For the defined temperature, three  $f_{cu}$  of the heating time (2 h, 3 h or 4 h) values are nearly stable. The  $f_{cu}$  reduction trend is obvious as the temperature increases. At 200 °C, the  $f_{cu}$  value reduces by about 12%~20%, compared to at room temperature. Due to free water evaporation, cracks and voids were produced in the inner part of the concrete. At 400 °C,  $f_{cu}$  the value reduces by 38%~50% compared to the  $f_{cu}$  value at room temperature. At 600~800 °C, the  $f_{cu}$  value reduces slowly, and  $f_{cu}$  value decreases by about 3%~9% for each 100 °C increase. At 800 °C, there was loss in the  $f_{cu}$  value of about 70%. As the constant heating time (2 h, 3 h, and 4 h) increased, the variations in the RCS maintained a decreasing trend. The mean  $f_{cu}$  values are 28.0 MPa, 25.0 MPa, 20.3 MPa, 17.4 MPa, 14.2 MPa, 11.4 MPa, and 9.6 MPa under 200~800 °C, respectively, and the corresponding max-deviations are 2.2 MPa, 1.4 MPa, 3.6 MPa, 3.3 MPa, 4.1 MPa, 3.0 MPa, and 3.2 MPa.

Figure 6. RCS vs. temperature under constant heating times.

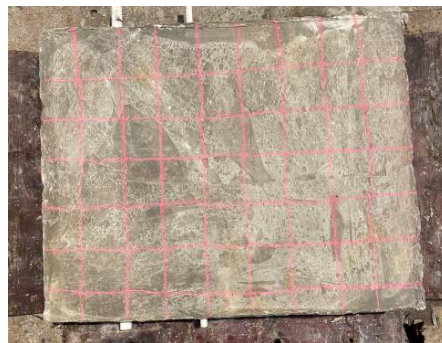
The concrete lining test site was located in the Zhijing tunnel, Hangzhou City, seen in Figure 9. The concrete lining slab was  $1000 \times 800 \times 200$  mm in size. The similar-sized specimen of the tunnel lining concrete slab was designed for inner defect detection and can be seen in Figure 10.

**Figure 10.** Schematic grid of the testing slab.

Based on the grid in Figure 10, each ultrasonic test provided an individual B-scan. After all of the B-scan results were fused, the slice in the transverse direction of the equipment provides a 3D view of the sample damage. In Figure 11a, the focused image has an apparent depth 210 mm, which is different from the actual bottom depth of 200 mm. The location error is about 10 mm. The focused images that were obtained using SAFT illustrated the existence of simulated fire damage inside the concrete lining. The four red dots at the upper portion of the screen indicate two voids ( $\phi 10$  mm,  $\phi 30$  mm) and two rebars ( $\phi 20$  mm,  $\phi 10$  mm). In Figure 11a, in the B-scan image from left to right, the depth of the voids and rebar are 93 mm, and the location error is  $-7$  mm. It is in the accepted error range. In Figure 11b, which shows a C-scan image, a  $\phi 10$  mm rebar and  $\phi 20$  mm,  $\phi 10$  mm, and  $\phi 30$  mm voids, and the diameters are 27 mm, 35 mm, 20 mm, and 40 mm, respectively. The location errors are  $+17$  mm,  $+15$  mm,  $+10$  mm, and  $+10$  mm. Though the depth location errors are not small due to heterogeneities in the concrete structure, they also supply rich information about the lining inner structure. A 3D-scan view of the concrete slab is shown in Figure 11c. MIRA was able to detect the diameter of a  $\phi 10$  mm void and to detect defects at the depths of 100 and 200 mm. These findings meet requirements for concrete lining structure inner defect inspection. The other red dots (clutters) indicate small cracks or voids inside the specimen, which indicate poor concrete consolidation or contamination.

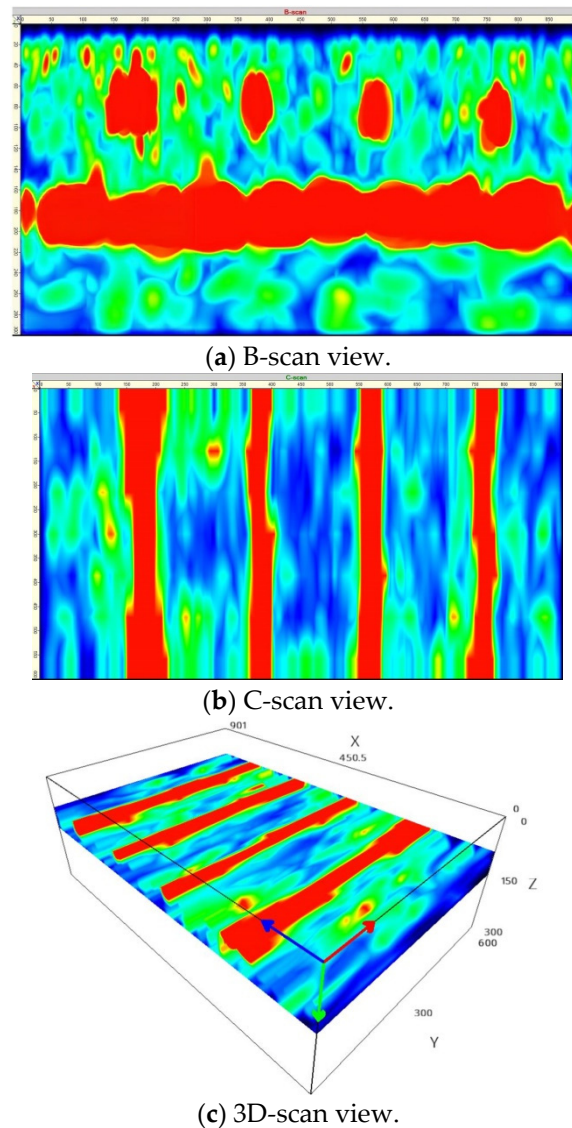
**Figure 11.** Illustrations of ultrasonic imaging test: (a) B-scan, (b) C-scan, (c) 3D-scan.
