Failure Mechanism Analysis and Support Technology for Roadway Tunnel in Fault Fracture Zone: A Case Study

Abstract: This paper introduces a case study on the failure mechanism and support design of a roadway tunnel in the fault fracture zone of the 106 mining area in the Yuandian no.2 coal mine. Based on the on-site geological conditions (in-situ stress test, borehole television imaging, and lithological analysis), the failure mechanism of the roadway tunnel in the fault fracture zone was studied. The test results showed that the high tectonic stress, fractured rock, and poor lithology are the primary reasons for the roadway instability. According to the support principles of grouting reinforcement, pre-reinforced support, and rational support range, a new type of combined support technology was proposed, including advanced grouting, grouting bolts, and grouting anchor cables. A 100 m roadway section was selected for field testing using the new support scheme, and detailed deformation monitoring was performed. Monitoring results showed that the roadway deformation under the new support was significantly reduced. During the roadway excavation process, no roof collapse phenomenon oc

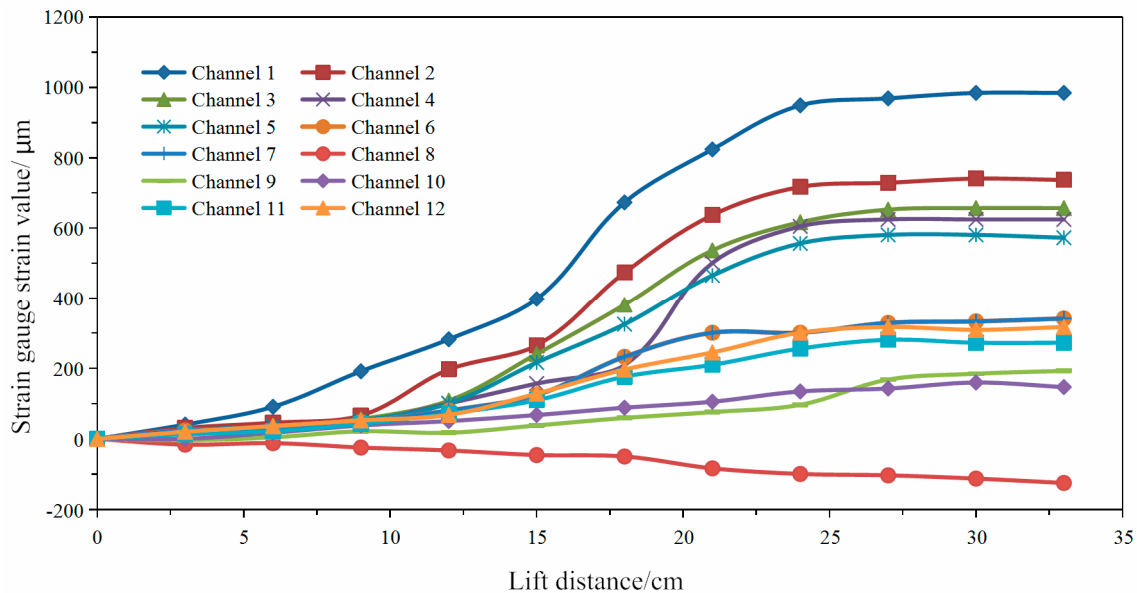
**Figure 6.** Stress relief curve of tested point 1.**Table 2.** Summary of rock mechanics parameters.

Figure 6 shows the typical stress relief curves at tested point 1. The stress relief curve shows good regularity, indicating that the working state of the strain gauge at the measuring point is normal. When the release distance does not reach the location of the strain gauge, the strain value is small, when the release distance is close to the location of the strain gauge, the strain value changes greatly, and when the release distance exceeds the location of the strain gauge, the strain value gradually stabilises. After the in-situ stress was measured, rock samples were collected, and the elastic modulus and Poisson's ratio of the rock samples were measured (Table 2). By processing the measured data, the magnitude and direction of the in-situ stress components and principal stress of the tested point were calculated, which are summarised in Table 3.

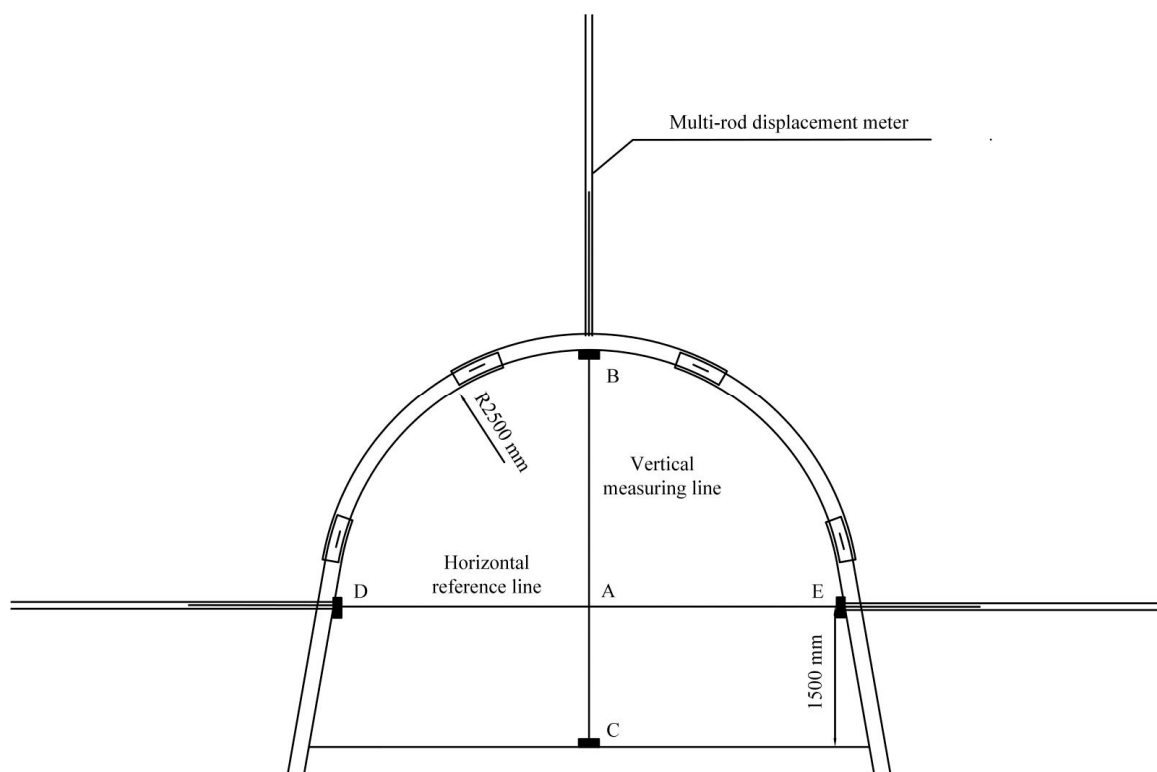
Figure 13. Monitoring layout of multi-point displacement and surface displacement.

Multi-rod displacement meters were placed on the roof and the two ribs of the roadway, as shown in Figure 13. Before installation, a 30 mm mounting hole was drilled in the roof, and the borehole fixing device was sequentially sent to the predetermined position. After the reading device was fixed at the hole, the wire rope of each tested point was tightened, and the measuring ring was pushed on the borehole measuring device to the 100 mm position. Then, the wire rope and measuring ring were fixed with screws. After installation, the initial reading of each tested point can be read, and the difference between the measured value and the initial reading is the displacement value, which must be accurate to 0.2 mm. Convergence meters were placed on the roadway to monitor the surface displacement.

As shown in Figure 13, points B and C are the vertical data marks of the roof and floor of the roadway, and points D and E are the horizontal data marks of the two ribs of the roadway. Point A is the midpoint of BC and DE. The decrease of BC means the deformation of the roof and floor. The decrease of DE means the contraction of the two ribs. Measurements by a convergence meter are required to be accurate to 0.2 mm.
