Dynamic Process and Damage Evaluation Subject to Explosion Consequences Resulting from a LPG Tank Trailer Accident

Citation: Wang, K.; Liu, Y.; Wang, H.; Liu, X.; Jiao, Y.; Wu, Y. Dynamic Process and Damage Evaluation Subject to Explosion Consequences Resulting from a LPG Tank Trailer Accident. *Processes* **2023**, *11*, 1514. <https://doi.org/10.3390/pr11051514>

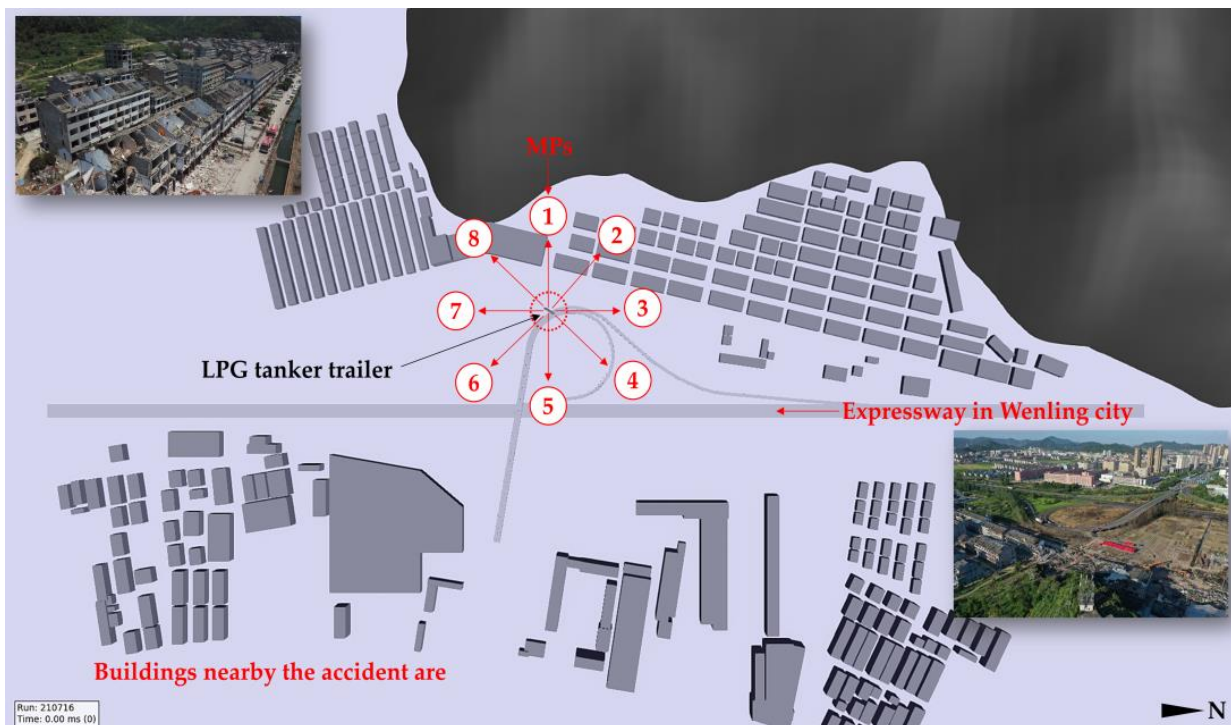
A 3D model is constructed based on the Wenling expressway explosion accident scene in China, as shown in Figure 3. The geometry model aims to reconstruct the scene according to the actual accident, including the expressway, LPG tank trailer, path, residential houses, vehicles parked on the side of the expressway, the surrounding environment, etc. The materials involved in the LPG tank trailer model are set as mixtures of propane and butane. In this numerical model, there are 89 monitoring points (MPs) set in the accident scene reconstruction model. The MPs can collect the required data of overpressure and temperature data in real time during the simulation process. Since the LPG tank trailer leakage and explosion accident scene occurs on an expressway road, 4 rows of MPs are set in FLACS along the X-Y horizontal direction in the shape of an “m”, with a total of 80 MPs, as shown in Table 2. The MPs in row 1 are in the same direction from northeast to southwest. The marked MPs range from 1 to 20. The second row of MPs is perpendicular to the direction of the mountain in the upper middle part of Figure 3, marked as MPs 21~40. MPs in row 3 are in the same horizontal direction, and the marked MPs range from 41 to 60. The fourth row of MPs is in the northwest to southeast direction, and the marked MPs range from 70 to 89. The vertical MPs layout at the site of LPG tank trailer explosion accident can be observed. With the coordinate (370,128,5) as the center, there are 9 MPs in total, which can be used to collect the transmission form of shock wave and thermal radiation in the air after the LPG explosion.

Figure 3. Schematic diagram of the 3D model of the LPG tank trailer accident scene.

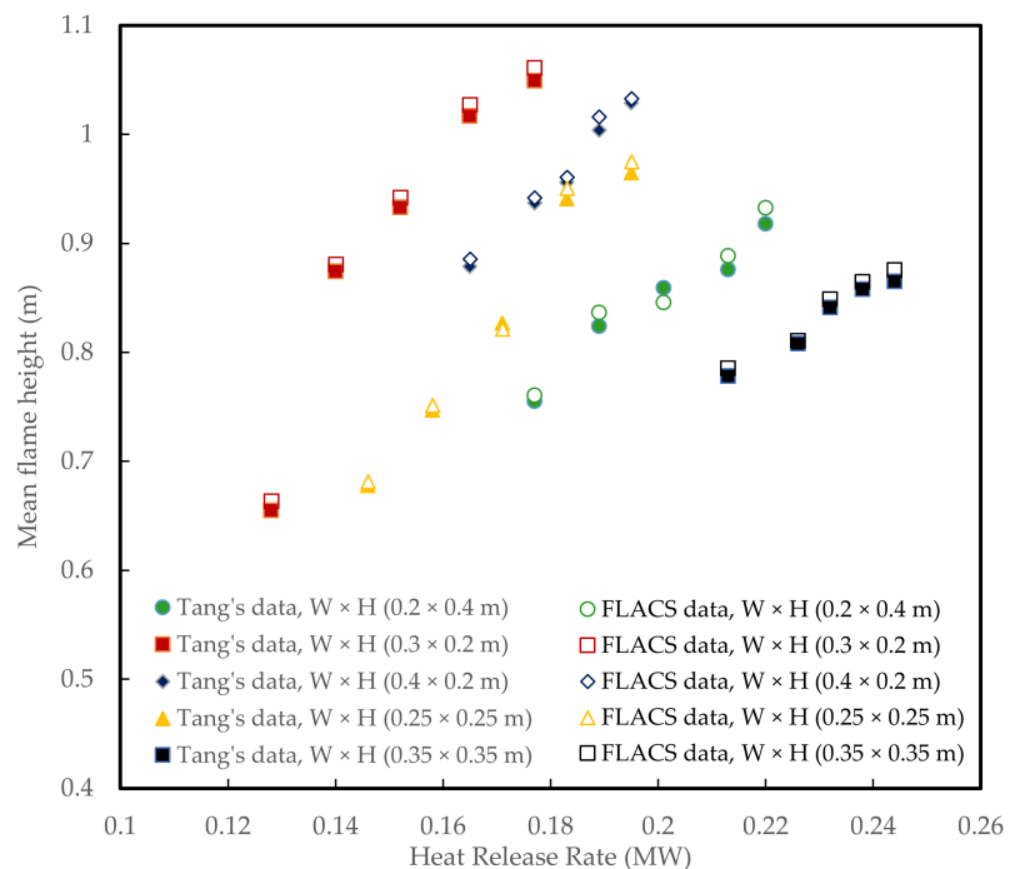
exposure to thermal hazards [27–30]. The previous research studies are useful to validate the results for the flammable gases, gaseous mixture dispersion, flame propagation and explosion consequences. In our work, a comparison between the experiment [31] and our present 3D model is carried out and analyzed, which aims to investigate the combustion and damage characteristics with the explosion process in a confined space. In the previous experiment, a total of six types of conditions are set in the different scenes. Based on the experiment, the six scenes are selected in FLACS, with variable vent geometries accordingly. These conditions account for the different ventilation factors, vent dimensions and vent aspect ratios. According to the experimental data, five types of fire source with elevated heat release rates (HRRs) are compared with computational schemes. MPs are in accord with the experiment condition. Figure 4 shows the variation of flame height induced by the vertically ejected fire in different scenarios. The solid points represent the experiment data, while the hollow points represent the FLACS data, respectively. It can be obviously observed that the variations of flame heights change with HRRs from the fire source when the vent sizes change. The excessive flammable gas ejects outside of the confined space, resulting in the flame heights induced by the ejected fire increasing with the enhancing HRRs. Figure 4 presents the variations of flame heights with HRRs displaying different trends for changed vents. The vent sizes under fire and explosion accidents have a remarkable impact on the upward flame height. It indicates that the minimum deviation of the comparison is approximately 1.18%, while the maximum deviation is 7.96%. The average deviation between the MPs groups is 3.61%, which is caused by neglecting radiant heat loss after adiabatic treatment of the computational model. Besides, the previous experiment results are affected by various environmental conditions. The above-mentioned problems have been improved upon in the current model and simulation process.

Figure 4. Comparisons between the experiment and FLACS data for model validation.

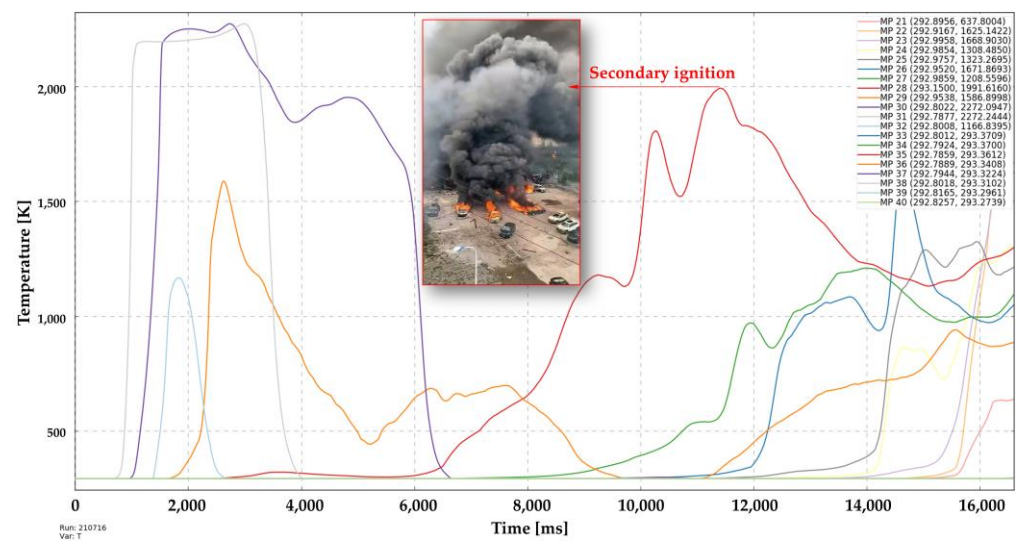
Figure 17. Heat flux fluctuates with time lapse from the east to west area (MP 21~40).

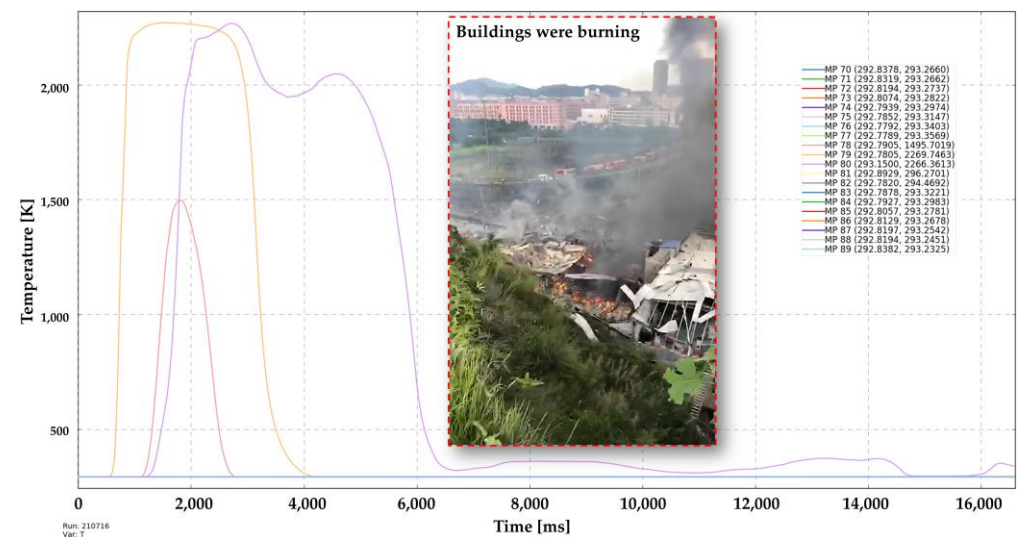
Figure 18. Heat flux fluctuates with time lapse from southwest to northeast area (MP 70~89).
