# Review on the Experimental Characterization of Fracture in Active Material for Lithium-Ion Batteries

**Keywords:** fracture mechanics; battery damage; experimental mechanics; damage mechanisms; lithium-ion batteries

**Citation:** Pistorio, F.; Clerici, D.; Mocera, F.; Somà, A. Review on the Experimental Characterization of Fracture in Active Material for Lithium-Ion Batteries. *Energies* **2022**, *15*, 9168. <https://doi.org/10.3390/en15239168>

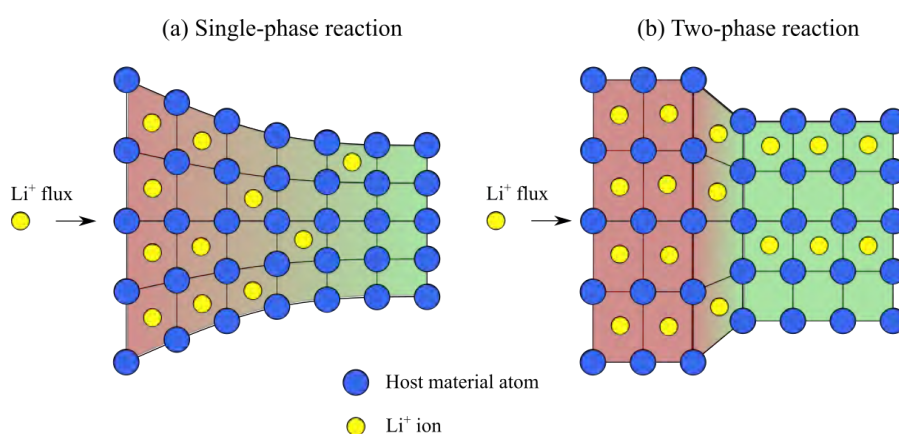
**Figure 1.** Mechanical stress resulting from inhomogeneous concentration due to (a) single phase-reaction and (b) phase transition.

Then, the inhomogeneous lithium concentration within the particle causes differential deformation of the lattice structure, leading to diffusion-induced stress (DIS) [8–13,21]. Furthermore, some materials show a two-phase behavior, i.e., two phases with a different lithium content coexist in the same particle, causing a significant strain mismatch at the interface between them, and thus stress, as illustrated in Figure 1b.

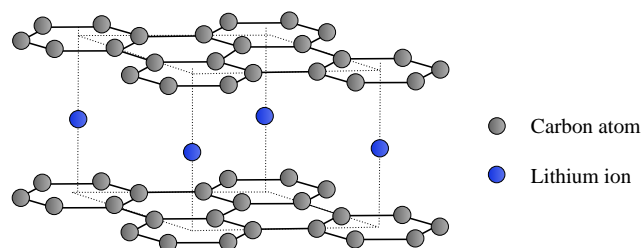
**Figure 2.** Crystalline structure of lithiated graphite. Lithium ions are depicted in blue and intercalate between the graphene planes. Carbon atoms are depicted in gray.

The structure of graphite is characterized by a stacking sequence of graphene layers, where carbon atoms are arranged in a hexagonal pattern. Lithium intercalates in the graphite structure occupying the interstitial defects between the graphene planes, as shown in Figure 2.

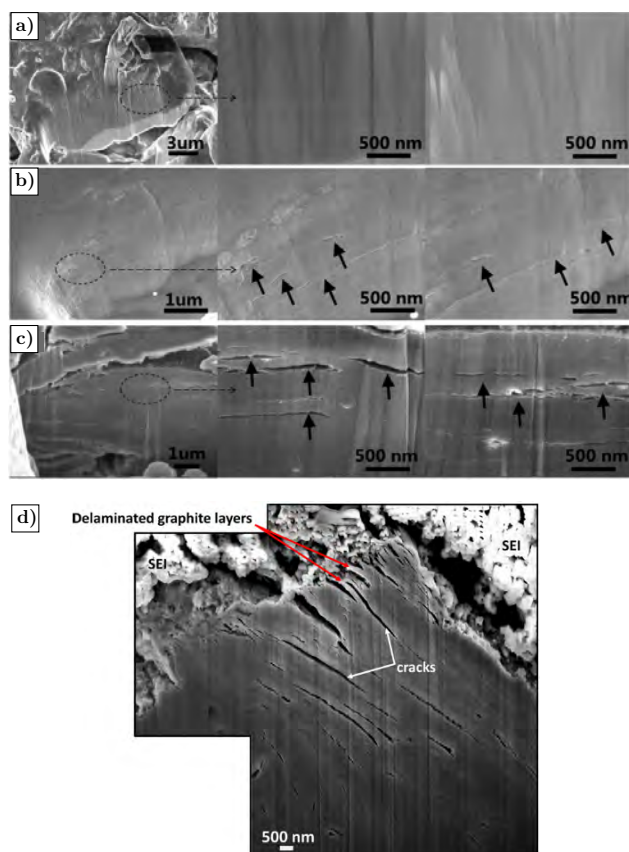
**Figure 3.** Cross-sectional SEM image of the (a) pristine graphite and graphite particles from cells cycled at 1C for (b) 200 and (c) 800 cycles. Black arrows point to the cracks. Reproduced with permission from Elsevier from [40], Copyright 2017. (d) Cross-section SEM image of graphite particle and SEI layer; parallel cracks may cause delamination. Reproduced with permission from Elsevier from [45], Copyright 2011.

Cracks in graphite particles are reported in the literature, and the research community is in agreement that the number of cycles and current rate are the main factors affecting the crack growth [40–44] (Figure 3), and that the formation of SEI over the fresh active material surfaces is the ultimate cause of capacity fade. Cracks are observed parallel to the larger external surface, leading the graphite to exfoliate [40,45], as shown in Figure 3c,d.

The EDX analysis revealed the presence of SEI inside the graphite particles, because electrolyte components react with the fresh active material, thereby increasing the SEI growth rate [43,45]. On the other hand, the formation of SEI on the cracks surfaces is supposed to reduce the stress intensity factor, hindering the crack growth. This phenomenon is known as roughness or asperity-induced crack closure, and it is caused by the physical contact of the SEI layers grown on the opposite flanks of the crack [45].

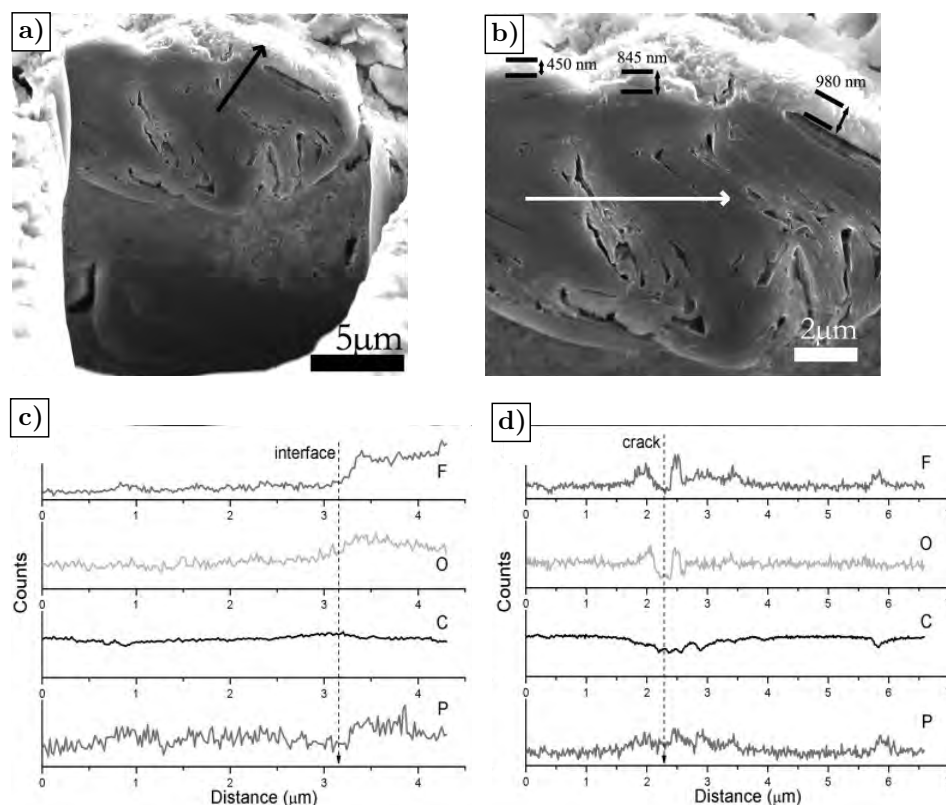
**Figure 4.** (a,b) Secondary electron FIB images of the cross-section of a graphite particle. (c,d) The elemental line scan analysis along the black and white lines in panels (a,b), respectively. Adapted with permission by American Chemical Society from [46], Copyright 2005.

Zhang et al. [46] used element scan analysis (ELSA) to identify the location and composition of the SEI layer. According to Figure 4, ELSA shows peaks in F, O and P elements when SEI is encountered, as it is composed of fluorides (LiF), Li-alkyl carbonates ( $\text{CH}_3\text{OCO}_2\text{Li}$ ,  $(\text{CH}_3\text{OCO}_2\text{Li})_2$ ) from EC/DMC decomposition and electrolytes ( $\text{LiPF}_6$ ). Then, they observed the SEI layer both on the particle surface and at the core, confirming the presence of surface and internal cracks.

The SEI layer on the external surface is between 450 nm and 950 nm, while the internal SEI is in the order of 100 nm. Furthermore, an ELSA analysis carried out in aged electrodes (25–50 cycles) showed that the composition remained unchanged, suggesting that SEI remains stable once formed. Zhang et al. [46] explained the nonlinear capacity fade of graphite according to a three-stage approach: in the first stage, where most of the capacity fade occurs, SEI forms on the particle surfaces and in the internal cracks, causing a severe reduction in lithium; in the second stage, the continuous breaking and repairing of the SEI film depleted the lithium further without increasing the SEI layer; in the last stage, structural degradation of graphite particles decreases the number of lithium sites, and this is the cause of the final capacity reduction.

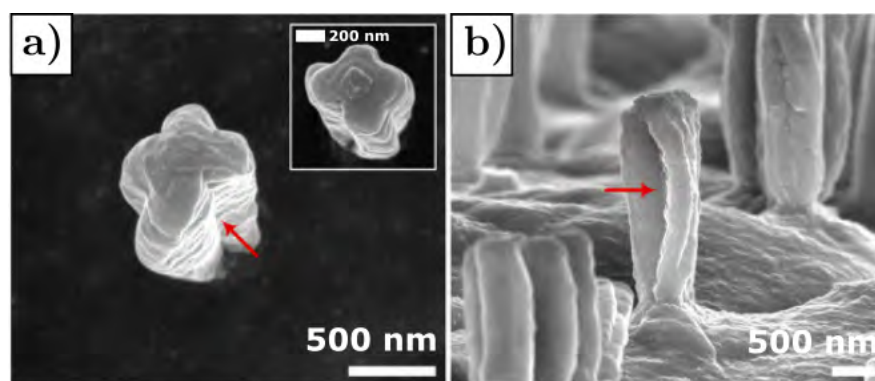
**Figure 5.** SEM images showing cracks in silicon nanowire, pointed out by the red arrow. (a) Top view and (b) Side view. Reprinted with permission from [54], Copyright 2012.

Concerning nanowires, they are characterized by a continuous 1D electronic pathway that facilitates efficient charge transport, as compared to nanoparticles [48]. Furthermore, they can grow directly from the current collector, making binder and conductive agents unnecessary but limiting the lithium flux and current rate as a consequence. Several studies observed an anisotropic expansion during the alloying process, which is greater in the [110] direction, making the cross-section elliptical [52,53]. As a result, intense tensile hoop stress arises along the shorter axis of the ellipse, causing severe crack propagation [54], as confirmed by the SEM images in Figure 5.

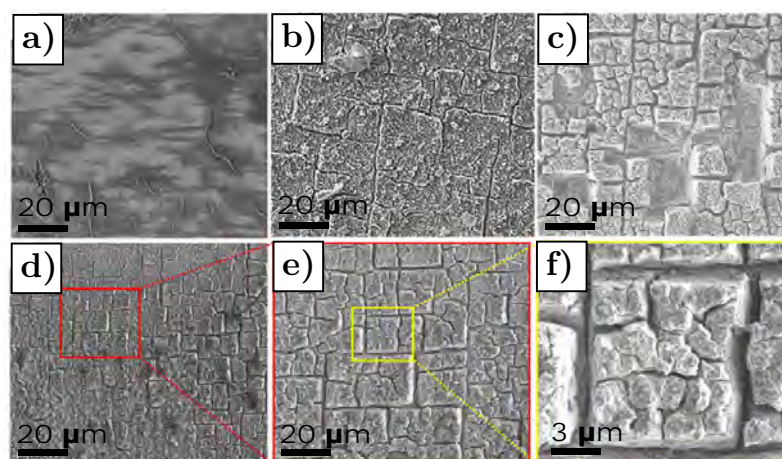
**Figure 6.** Crack growth as a function of lithiation cycles in thin film after (a) 3, (b) 8, and (c) 50 cycles. (d–f) Detail of crack pattern after 30 lithiation cycles. Reprinted with permission by Nature Publishing Group from [55], Copyright 2016.

The lithiation of thin film electrodes causes strains leading to the curvature of the film, which ultimately leads to surface cracks, resembling the ones occurring in drying media, as shown in Figure 6.

A particular crack pattern arises on the surface of the silicon thin film as a result of lithiation cycles, as observed with SEM [55,57]. Shi et al. [55] showed that the crack density is a function of the number of cycles, as shown in Figure 6. In addition, Li et al. [57] reported that crack density depends on the thickness of the film as well, and a critical size below which cracks do not propagate exists.

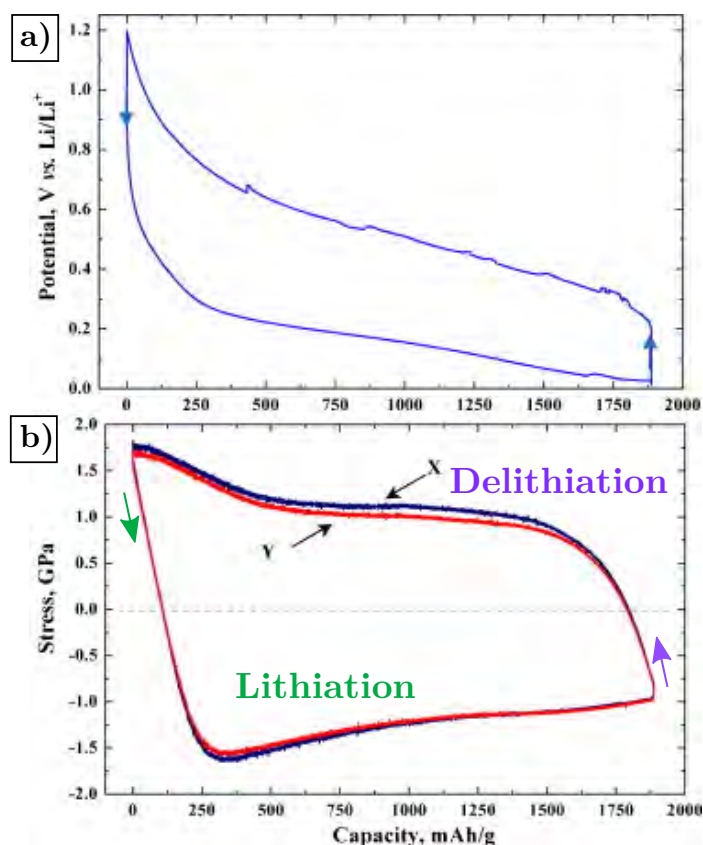
**Figure 7.** (a) Cell potential vs. capacity curve corresponding to lithiation and delithiation Si thin–film electrode cycled at C/4 rate, and (b) the corresponding average stress computed from the measured curvature of the substrate. Adapted with permission by Elsevier from [56], Copyright 2010.

Sethuraman et al. [56] computed the average stress of silicon thin film from the substrate curvature with a Multi-beam Optical Sensor (MOS) during lithiation and delithiation. The results of their in-situ experiments are reported in Figure 7.

It was shown that the average stress becomes elastically compressive during lithiation until 12% of the total capacity, reaching  $-1.75$  GPa. Then, plastic flow occurs until the end of lithiation. Stress is reversed during delithiation and becomes elastically tensile until 75% capacity, reaching 1 GPa, followed by plastic flow. Therefore, delithiation is the critical phase from the fracture point of view, as the electrode is subjected to severe tensile stress.

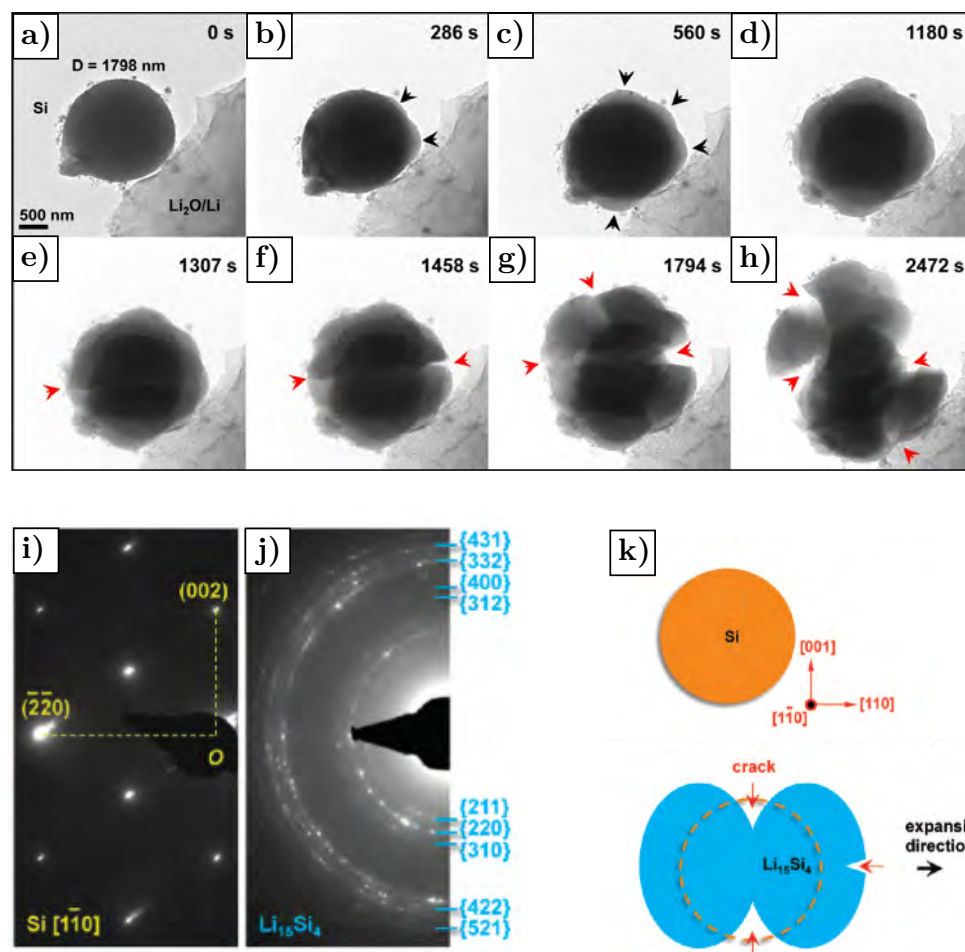
**Figure 8.** (a–h) Crack growth during single lithiation cycle in silicon nano-particle. The black arrows mark the bumps due to anisotropic lithiation of Si before crack formation, whereas the red arrows mark the cracks. (i,j) Electron diffraction pattern showing the silicon phase transformation from (i) crystalline structure (Si) to (j) polycrystalline structure ( $\text{Li}_{15}\text{Si}_4$ ). (k) Anisotropic swelling in silicon nanoparticle favoring cracks in [110] direction. Reprinted with permission by American Chemical Society from [51], Copyright 2012.

Concerning silicon nano-particles, crack growth within the same particle was observed during a single lithiation, as reported in Figure 8a–h [51]. At the end of lithiation, the particle is heavily damaged, and cracks propagating along the [110] direction affect the structural stability considerably. Furthermore, the electron diffraction pattern (EDP) analysis reported in Figure 8i,j shows the phase transformation from crystalline (Si) (Figure 8i), to polycrystalline ( $\text{Li}_{15}\text{Si}_4$ ) (Figure 8j) due to the lithiation process. Figure 8k explains the anisotropic swelling characteristic of silicon nano-particles, leading to cracks predominantly along the [110] direction [51,58].

Furthermore, it was reported that size has a significant impact on the fracture of silicon nanoparticles, and fractures do not occur below a critical size. For example, Liu et al. [51] showed that the critical size is 150 nm in their case study.

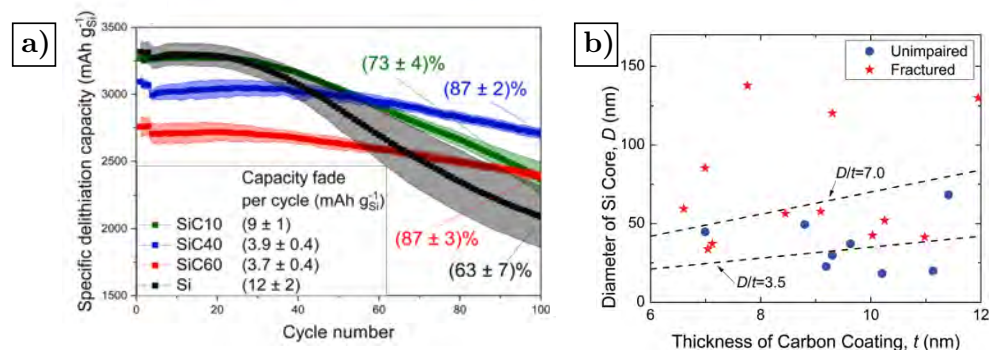
**Figure 9.** Effect of carbon coating on capacity fade. (a) Specific delithiation capacity as a function of the number of cycles for silicon thin film with carbon coating of different thickness, namely 10 nm, 40 nm, and 80 nm, for SiC10, SiC40 and SiC80, respectively. Reprinted with permission by Elsevier from [64], Copyright 2021. (b) Occurrence of fracture as a function of the ratio between particle diameter ( $D$ ) and coating thickness ( $t$ ). Reprinted with permission by Royal Society of Chemistry from [65], Copyright 2016.

In particular, Casino et al. [64] demonstrated that carbon coating mitigates the capacity fade. They observed that an increased coating thickness reduces the capacity drop, but a thickness greater than 60 nm does not have greater beneficial effects. On the other hand, the greater the coating thickness, the lower the nominal capacity. Consequently, a trade-off should be found to obtain the best performance; Casino et al. showed that a coating thickness of 60 nm guarantees good nominal capacity and capacity fade mitigation, as depicted in Figure 9a.

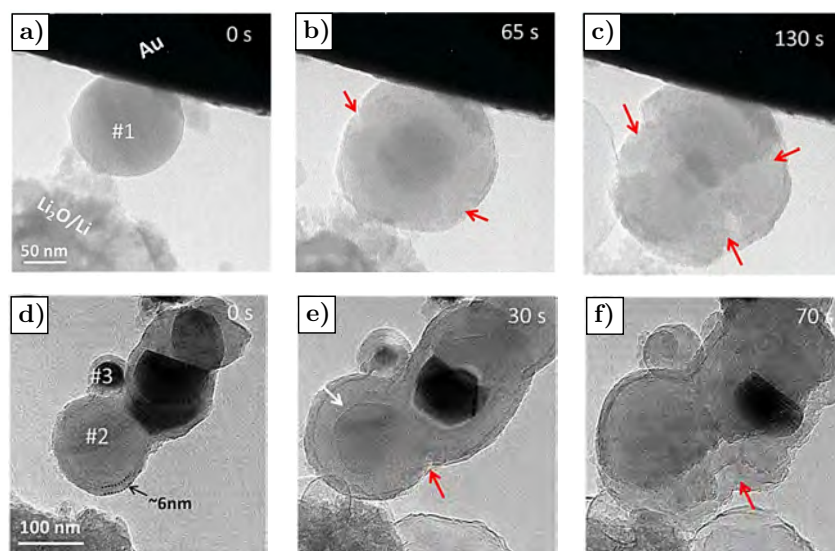
**Figure 10.** Lithiation of (a–c) uncoated silicon particle and (d–f) coated silicon particles. The time value depicted in the figure refers to the lithiation time. Reprinted with permission by Elsevier from [68], Copyright 2016.

Fractures were observed with TEM in carbon-coated silicon particles in some works [65,67,68]. Xu et al. [68] compared the lithiation of two sets of geometrically similar particles (130–150 nm), one with a 6 nm carbon coating and the other without coating. Few fractures were observed in the coated particles, depicted by the red arrows in Figure 10e,f. On the other hand, a greater number of fractures were observed in the uncoated particles, as confirmed by the red arrows in Figure 10a–c. During the lithiation of the coated particles, the coating thickness increases from 6 nm to 8 nm, because of the strong radial stress due to the silicon core expansion. Then, fractures are triggered in the coating thickness and they further propagate in the silicon core. These factors may explain the reason why fracture occurs in coated particles that are smaller than the critical fracture size, i.e., 150 nm as explained by Liu et al. [51].

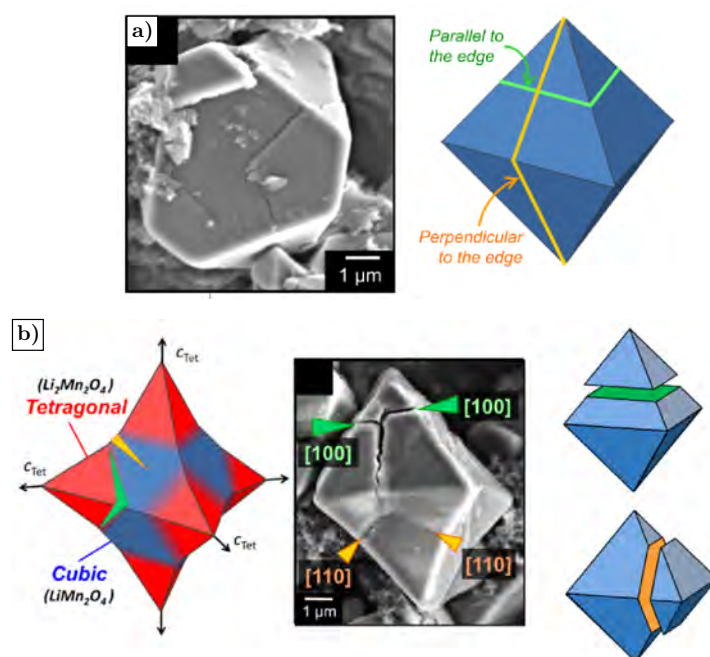
**Figure 11.** (a) Cubic and (b) tetragonal structure of LMO with the corresponding preferential cracks directions. Reprinted with permission by American Chemical Society from [83], Copyright 2021.

Severe cracking is observed when the LMO undergoes Jahn–Teller transformation, and intragranular cracks are observed at the cubic/tetragonal ([100] direction) and tetragonal/tetragonal ([110] direction) grain boundaries, indicated in green and orange in Figure 11b, respectively. Thus, cracks appear oriented along the [100] and [110] directions [83].

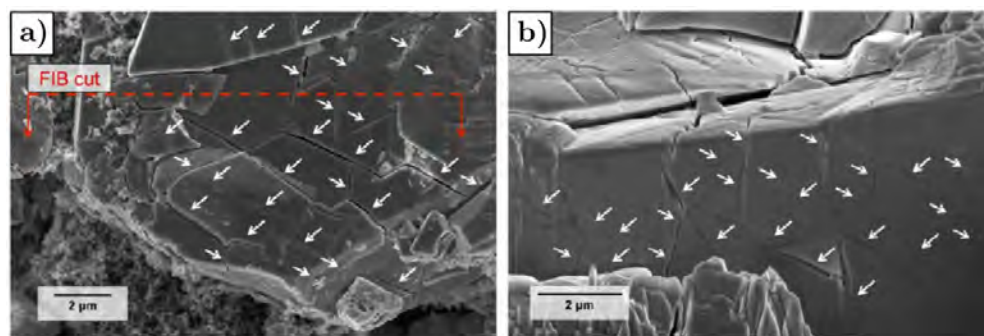
**Figure 12.** (a) Fracture in LMO particle after 16 deep discharge cycles with Jahn–Teller transformation and 51 cycles without Jahn–Teller transformation. (b) Internal view of LMO particle shown in (a) after FIB milling. White arrows point to the cracks. Reprinted with permission by Journal of The Electrochemical Society from [84], Copyright 2018.

McGrogan et al. [84] cycled the LMO electrode above Jahn–Teller transformation and milled the cycled electrode with FIB to study the internal cracking network, as shown in Figure 12a,b. The dense crack network, probably caused by Jahn–Teller transformation, allows the electrolyte to penetrate inside the particle, causing the dissolution of  $Mn^{2+}$ , as will be explained in Section 4.

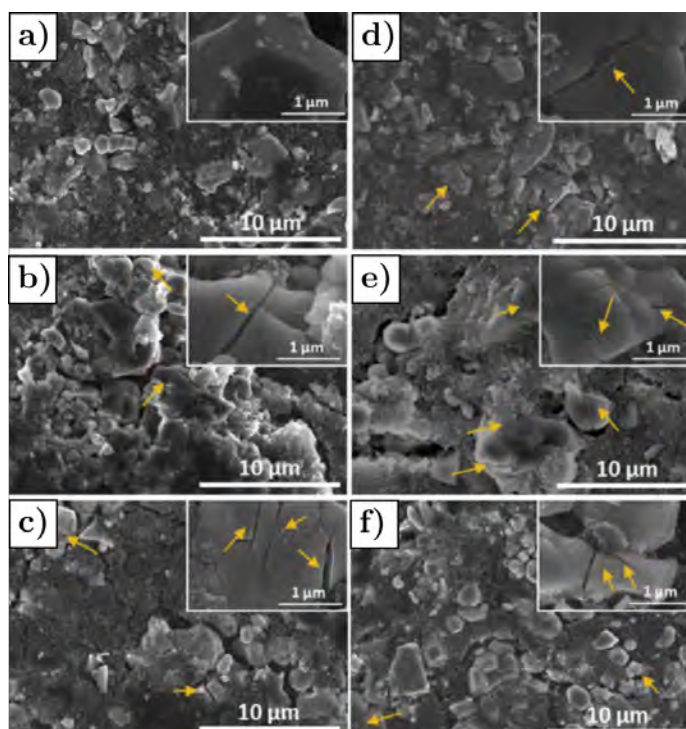
**Figure 13.** SEM images of the electrode structure (a) before cycling and after (b) 40 cycles, (c) 125 cycles, (d) 500 cycles, (e) cycled at low voltage to trigger Jahn-Teller transformation and (f) cycled at high temperature. Reprinted with permission by Elsevier from [88], Copyright 2017.

Some works tried to correlate the capacity fade in LMO with the occurrence of fracture due to cycling. Liu et al. [88] compared the increase in free surfaces created by cracks with capacity loss, observing an interesting correlation. They analyzed different samples subjected to an increasing number of cycles with TXM and SEM (Figure 13), and measured the increase in free surfaces created by cracks with an image processing tool.

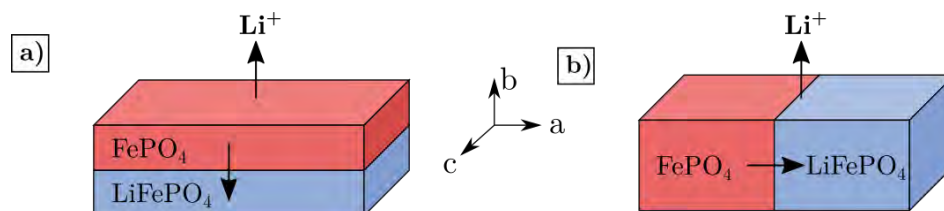
**Figure 15.** Scheme of the phase boundary movement for LFP. (a) Phase boundary moving along the  $b$ -axis; (b) Phase boundary moving along the  $a$ -axis.

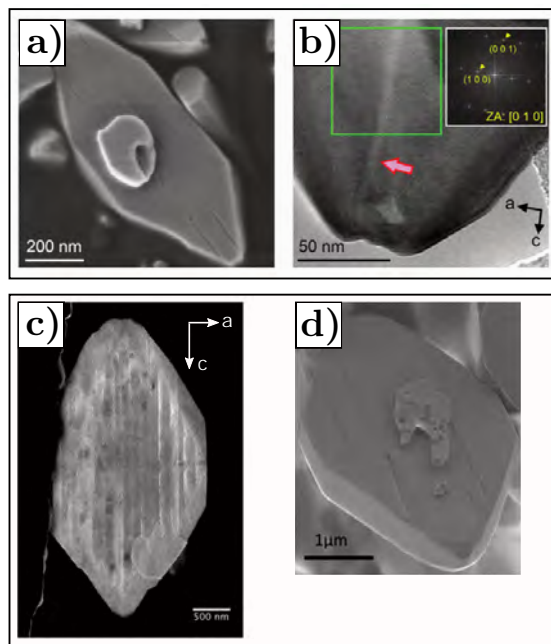
**Figure 16.** Top: Electron microscopy results for a micrometric plate-like LFP crystal subjected to partial chemical delithiation. (a) SEM image and (b) High-resolution transmission electron (HRTEM) image with the inset of the Fourier transform pattern obtained from the region marked with the green box. The red arrows indicate the crack running parallel to the  $c$ -axis. Reprinted with permission by American Chemical Society from [97], Copyright 2015. Bottom: SEM observations of partially delithiated  $\text{Li}_{0.5}\text{PO}_4$  crystal. (c) SEM image and (d) STEM-HAADF image, showing cracks evenly spaced and oriented along the  $c$ -axis. Reprinted with permission by American Chemical Society from [96], Copyright 2013.

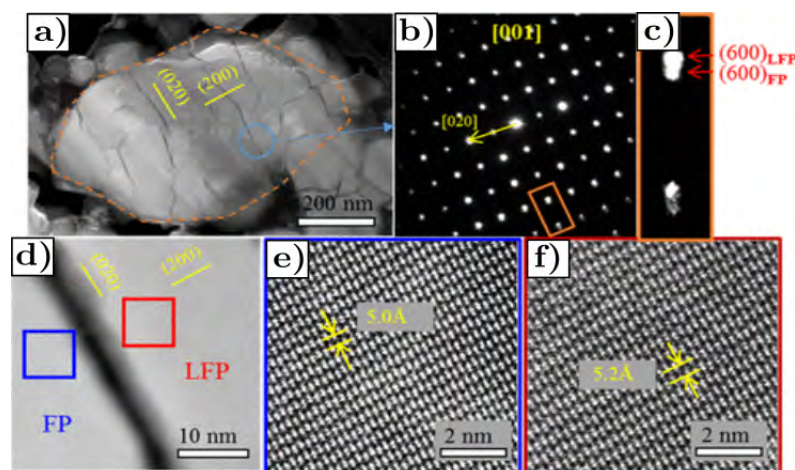
**Figure 17.**  $\text{LiFePO}_4$  and  $\text{PO}_4$  phases separated by  $ac$  plane cracks in a LFP crystal electrochemically cycled, with (a) STEM-HAADF image of the crystal at 100% SOC, (b,c) SAED patterns and (d–f) STEM-HAADF images. Reprinted with permission by American Chemical Society from [99], Copyright 2020.

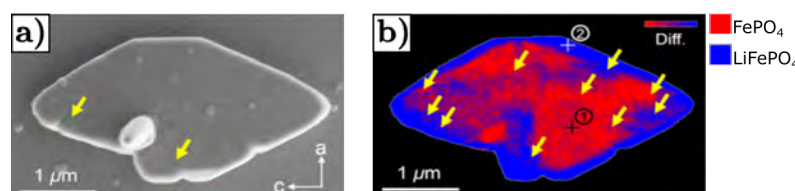
**Figure 18.** Relation between defects and phase distribution within micrometric LFP chemically delithiated plate-like crystal, with (a) SEM image and (b) Chemical phase distribution map. Reprinted with permission by American Chemical Society from [97], Copyright 2015.

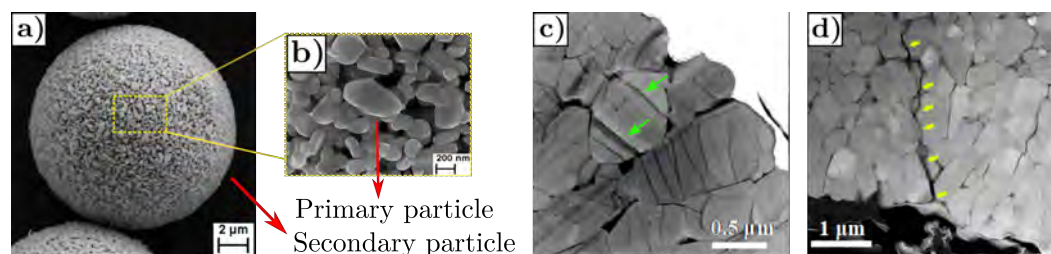
**Figure 19.** (a,b) SEM images of NMC secondary and primary particles. Reproduced with permission from [105], ©2020 American Chemical Society. (c,d) TEM images of the cross-section of discharged NMC cathode after 100 cycles: intragranular cracks within primary particles are marked with green arrows, whereas intergranular cracks developing along grain boundaries are marked with yellow arrows. Reprinted with permission by American Chemical Society from [106], Copyright 2018.

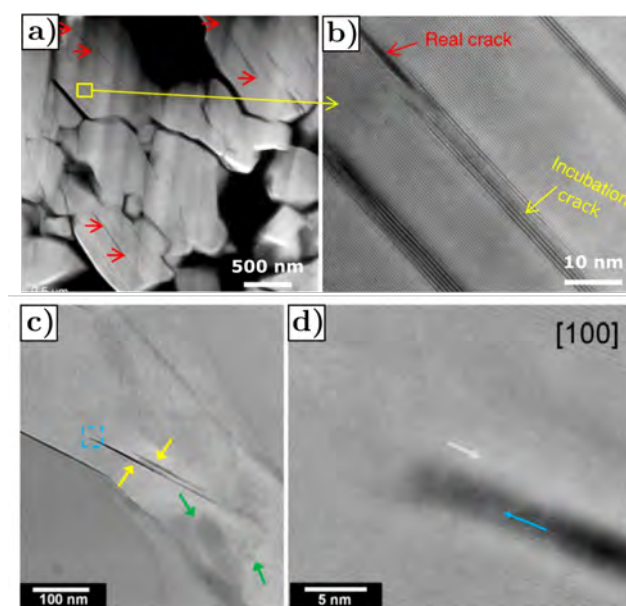
**Figure 20.** (a,b) SEM image of electrochemically cycled  $\text{LiNi}_{0.6}\text{Mn}_{0.2}\text{Co}_{0.2}\text{O}_2$  (NMC622) particles, showing cracks parallel to the (003) planes. Cracks are marked with red arrows. Reprinted with permission of [109] ©2018 Springer Nature. (c) Intragranular cracks in  $\text{Li}_{1+x}(\text{Ni}_{0.85}\text{Co}_{0.1}\text{Mn}_{0.05})_{1-x}\text{O}_2$  (NCM851005) after 200 cycles, with (d) High-resolution image of the marked area in (c) showing the rock-salt phase along the crack surface. The direction parallel to (003) planes, cracks and the rock-salt phase are marked with grey, yellow and blue arrows, respectively. Reprinted with permission from American Chemical Society by [110], Copyright 2019.

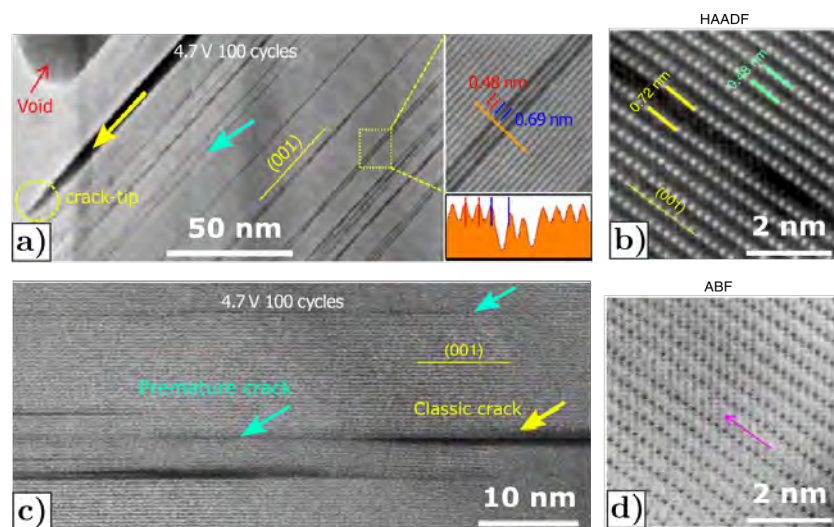
**Figure 21.** (a,c) HAADF images from cycled NMC333 cathode particle showing intragranular cracks along the (001) plane. The yellow and light blue arrows indicate classic and premature cracks, respectively. (b) HAADF and (d) ABF images along [010] axis of the premature crack showed in (a). Reprinted with permission from Springer Nature by [108], Copyright 2017.

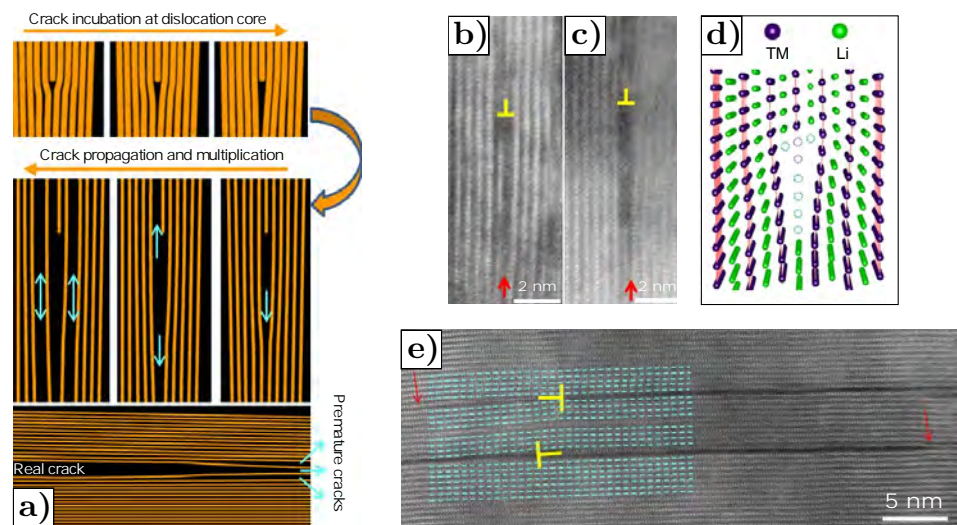
**Figure 22.** (a) Schematic diagrams of the dislocation-assisted crack incubation, propagation and multiplication process in NMC cathode particles. (b,c) Nucleation of premature cracks at the dislocation core in NMC333 cycled particles, also schematized in (d). (e) Edge dislocations associated with intragranular cracks in cycled NMC333 particles. Crack tip is indicated with the red arrows. Reprinted with permission from Springer Nature by [108], Copyright 2017.

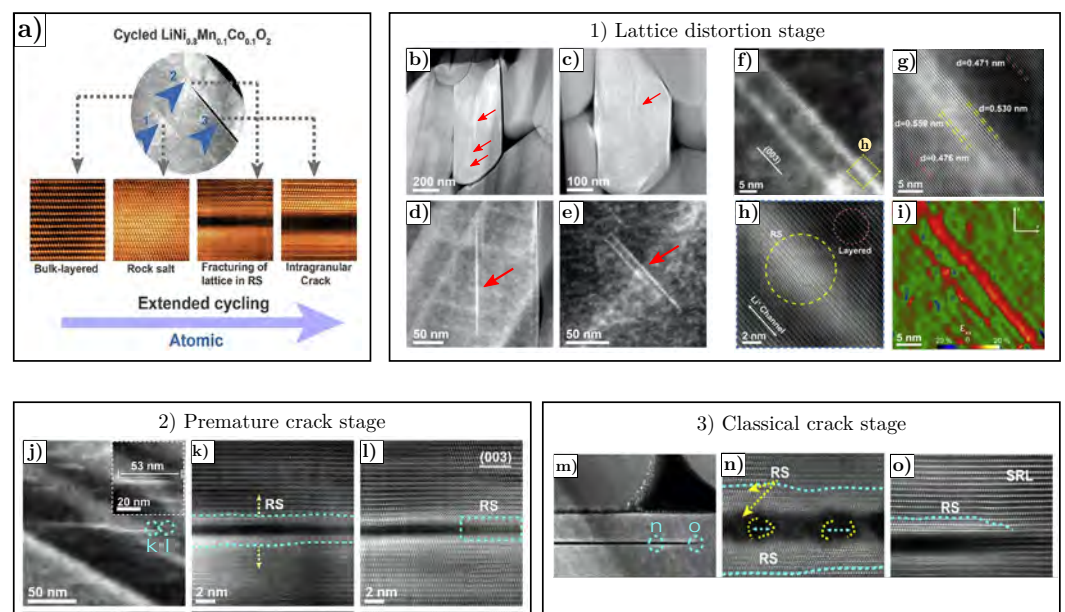
**Figure 23.** (a) Development process of intragranular cracks in NMC811: (b–i) Lattice distortion stage, (j–l) Premature crack stage and (m–o) Classical crack stage. STEM-HAADF images of cycled NMC811 particle in  $\langle 010 \rangle$  zone projection, after (b–d) 50 cycles and (c–e) 20 cycles. The white lines appear with different length. (f) STEM-HAADF image of enlarged morphology of a white line shown in (a). (g) High-resolution STEM-HAADF image, showing the lattice distortion of the white line region. (h) Atomic-resolution STEM-HAADF image from the region marked by yellow dashed square box in (f), showing the detailed structure of the white line, with the formation of the rock-salt phase. (i) Strain map simulated by GPA due to lattice distortion. (j–l) Atomic-resolution STEM-HAADF images of premature intragranular crack in NMC811 particle after 50 cycles, showing the presence of the rock-salt phase both in the (k) partially cracked region and (l) uncracked tip. (m–o) Atomic-resolution STEM-HAADF images of mature intragranular crack in NMC811 particle after 100 cycles, showing the increase in the crack length along the (003) plane and in the rock-salt phase thickness. Reprinted with permission from Elsevier by [111], Copyright 2020.

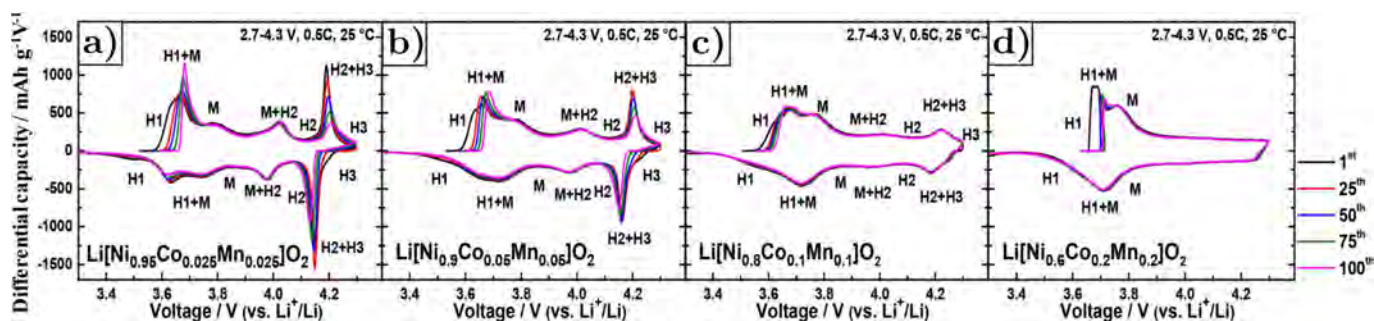
**Figure 24.** Differential capacity curves of  $\text{Li}[\text{Ni}_x\text{Co}_y\text{Mn}_{1-x-y}]\text{O}_2$  with different Ni content: (a)  $x = 0.95$ , (b)  $x = 0.9$ , (c)  $x = 0.8$ , and (d)  $x = 0.6$  as a function of the number of cycles. Reprinted with permission of [106], ©2018 American Chemical Society.

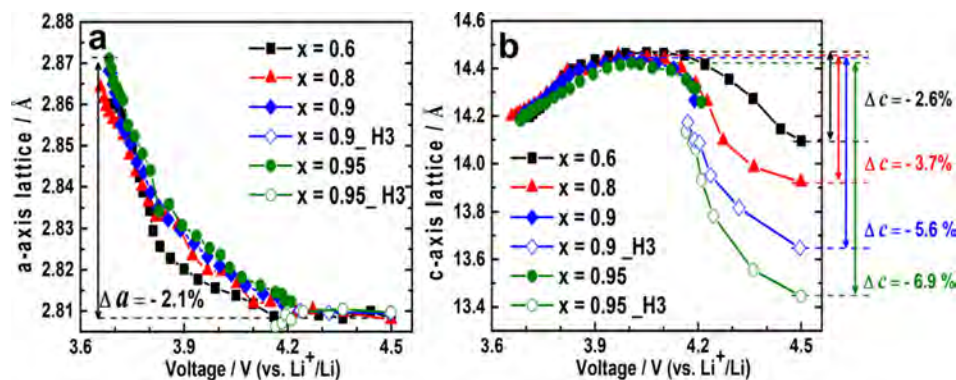
**Figure 25.** (a)  $a$ -axis and (b)  $c$ -axis lattice parameters of  $\text{Li}[\text{Ni}_x\text{Co}_y\text{Mn}_{1-x-y}]\text{O}_2$  as a function of the Ni content ( $x = 0.95$ ,  $x = 0.9$ ,  $x = 0.8$  and  $x = 0.6$ ) and the cell voltage. Reprinted with permission of [106], ©2018 American Chemical Society.

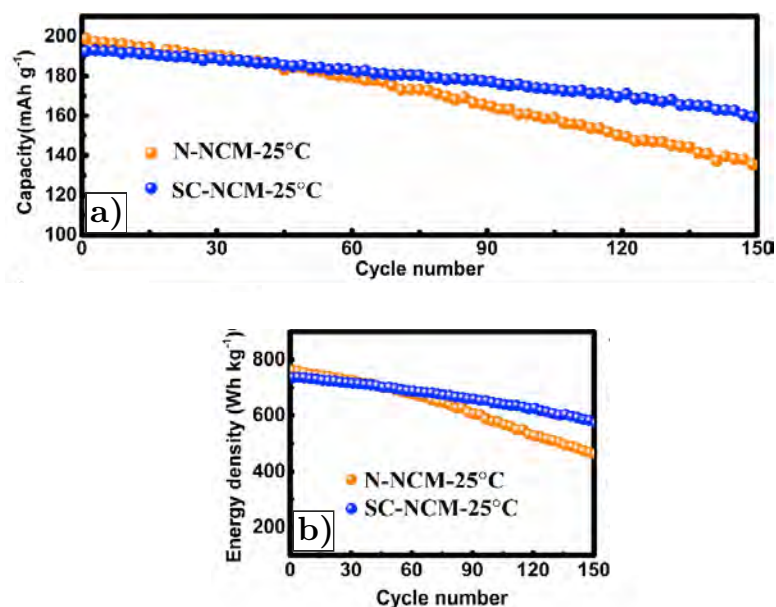
**Figure 26.** (a) Comparison of capacity and (b) Energy density decay between single-crystalline (SC-NMC) and commercial polycrystalline (N-NMC) NMC831106 cycled at 1C in the voltage range of 2.75–4.4 V over 150 cycles. Reprinted with permission of [123], ©2020 Elsevier.

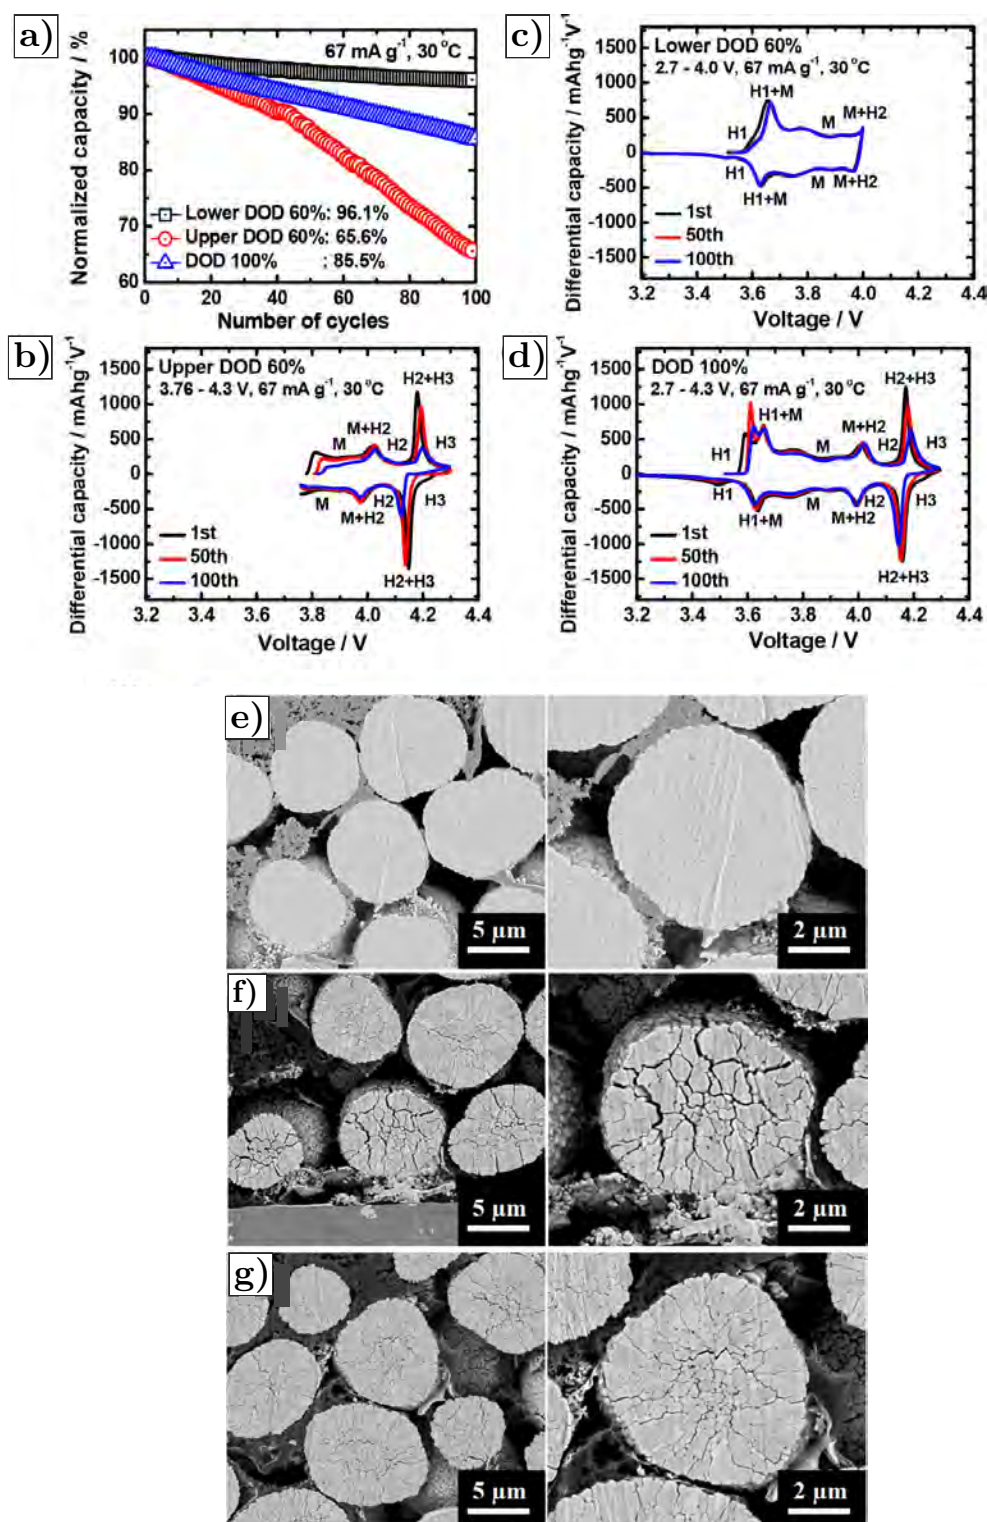
**Figure 27.** (a) Capacity decay of NCA95 during cycling at different DOD and initial SOC values. Derivative of charge-discharge curves of NCA95 cycled (b) from SOC 40 to 100% (3.76–4.3 V) (c) from SOC 0 to 60%, (d) from SOC 0 to 100%. Cross-sectional SEM images of NCA95 particles cycled for 100 cycles (e) from SOC 0 to 60%, (f) from SOC 40 to 100% and (g) from SOC 0 to 100%. Reprinted with permission by American Chemical Society from [132], Copyright 2019.

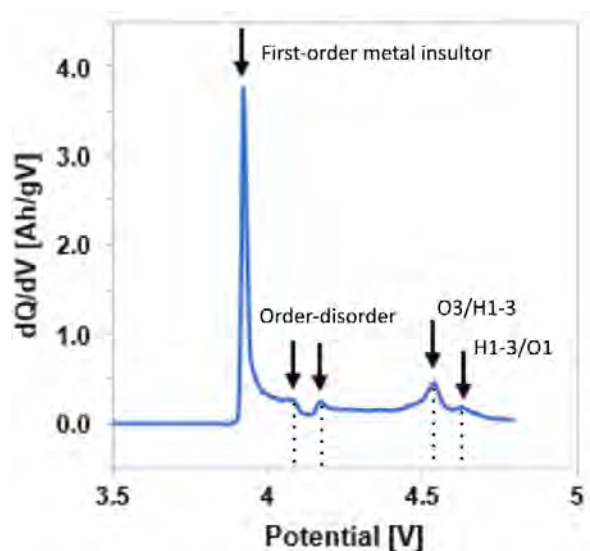
**Figure 28.** Differential capacity curve of a fresh LCO half-cell charged to 4.8 V at 0.05C. Most relevant phase transitions are highlighted by the black arrows. Adapted with permission by Elsevier from [137], Copyright 2022.

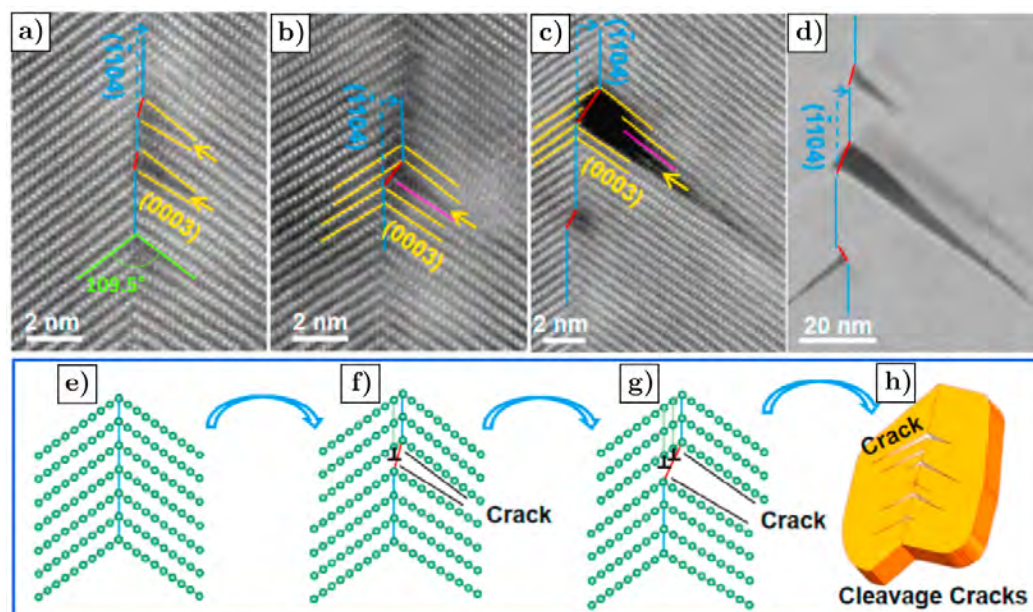
**Figure 29.** Cleavage crack's nucleation and propagation. (a) STEM-HAADF image showing the nucleation of cleavage cracks at the kinks occurring after 50 cycles. The (0003) plane is highly strained as indicated by the yellow arrows. (b,c) Further deformation-induced crack growth at the twin boundary. Pink lines indicate the extra (0003) planes generated to release the local strain. (d) V-shaped cleavage cracks induced by deformation. (e–h) Schematic diagrams to illustrate the cleavage crack nucleation and growth process. Reprinted with permission by Elsevier from [136], Copyright 2020.

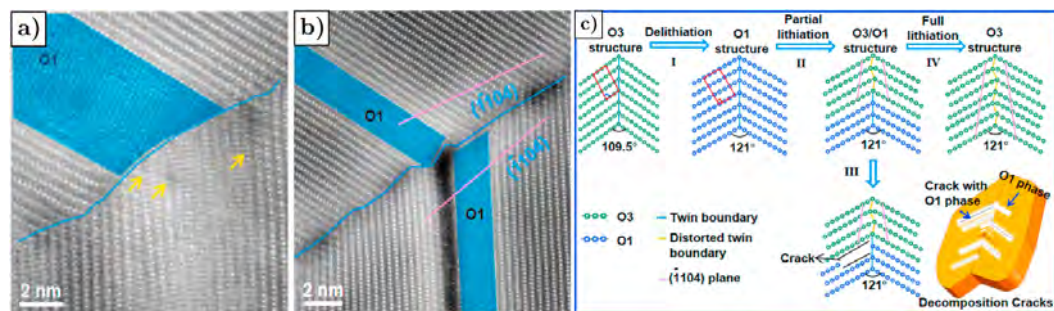
**Figure 30.** Phase transition induced cracking at the twin boundary. (a) A STEM-HAADF image showing the O1 phase (light blue region) formed at the highly distorted twin boundary, indicated by the light blue line. Incubation cracks at the twin boundary are marked by yellow arrows. (b) Decomposition crack formed along an O1 phase strip. (c) Schematic diagrams illustrating the cracking mechanism induced by phase transition at the twin boundary. Reprinted with permission by Elsevier from [136], Copyright 2020.

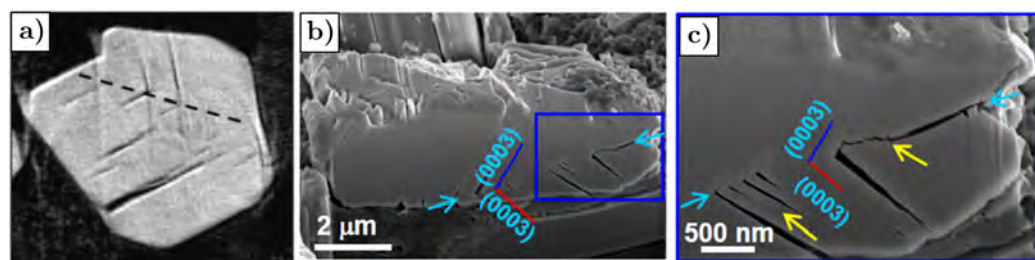
**Figure 31.** Cracking along the twin boundary. (a) Reconstructed image from X-ray nano-tomography reprinted from [137]. (b,c) SEM images of a cross-section of LCO particles (milled with FIB), showing cracks originating from twin boundary and their planes direction. Reprinted with permission by Elsevier from [136], Copyright 2020.

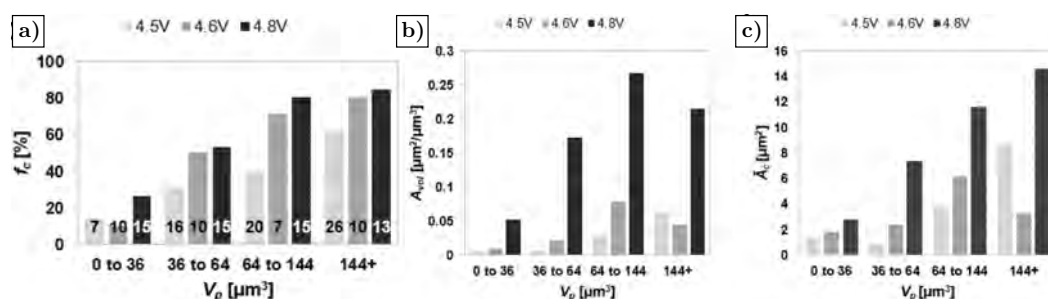
**Figure 32.** (a) The percentage of LCO particles within a given volume range that contains cracks after a single charge cycle to a given cutoff voltage. (b) The crack area per unit of volume for particles within a given volume range after a single charge cycle to a given cutoff voltage. (c) The average individual crack area (proportional to crack length) for particles within a given volume range after a single charge cycle to a given cutoff voltage. Reprinted with permission by Elsevier from [137], Copyright 2022.

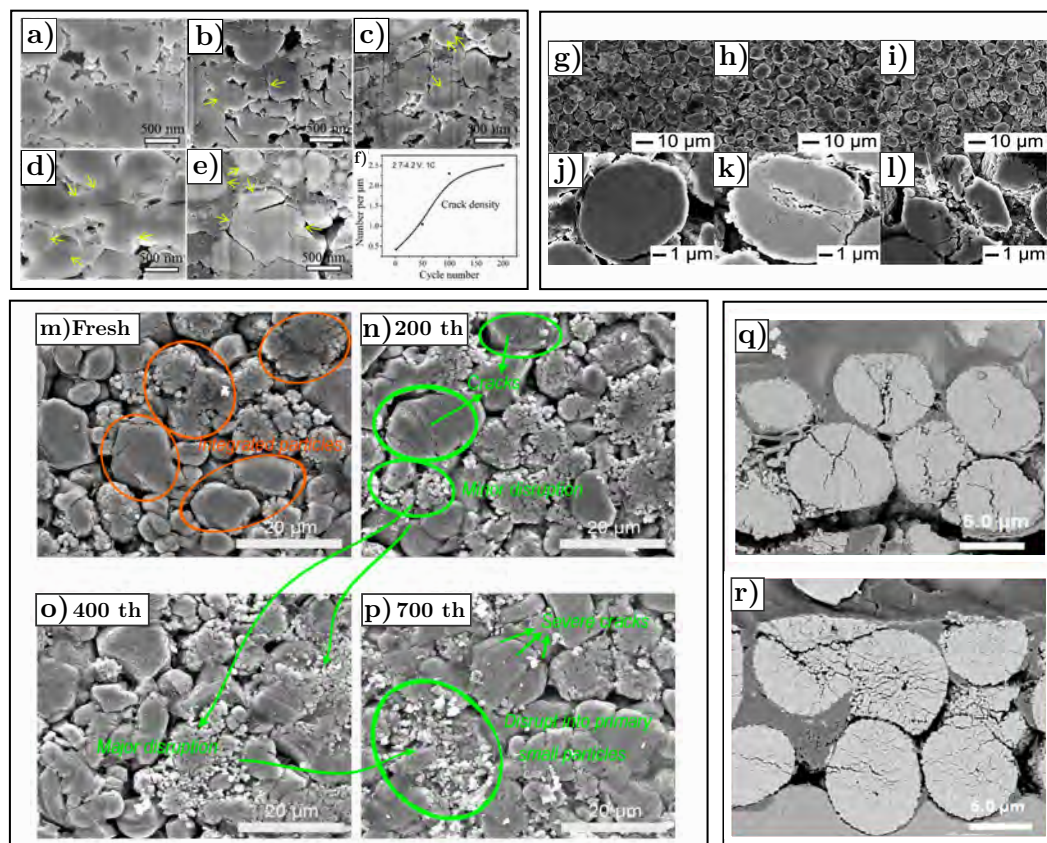
**Figure 33.** (a–f) Cross sectional SEM images of cracks evolution in  $\text{LiFePO}_4$  cathode cycled at 1C. Samples (a) before cycling, (b) after 1 cycle, (c) after 50 cycles, (d) after 100 cycles, (e) after 200 cycles, and (f) crack density as a function of the cycle numbers. Reprinted with permission by American Chemical Society from [99], Copyright 2018. Top view and cross-sectional SEM images of the NCM851005 cathode (g,j) before cycling, (h,k) after 100 cycles and (i,l) after 500 cycles at 1C. Reprinted with permission by American Chemical Society from [154], Copyright 2019. (m–p) FESEM images of hervester LCO/NMC532 cathode electrodes at various cycle numbers. Reprinted with permission by MDPI from [153], Copyright 2017. (q,r) Cross-sectional SEM images of  $\text{Li}[\text{Ni}_{0.90}\text{Co}_{0.05}\text{Mn}_{0.05}]\text{O}_2$  at first cycle and after 1000 cycles, respectively. Reprinted with permission by American Chemical Society from [152], Copyright 2019.

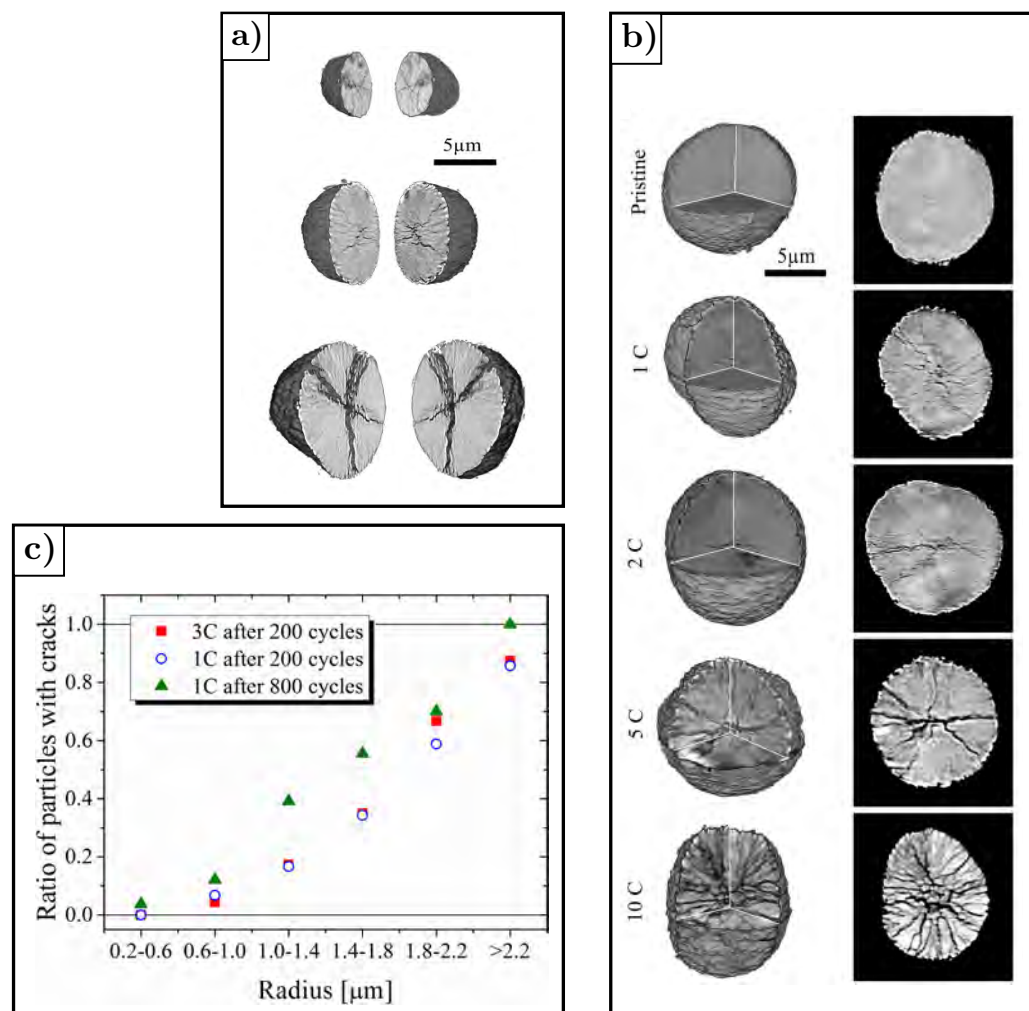
**Figure 34.** (a) Fracture in NMC particles of different size, after 50 cycles at 10C. (b) Fracture in NMC particles after 50 cycles at 1C, 2C, 3C, 5C and 10C. Reprinted with permission by Elsevier from [116], Copyright 2018. (c) Fracture occurrence in LiMn<sub>1.95</sub>Al<sub>0.05</sub>O<sub>4</sub> as a function of current rates and particles radius. Reprinted with permission by Elsevier from [155], Copyright 2017.

Cracks are found more frequently in larger particles than in smaller ones (Figure 34a,c).
