# Review on the Experimental Characterization of Fracture in Active Material for Lithium-Ion Batteries

**Keywords:** fracture mechanics; battery damage; experimental mechanics; damage mechanisms; lithium-ion batteries

**Citation:** Pistorio, F.; Clerici, D.; Mocera, F.; Somà, A. Review on the Experimental Characterization of Fracture in Active Material for Lithium-Ion Batteries. *Energies* **2022**, *15*, 9168. <https://doi.org/10.3390/en15239168>

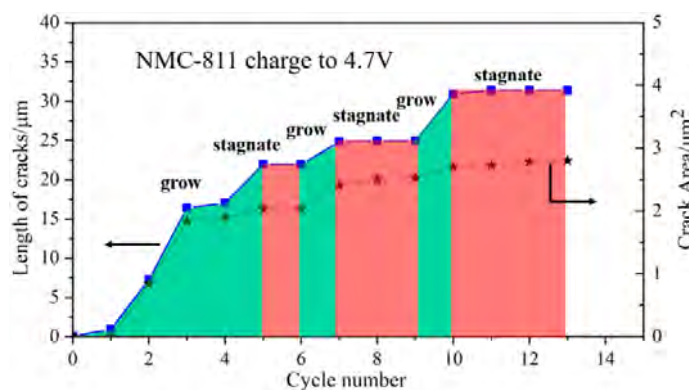
**Figure 35.** Measures of crack length and area as a function of number of cycles with in-situ SEM. The material is NMC811 cycled with a lithium counter electrode at 0.5C and 2.7 V–4.7 V. Reprinted with permission by Elsevier from [157], Copyright 2021.
