Article

Damped AC Testing and Diagnosis of Wind Farm HVAC Long-Length Cable Circuits

Citation: Gulski, E.; Anders, G.J.; Jongen, R.; Parciak, J. Damped AC Testing and Diagnosis of Wind Farm HVAC Long-Length Cable Circuits. *Energies* **2022**, *15*, 8426. <https://doi.org/10.3390/en15228426>

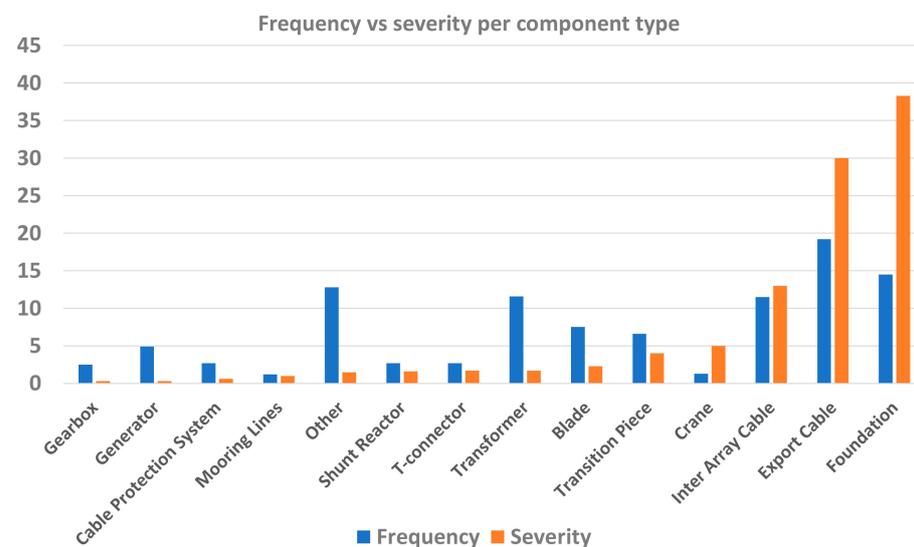
Figure 1. In offshore wind farms, the total claims account for over 50% of subsea cable issues [10].

Considering offshore wind farms, where long cable circuits are frequently used, the severity and the frequency of the failures of export and inter-array cables, compared to other components, are highest [10,11]. See Figure 1.

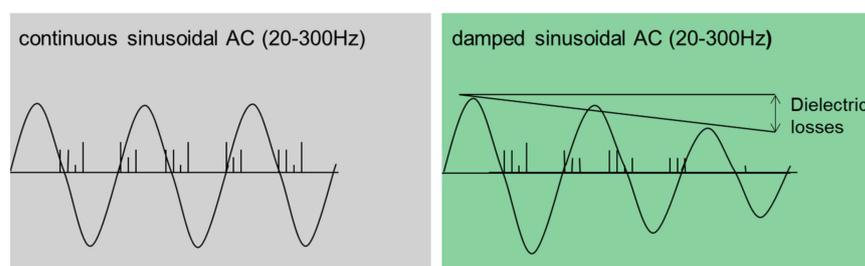
Figure 2. Visualization of onsite energizing and diagnosis at continuous AC (ACRT) and at damped AC (DAC) voltages.

Figure 2 shows the principal differences between the above-mentioned test methods.

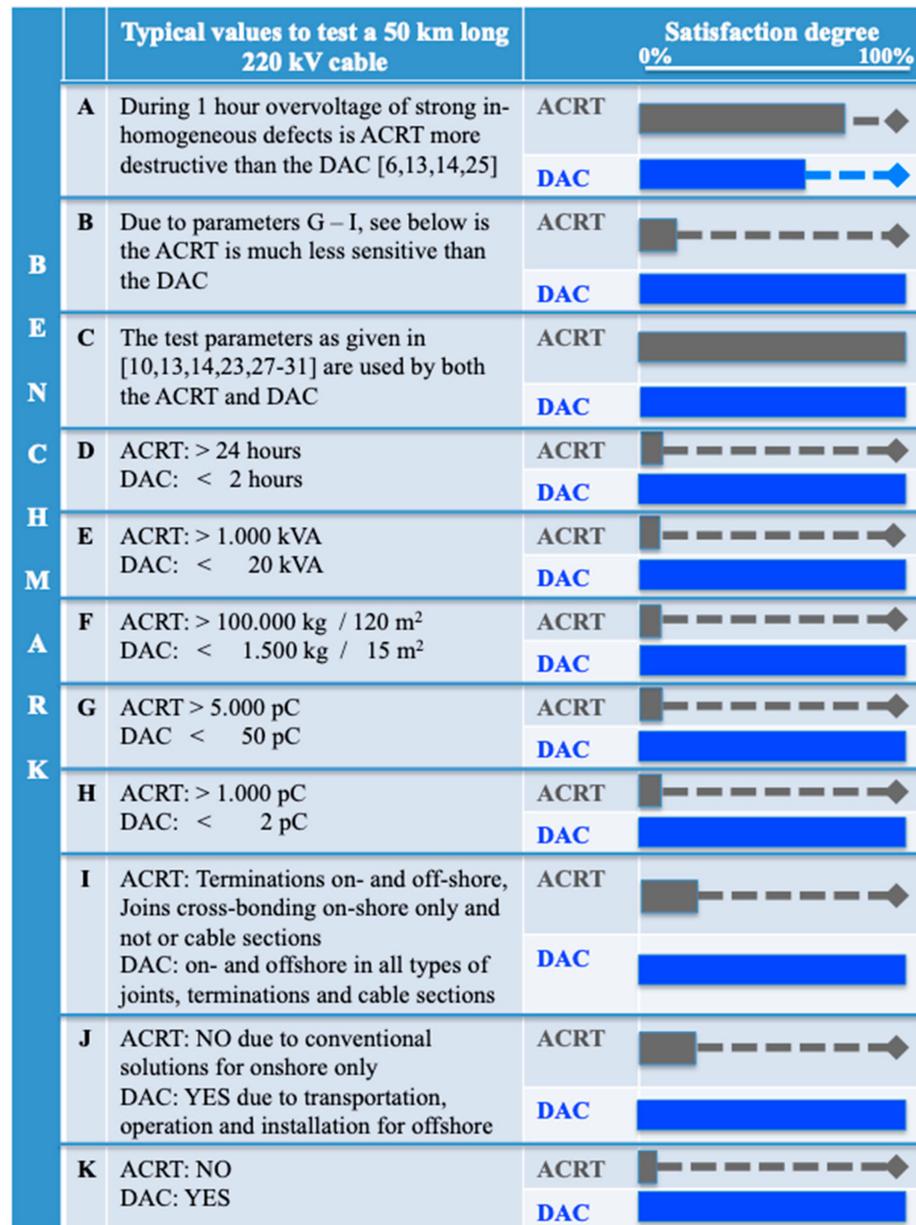
Figure 3. Example of a comparison of ACRT and DAC testing techniques based on different technical and practical parameters for testing a 50 km long 220 kV cable system.

To quantify the selected technical parameters, typical values from practical applications used for testing a typical 50 km long 220 kV cable were chosen. The comparison shown in Figure 3 confirms that the DAC technology outperforms the ACRT method in the efficient testing and condition assessment of long-length power cable connections.

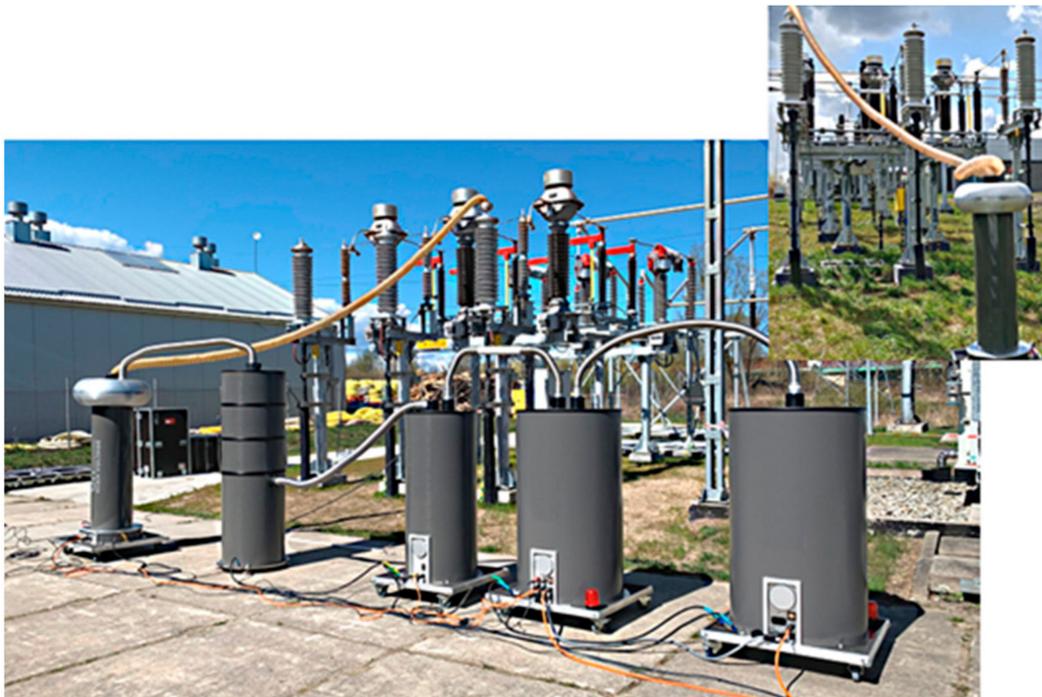
Figure 4. Test setup with the DAC system connected to the 110 kV cable phase under test at the near end and an additional PD detector at the remote end of the same cable phase.

The test setup can be seen in Figure 4, with the DAC test system installed at the near end and the additional PD detector installed at the remote end of the cable phase.

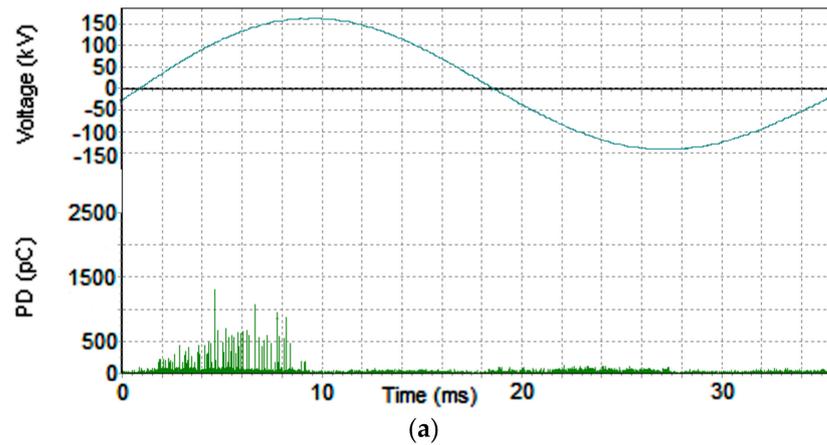
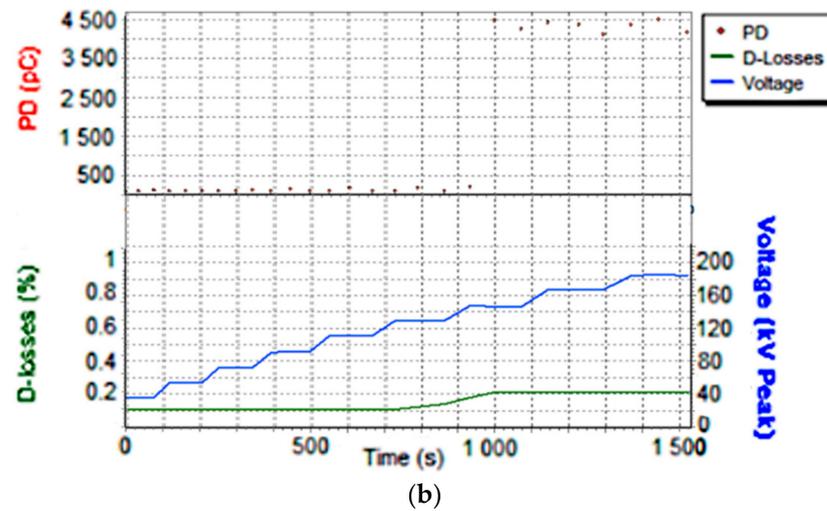
Figure 5. Test result overview of the PD-monitored ramp-up test (a) Obtained phase-resolved PD pattern at $1.8 U_0$, (b) Overview of the ramp-up test from $0.4 U_0$ to $2.0 U_0$ prior to the voltage withstand test, duration 25 min.

PD activity was detected during the ramp-up test in cable phase L2; see Figure 5a,b. Starting at a voltage level of $1.7 \times U_0$, a clear PD pattern could be seen; see Figure 5a. After the ramp-up test, the voltage withstand test of 50 DAC excitations was performed, with a duration of 65 min. The analysis resulted in a PD location at cable joint No. 11, located 7520 m from the near end.

As the PD level was in the range of 100–12,000 pC, it also produced an increase in the dissipation factor $\tan \delta$; see Figure 5b. The conclusion was reached that PD could be detected and localized by means of a double-sided measurement.

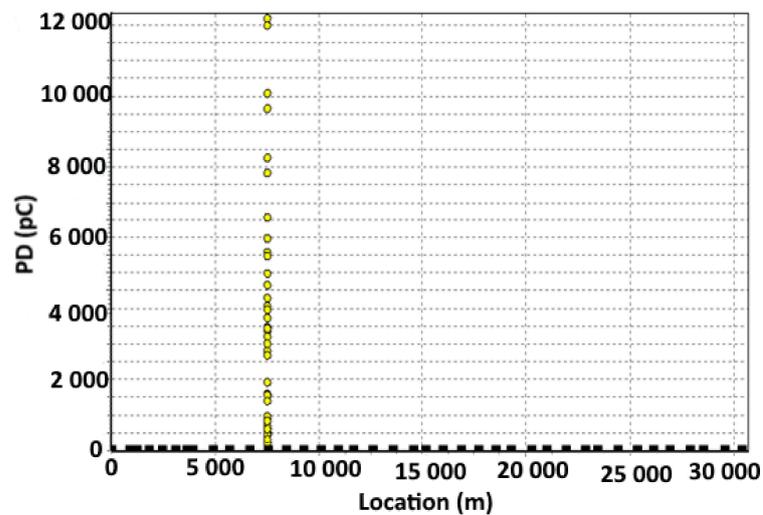
Figure 6. PD mapping showing the overall cable length versus the PD concentration. The black dots represent the joint locations.

The PD mapping is a graphical representation of the cable length that shows the concentration of the localized PD pulses along the cable length, see Figure 6.

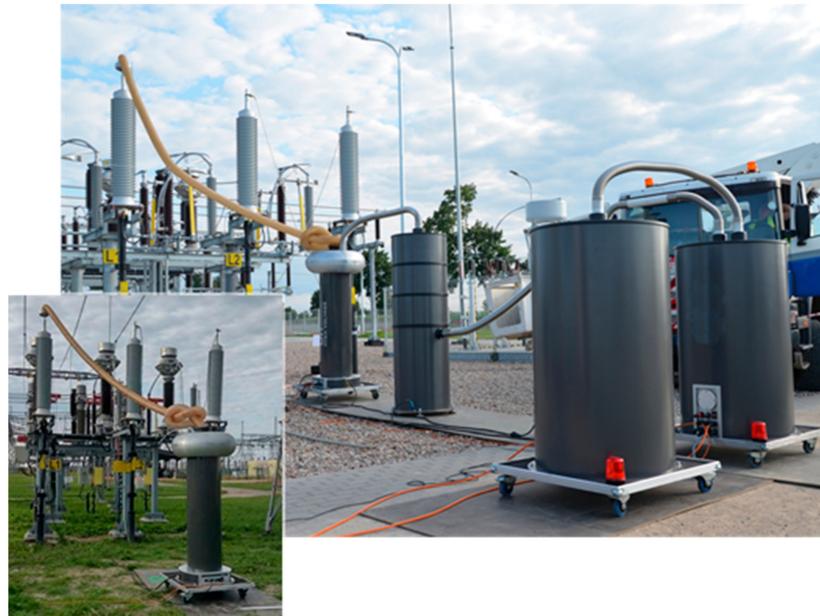
Figure 7. Test setup with the DAC system connected to the 132 kV cable phase being tested at the near end and an additional PD detector at the far end of the same cable phase.

Each phase was tested with DAC with a voltage level of $1.73 \times U_0$ and 50 excitations at the maximum voltage level. The DAC frequency was 18.7 Hz. The background-noise level for the PD measurement was 15 pC. The complete setup on both sides of the cable is shown in Figure 7.

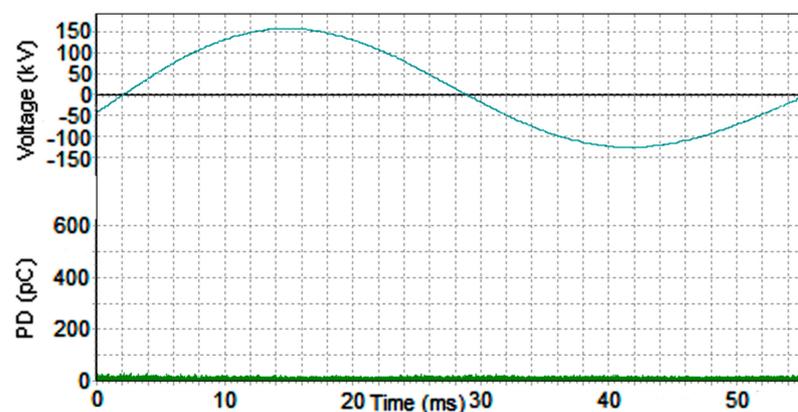
Figure 8. DAC phase-resolved PD pattern only showing the background-noise level.

The test on three phases (executed separately on each phase) resulted in a clear pass as there were no breakdowns and no internal PD was detected in all three phases; see Figure 8.

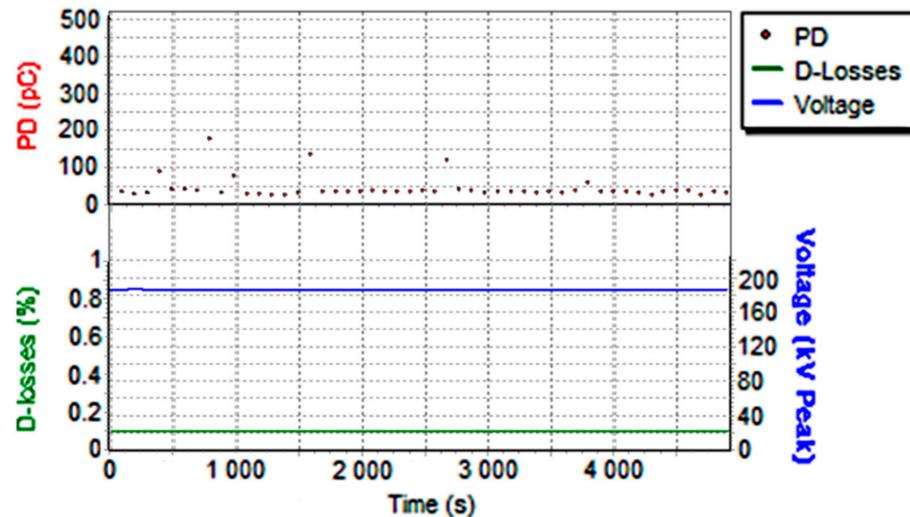
Figure 9. Test result overview of the PD-monitored voltage withstand test for 50 DAC excitations, with a duration of 1 h 25 min.

In Figure 9, an overview of the voltage withstand test for 50 DAC excitations per phase is shown, indicating there was no breakdown during the test. As a result of this successful after-laying test the cable circuit was successfully taken into service operation.

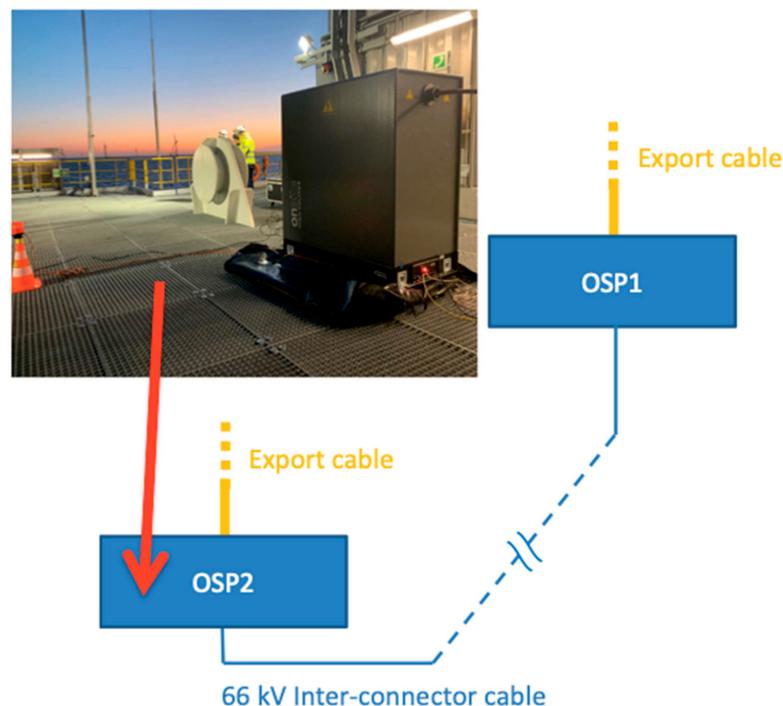
Figure 10. Onsite testing of a 66 kV 10.8 km long XLPE inter-array connector cable system. The HV system is connected to one of the cable section phases. DAC voltages and PD patterns as observed during DAC-monitored voltage withstand testing.

In accordance with [13], the after-laying test of a newly installed XLPE off-shore wind farm 66 kV inter-connector cable system between two offshore substations (OSS) was performed by partial-discharge-monitored damped AC (DAC) testing at $2.0 U_0$ within the recommended frequency testing range (20 Hz–300 Hz) at 79 Hz power; see Figure 10.

The length of the cable system was 10.8 km, and the cable capacitance was 3.04 μF . The connection from the array cable to the system was made via a test adapter cable on the T-connector. The PD background-noise level was below 30 pC.

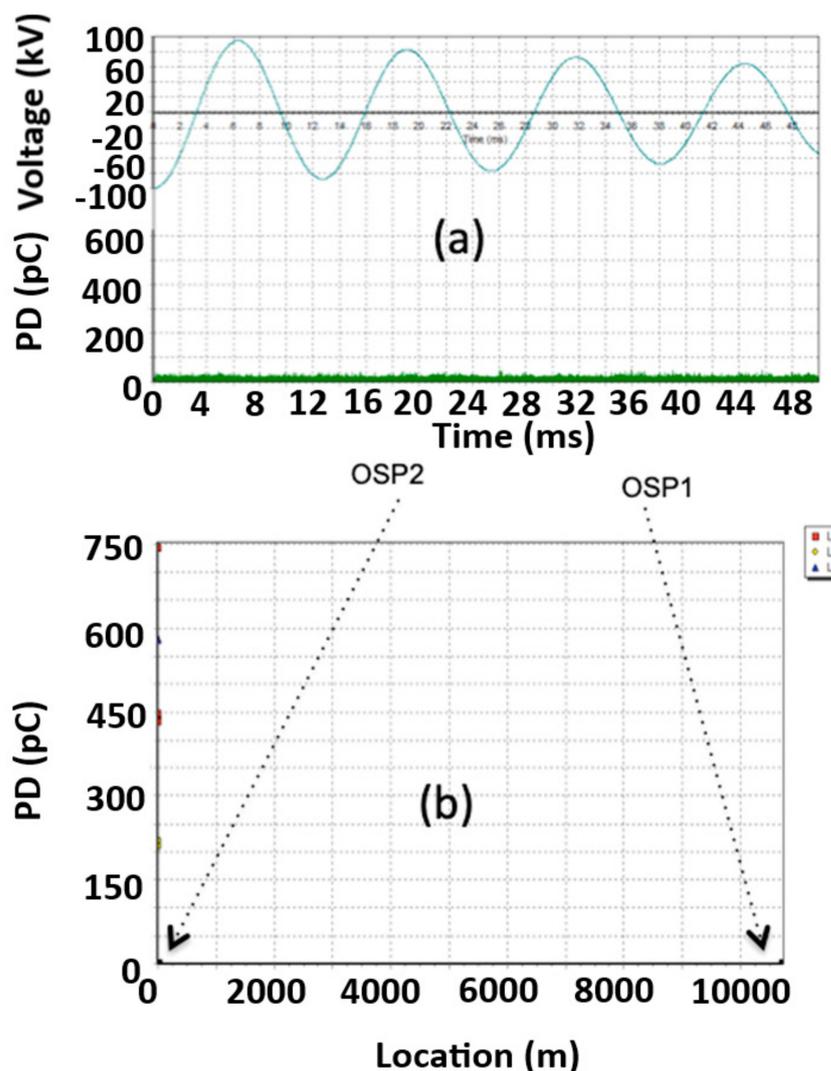
Figure 11. Onsite testing of a 66 kV 10.8 km long XLPE inter-array connector cable system: (a) PD pattern as observed up to 2.0 U_0 test voltage (b) PD mapping showing that there is no PD observed above the background-noise level of 30 pC.

As a result, the after-laying testing using a damped AC voltage with a DAC HV110os system combined with PD detection proved to be effective for the PD-monitored testing of a long-length, 10.8 km newly installed 66 kV inter-cable system between two offshore substations; see Figure 11.
